# INSPECTION REPORT

For the Property at:  
**SAMPLE PROPERTY**  
GATINEAU, QC XXX XXX

RE: Report No. 1230  
Sample Property  
Gatineau, QC  
XXX XXX

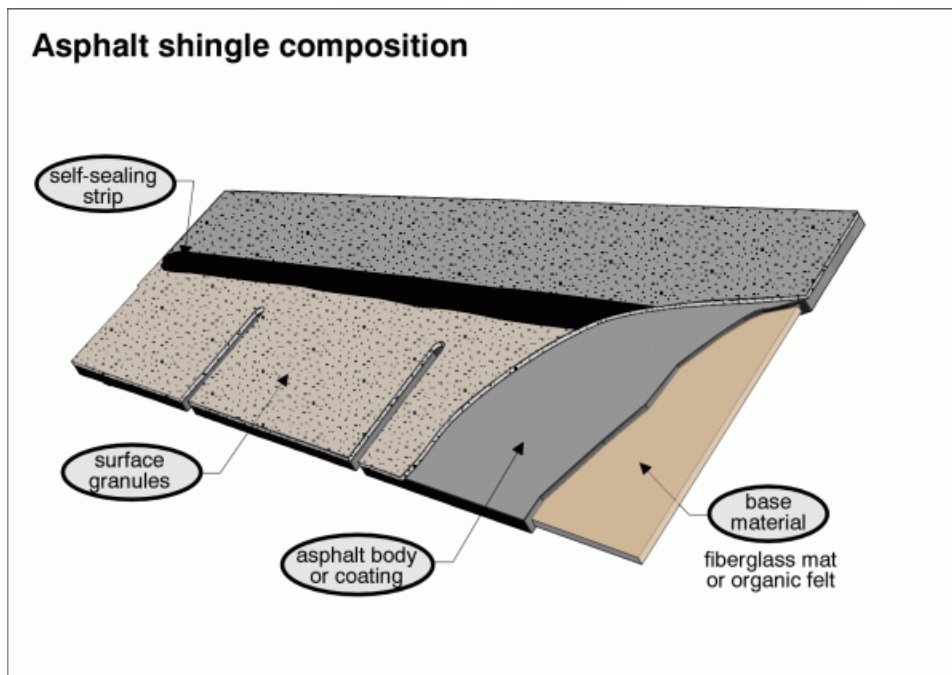
The asphalt shingle roofing system was observed to be at or nearing the end of its expected service life. Widespread signs of age-related deterioration were noted, including granular loss, tab separation, and exposed fibreglass matting at various locations. In addition, localized soft spots were identified adjacent to the main plumbing vent stacks at the front, suggesting deterioration of the underlying roof sheathing in this area.

It is recommended that a qualified roofing contractor perform a comprehensive evaluation of the roof. Localized repairs to the deteriorated sheathing around the plumbing vent stacks are required; however, due to the overall age and condition of the roofing material, budgeting for a complete roof replacement in the near future is strongly recommended.

Replacement should include inspection and repair of any damaged roof decking, installation of new underlayment, flashing, and plumbing vent flashings, as required.

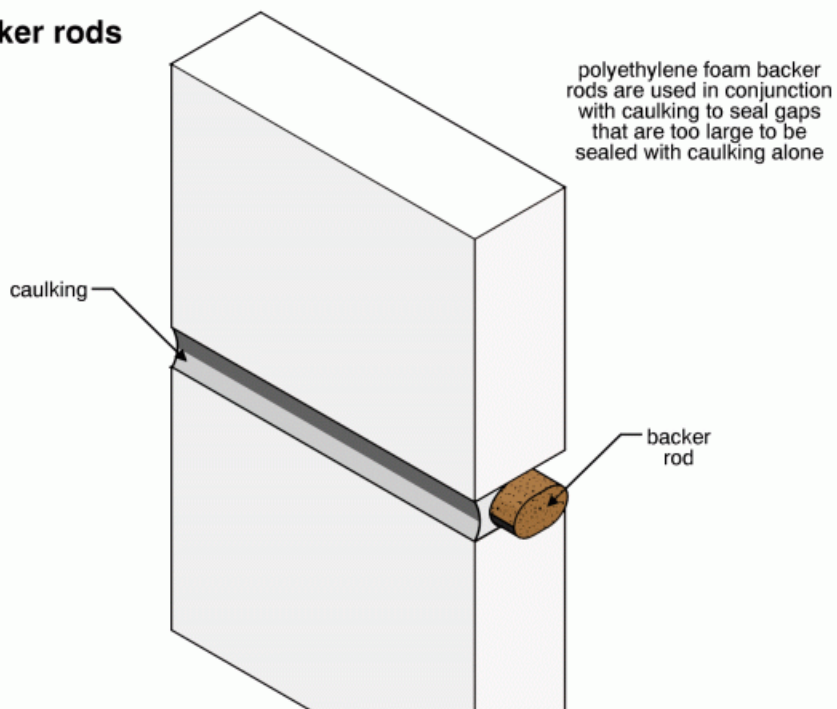
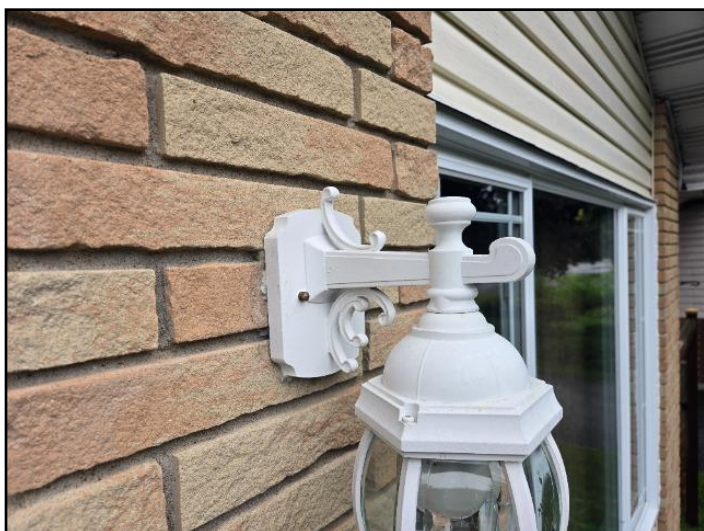
Sealant missing

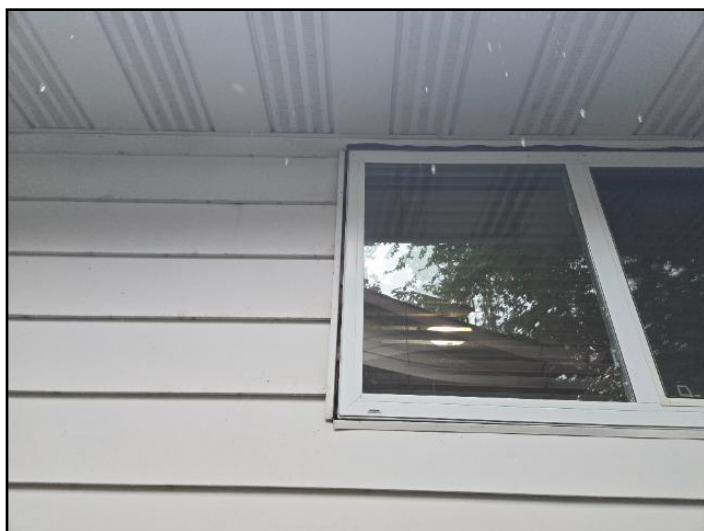
Sealant missing

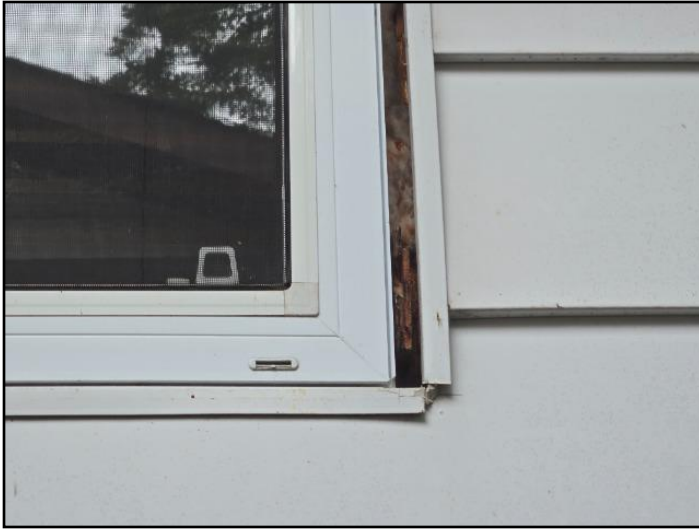
*Sealant missing*

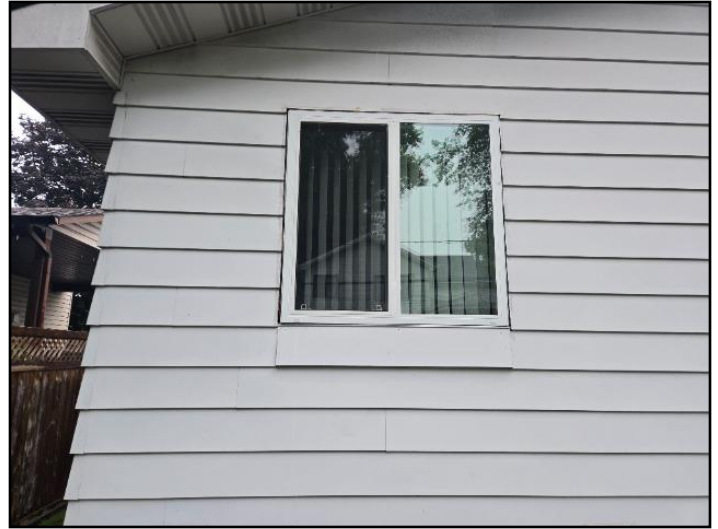
*Sealant missing*

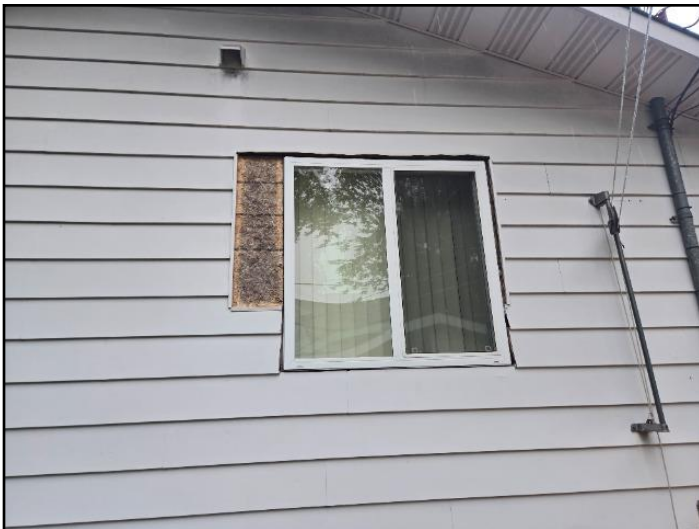
*Sealant missing*

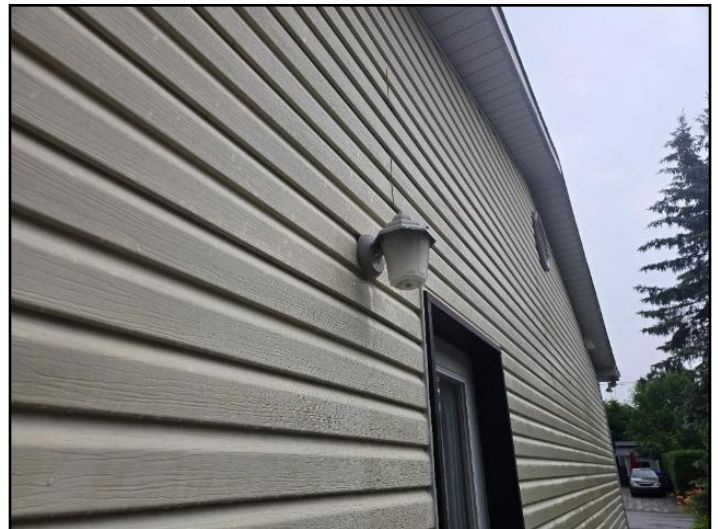
*Sealant missing*

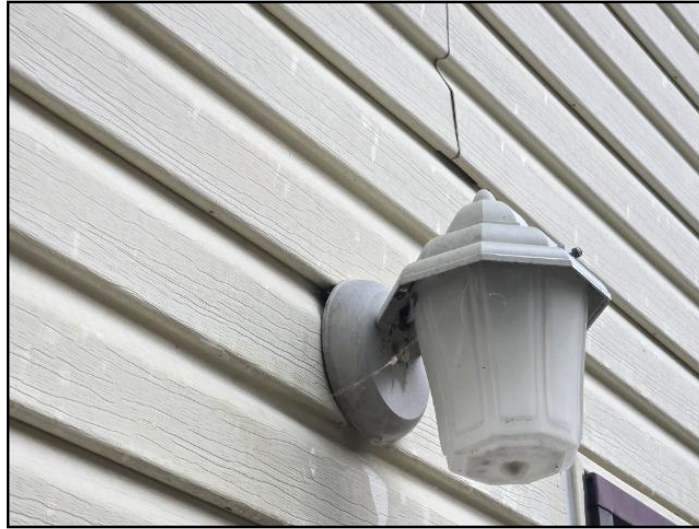
*Sealant missing*

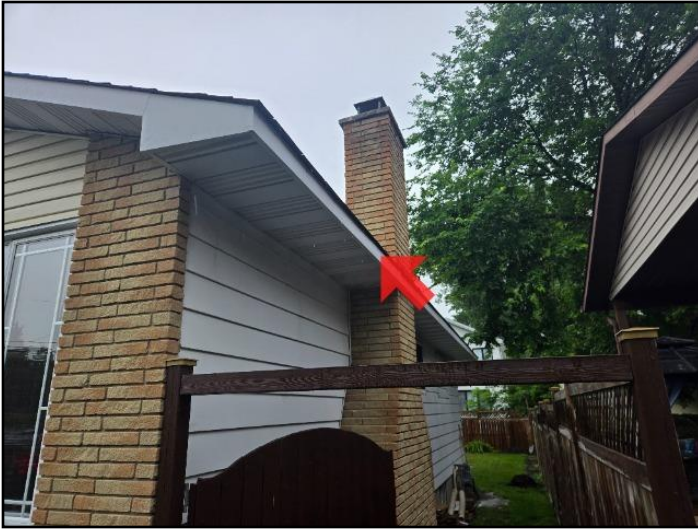
Missing

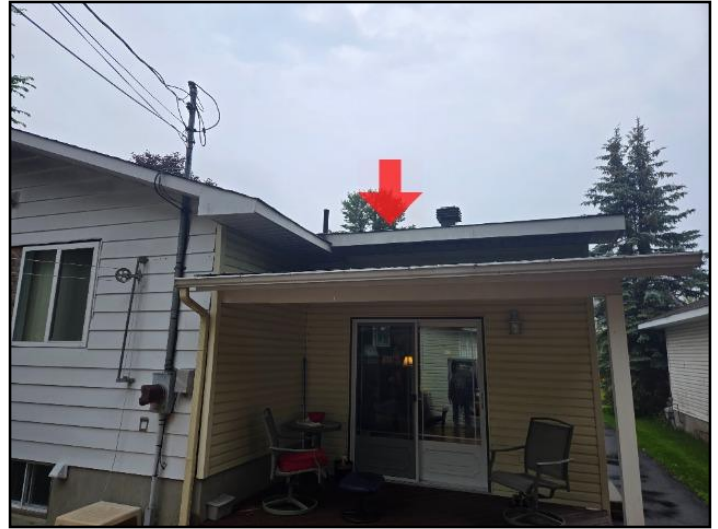
Missing

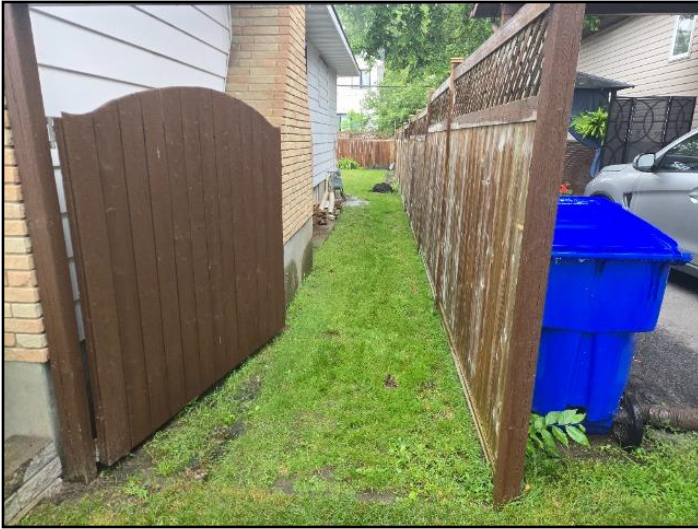
*Improper slope or drainage*

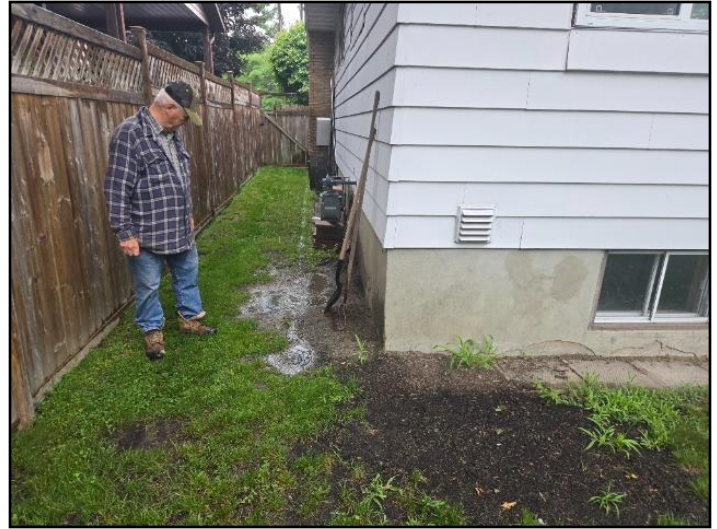
*Improper slope or drainage*

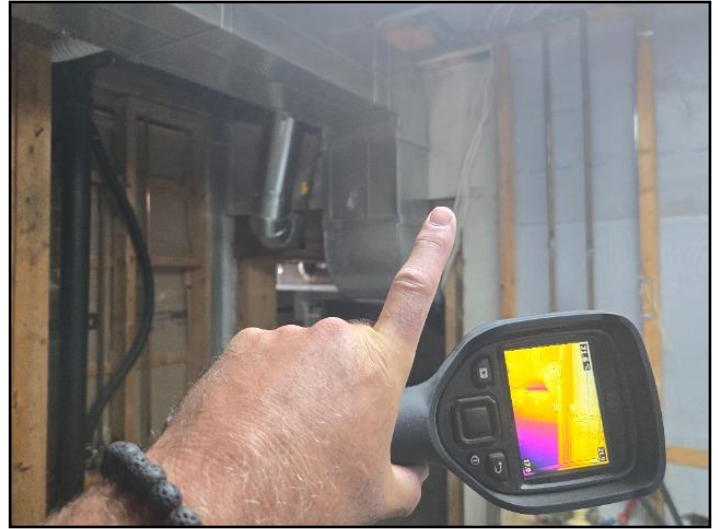
Location of minor crack

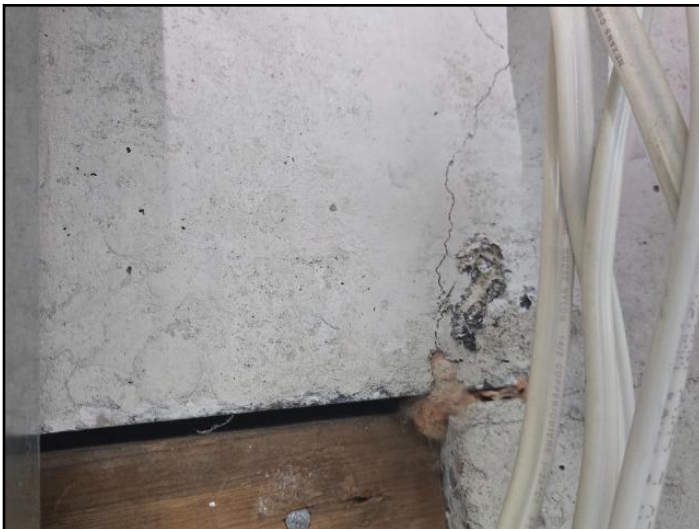
Cracked

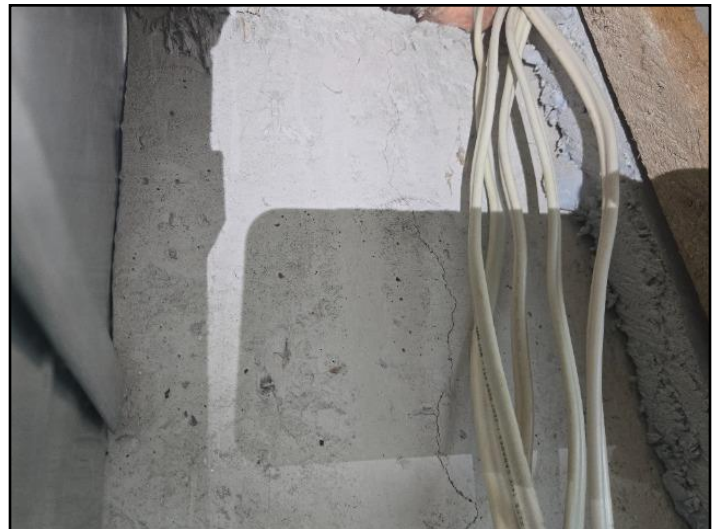
Cracked

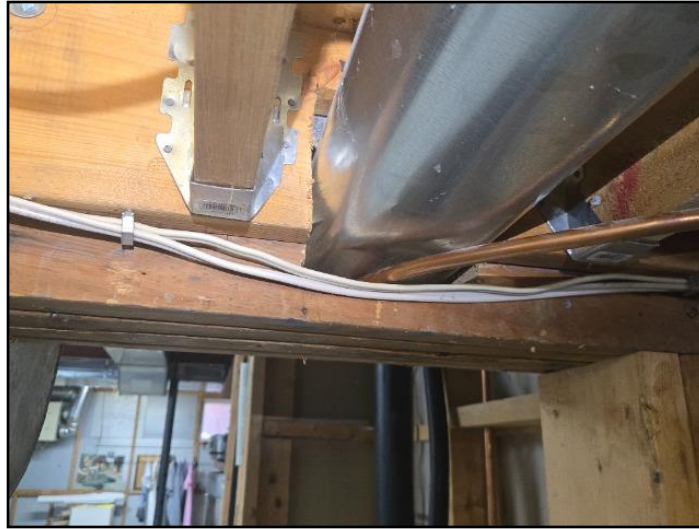
*Wood header compromised*

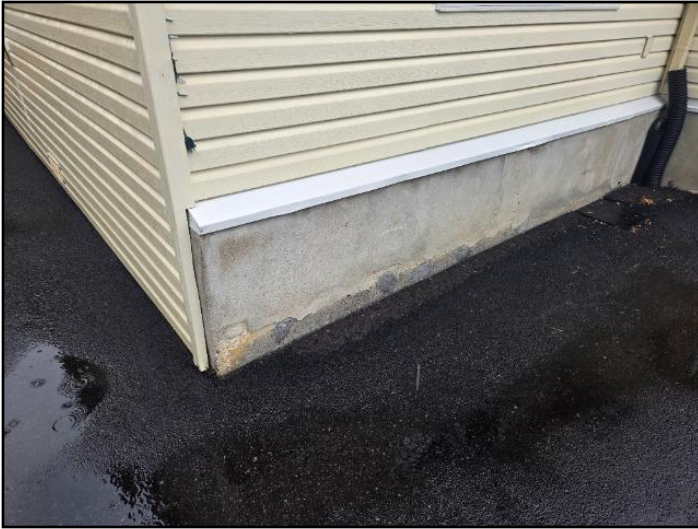
Parging damaged

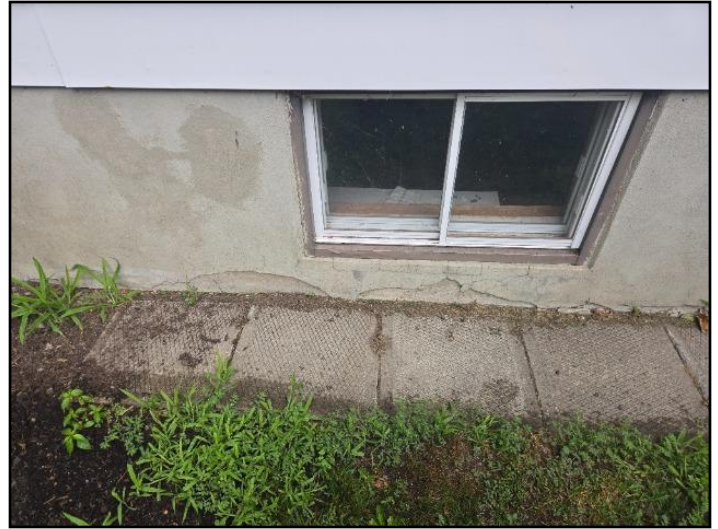
Parging damaged

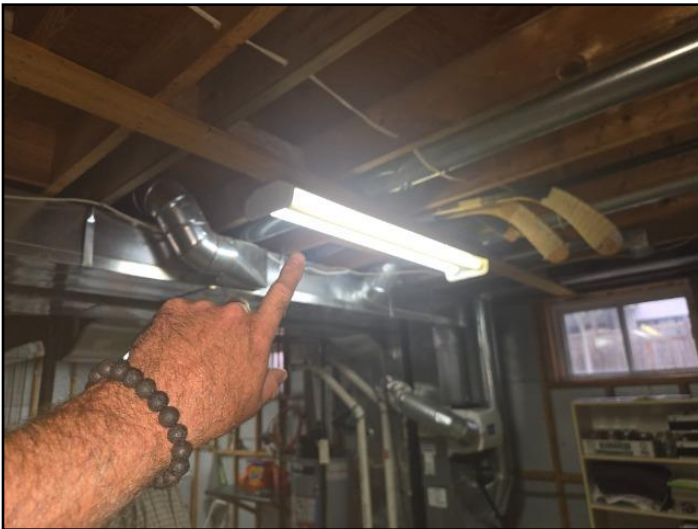
No smoke or carbon monoxide detectors were observed within the mechanical room containing the gas-fired furnace, in the vicinity of the gas fireplace located in the living room, or near the kitchen containing the gas range. Although detector placement requirements vary, the absence of detectors in these areas reduces the level of occupant protection in the event of fire or a carbon monoxide incident.

*Detectors missing*

It is recommended that smoke and carbon monoxide detectors be installed and maintained in accordance with the manufacturer's instructions and the applicable requirements of the Quebec Construction Code. At a minimum, smoke alarms should be installed on every storey and outside sleeping areas, while carbon monoxide alarms should be installed outside sleeping areas and in locations serving fuel-burning appliances. Test all alarms regularly and replace units at the end of their service life, typically every 7 to 10 years, depending on the manufacturer's recommendations.

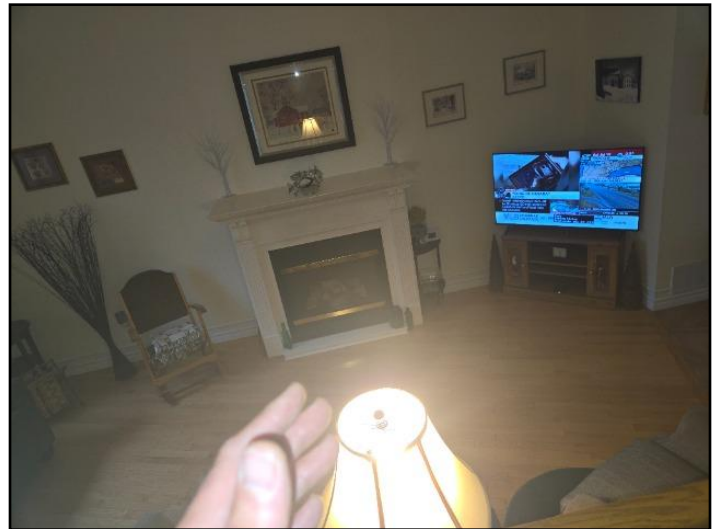
*Detectors missing*

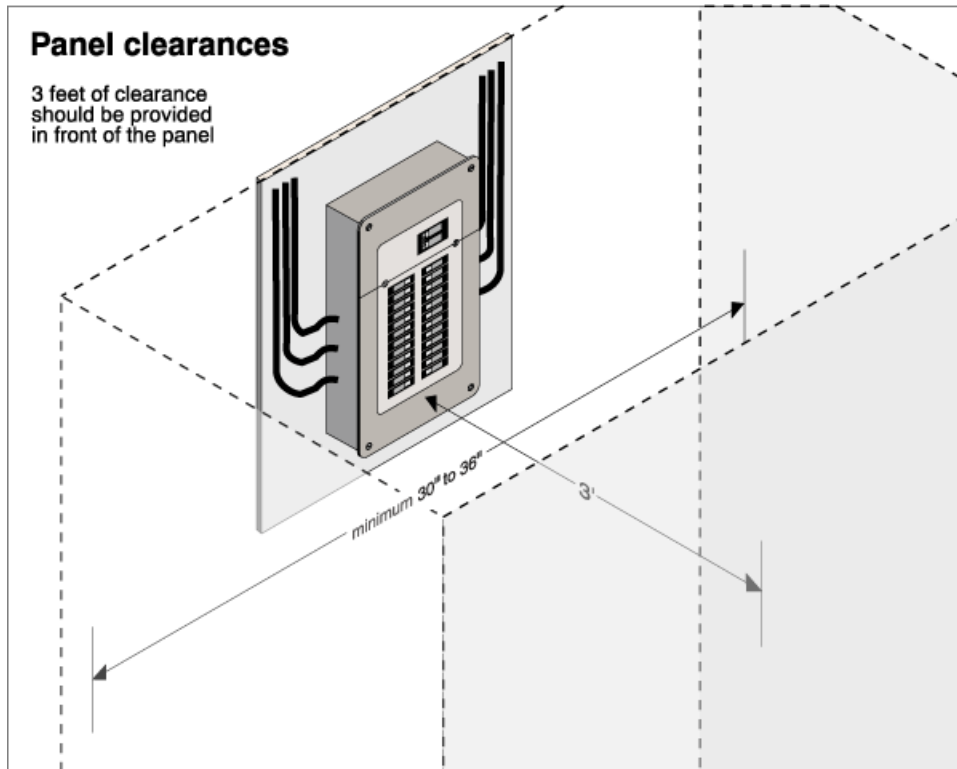
The main electrical panel was obstructed by the washer and dryer. The workshop subpanel was installed above the utility sink, not recommended near a water source and surrounded by shelving and stored materials. These conditions restrict access and do not provide a suitable working position in front of the panels.

Box location poor

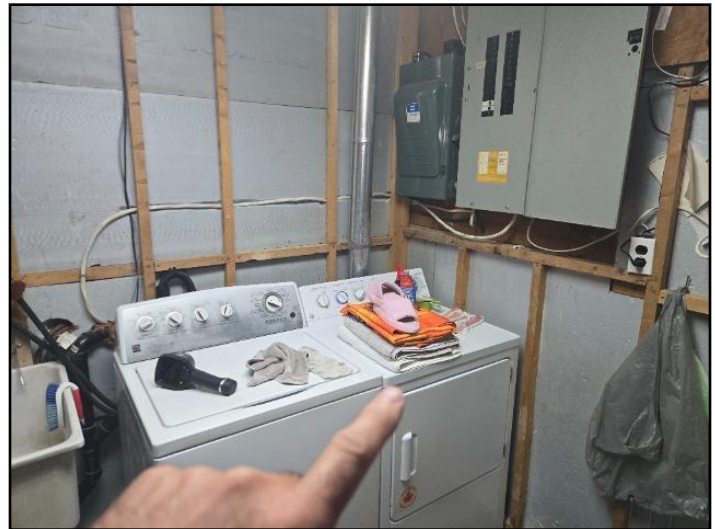
Box location poor

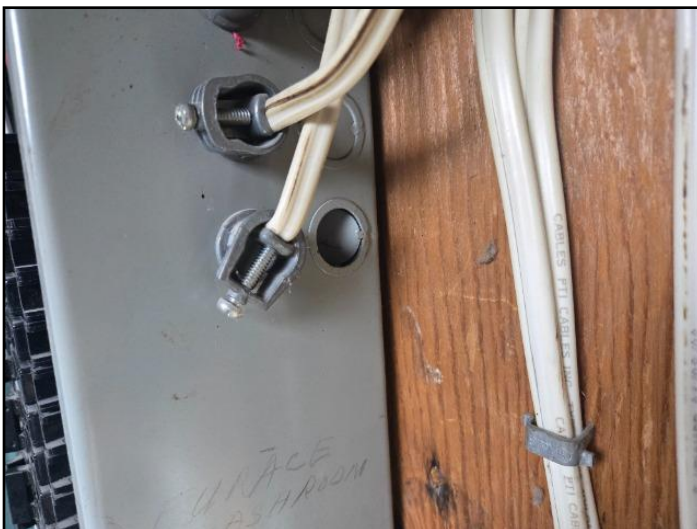
Unprotected openings

It is recommended that a licensed electrician install approved knockout seals in all unused panel openings and verify that all cable entries are properly secured and protected to maintain the safety and integrity of the electrical enclosure.

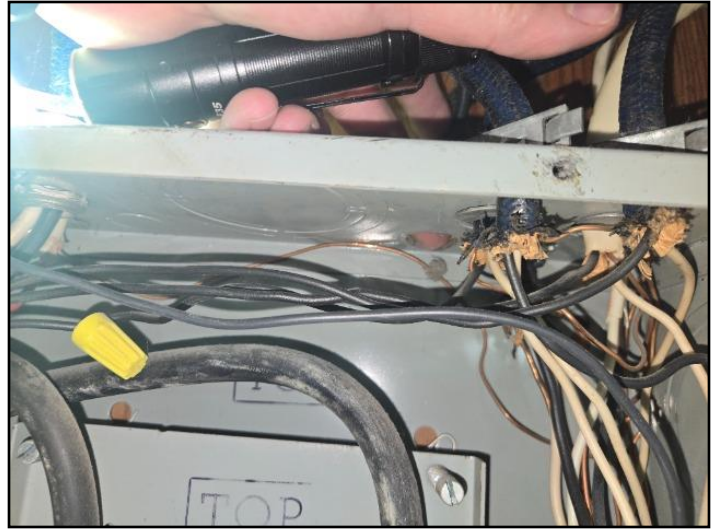
Unprotected openings

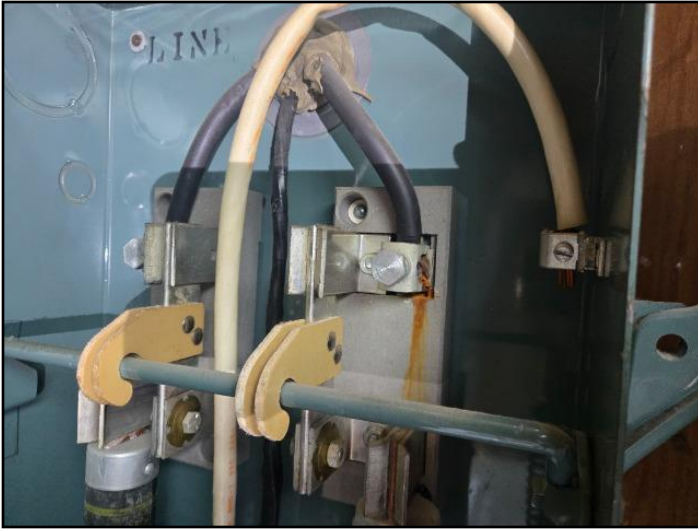
Surface corrosion and rust staining were observed within the electrical service disconnect enclosure, including around the lower portion of the cabinet and one service lug. The corrosion pattern suggests previous or ongoing moisture intrusion into the enclosure. No overheating, arcing, or damaged conductors were observed at the time of the inspection; however, the source of the moisture could not be determined during this visual inspection.

Rust

Have a licensed electrician evaluate the service disconnect to determine the source of the moisture intrusion, verify the integrity of the electrical connections and lugs, and clean or replace affected components as required. Any openings or

entry points allowing water to enter the enclosure should be properly sealed to prevent further corrosion.

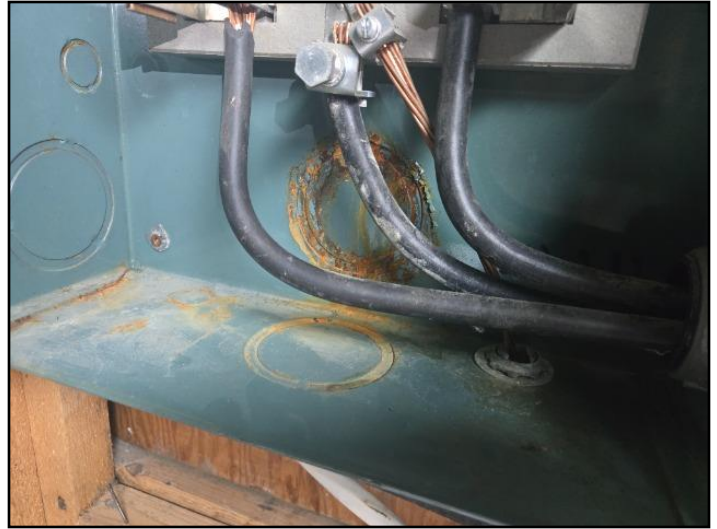
Rust

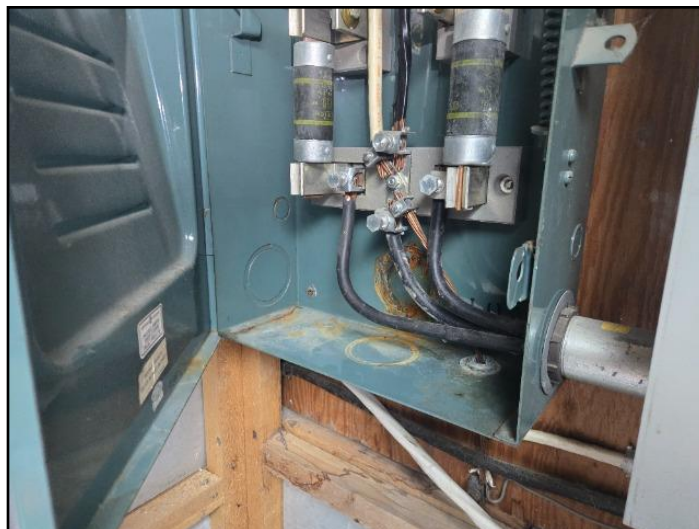
Rust

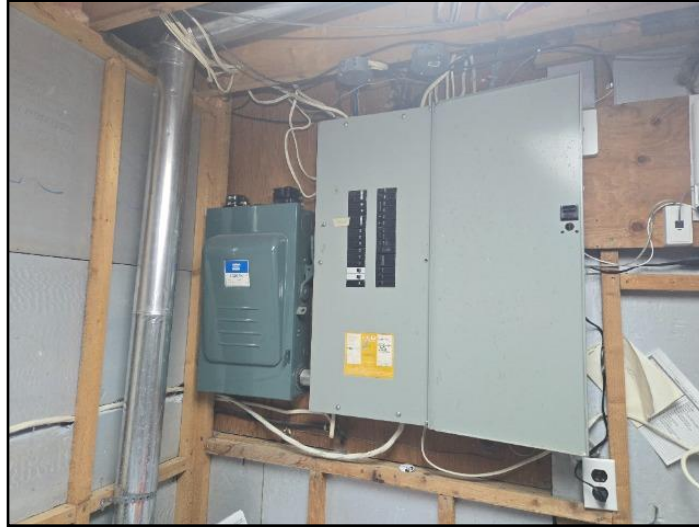
The residence was constructed in approximately 1949, and the installed CEB electrical service panel appears to be an older unit that is approaching or has exceeded its typical expected service life. Although no immediate operational deficiencies affecting the panel were identified beyond those noted elsewhere in this report, the age of the equipment should be considered when planning future upgrades.

*Aging*

Due to the age of the electrical service equipment, it is recommended that the panel be evaluated by a licensed electrician as part of future maintenance planning. Consider budgeting for the replacement or modernization of the electrical service panel to improve long-term reliability, safety, and compatibility with modern electrical demands.

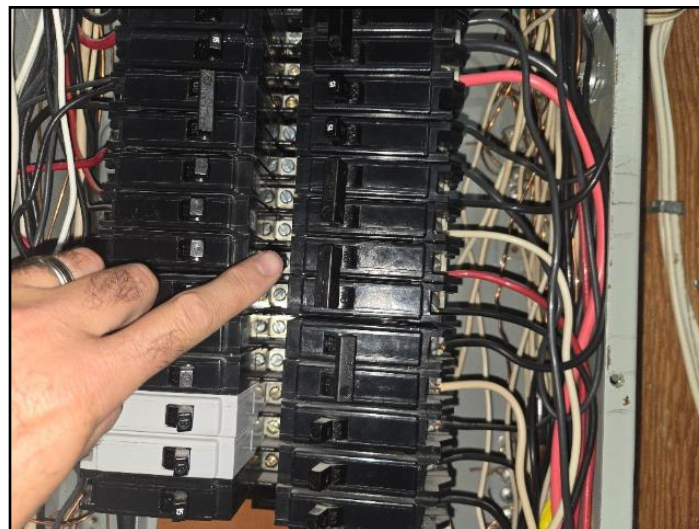
The air-conditioning condenser was supplied by a double-pole 20-ampere breaker, exceeding the manufacturer's maximum permitted overcurrent protection. This may reduce protection against excessive current and equipment damage.

20 Amp breaker

Have a licensed electrician replace the breaker with the manufacturer-specified rating and verify the circuit conductors, disconnect, and equipment connections.

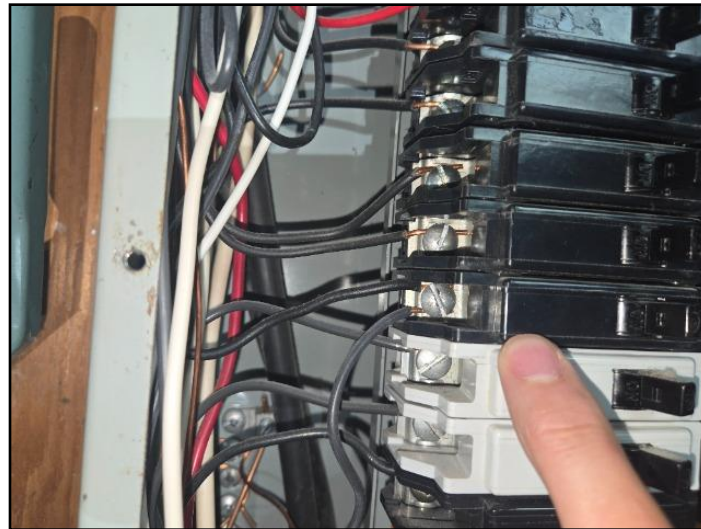
Double taps

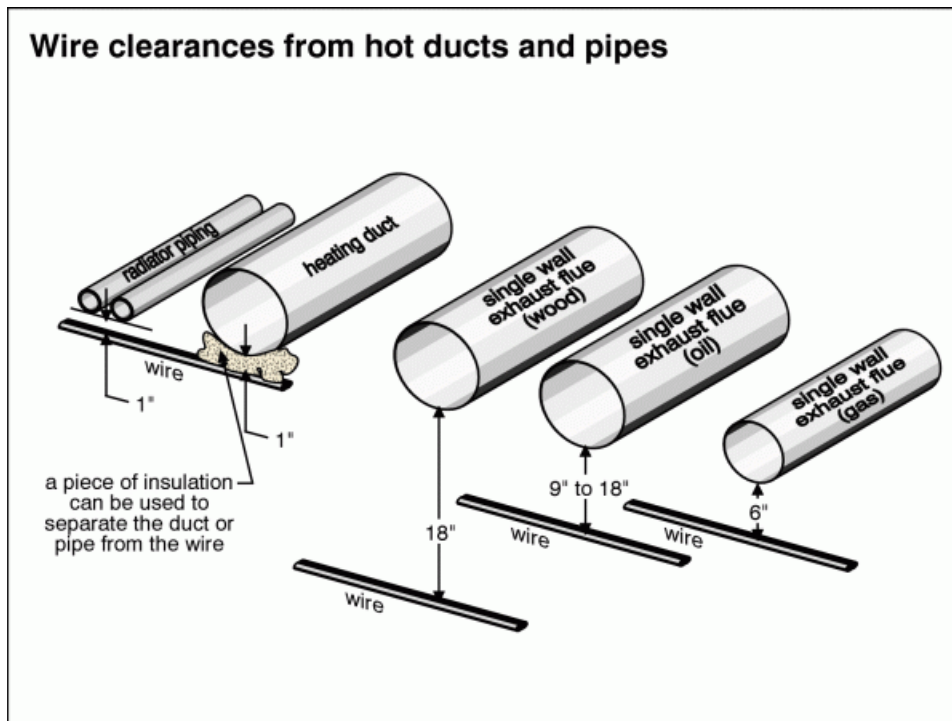
*Wiring touching heating supply ductwork*

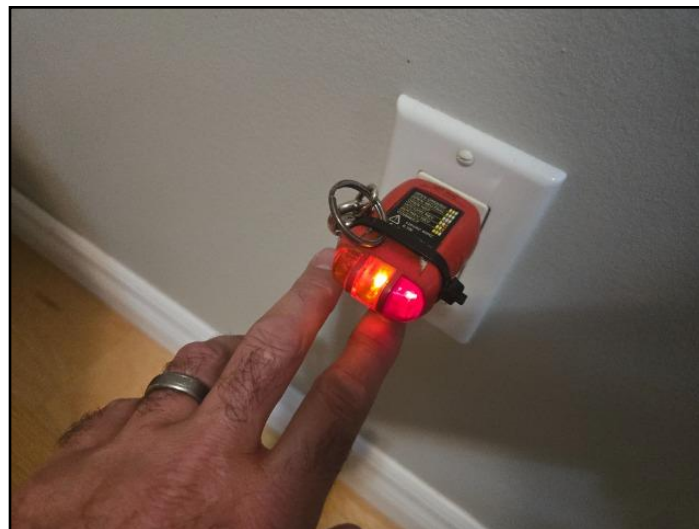
*Reversed polarity Study*

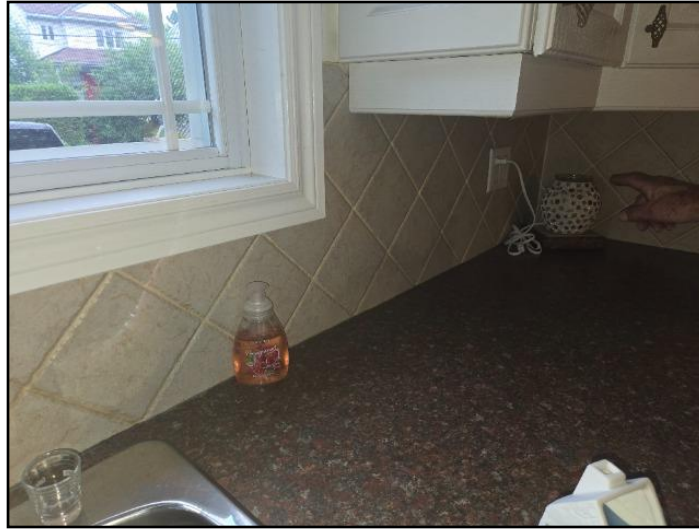
No GFCI/GFI (Ground Fault Circuit...

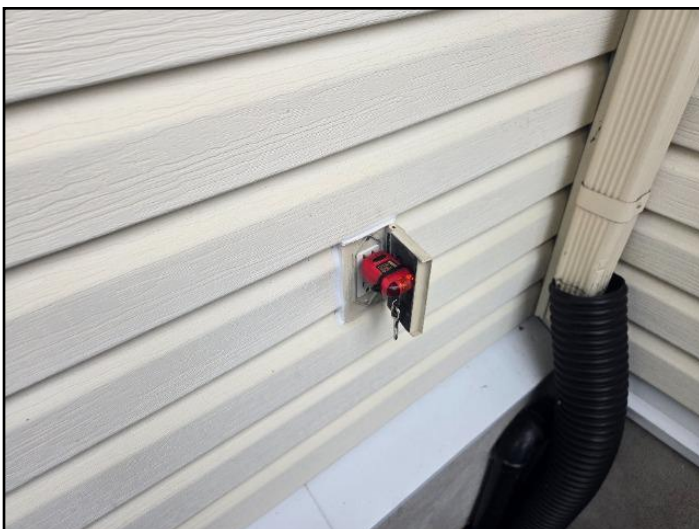
Test faulty on GFCI

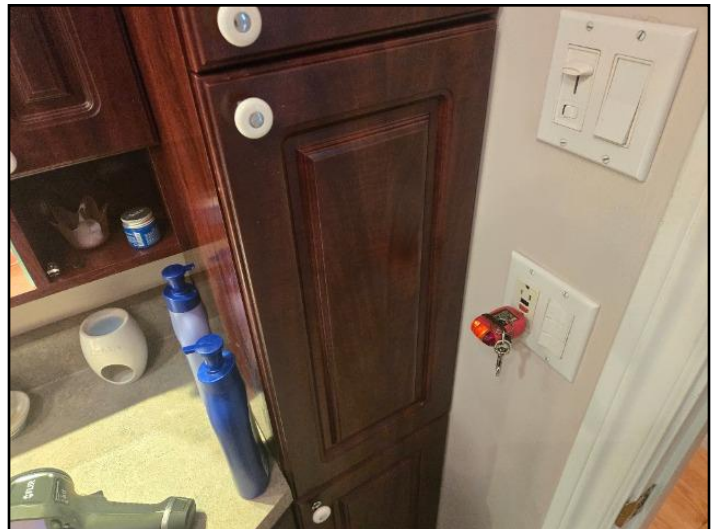
Test faulty on GFCI

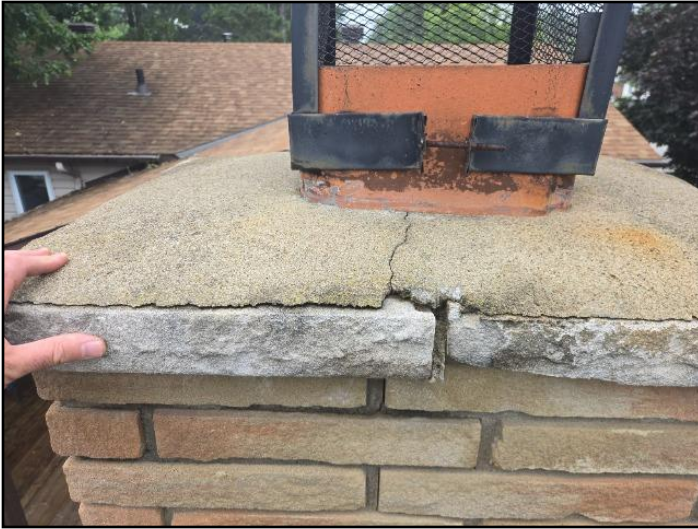
The masonry chimney exhibited signs of age-related deterioration at the crown and upper chimney structure. Separation and displacement of the stone cap were observed, along with open mortar joints beneath the capstones. These conditions can permit water infiltration into the chimney structure, accelerating deterioration through freeze-thaw cycles and potentially causing damage to the masonry, chimney liner, and adjacent building components. No evidence of significant movement was observed at the time of the inspection; however, the noted deficiencies require corrective action.

It was also observed that the chimney appears to contain an original clay tile flue liner. While clay tile liners were commonly installed at the time of construction and may continue to function if in good condition, they are more susceptible to cracking and deterioration from age, thermal expansion, and previous chimney fires. Many insurance providers now prefer or require older masonry chimneys serving wood-burning appliances to be upgraded with a listed stainless steel liner system before coverage is provided or renewed.

Cracked

It is recommended that a qualified masonry contractor repair the chimney by reconstructing or replacing the damaged chimney crown, resetting and securing the displaced capstones, repointing deteriorated mortar joints, and sealing the masonry as required. The chimney flashing and overall chimney structure should also be evaluated to ensure a watertight installation.

Before operating the fireplace, the chimney should be inspected by a qualified WETT-certified technician. If the original clay tile liner is found to be cracked, deteriorated, or unsuitable for continued service, it should be upgraded with a code-compliant stainless steel chimney liner in accordance with the Quebec Construction Code and applicable CSA B365 requirements. This upgrade improves fire safety, reduces the risk of heat transfer to combustible materials, and helps minimize the potential for chimney fires while satisfying many insurance carrier requirements.

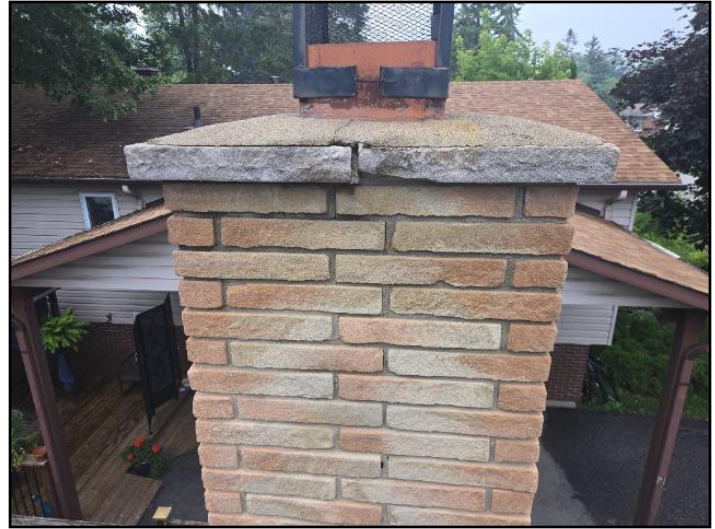
Cracked

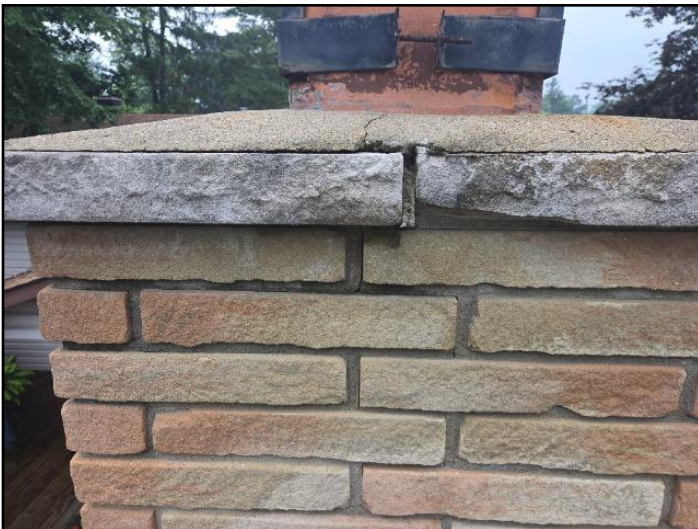
Cracked

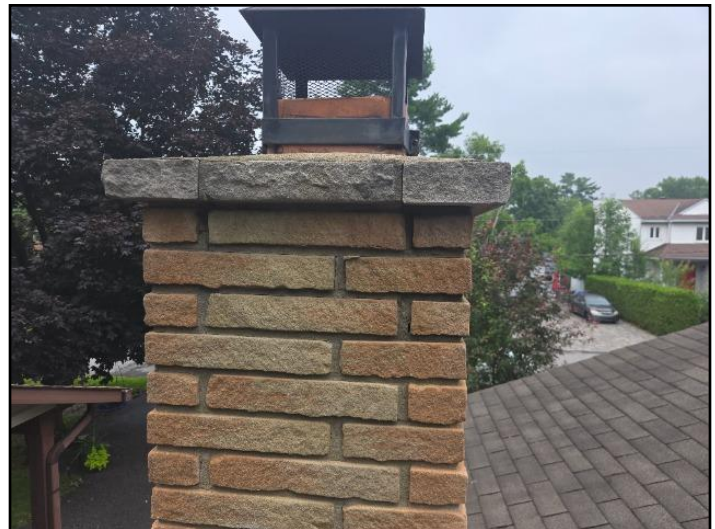
Cracked

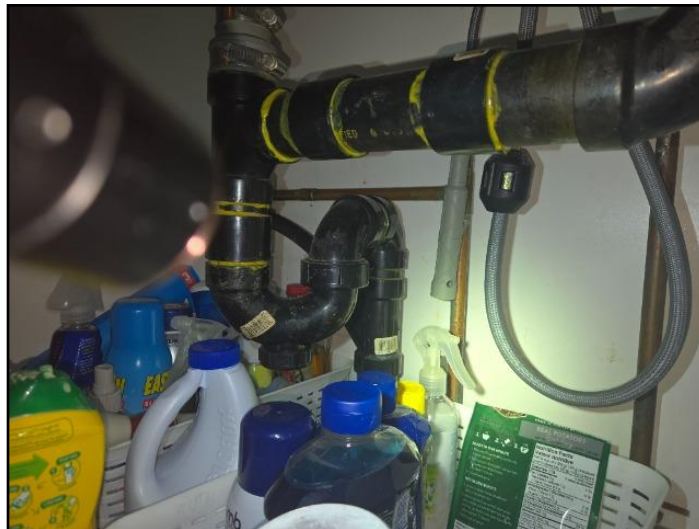
Missing

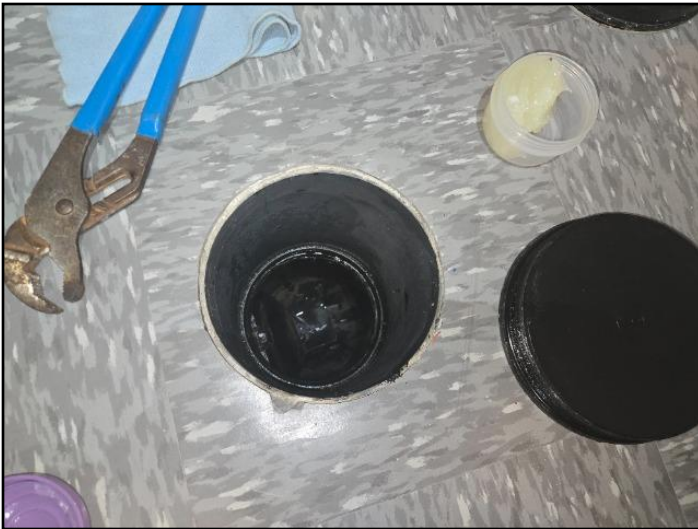
At the time of the inspection, the access cap to the backwater valve was removed for inspection. Water was observed beneath the inspection cap. Further examination determined that the rubber O-ring gasket (seal) installed within the threaded access cap was damaged or improperly seated, allowing minor seepage to enter around the cap.

Inoperative

It is recommended that the damaged O-ring gasket (inspection cap seal) be replaced with a manufacturer-approved replacement gasket and that the access cap be reinstalled and tightened in accordance with the manufacturer's specifications to provide a watertight seal. Following replacement, the valve should be periodically inspected and maintained to ensure it remains clean, accessible, and capable of operating as intended during a sewer backup event.

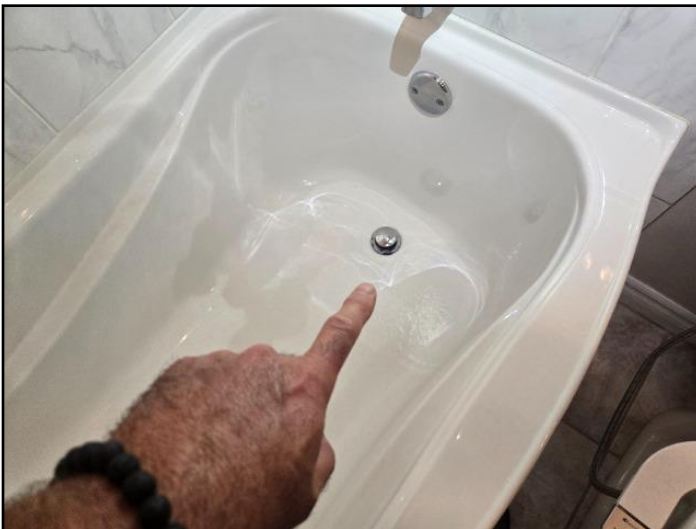
Surface defects

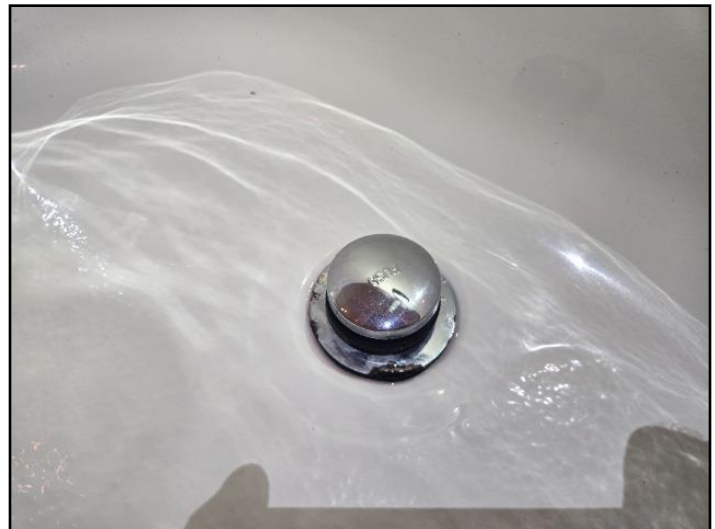
Surface defects

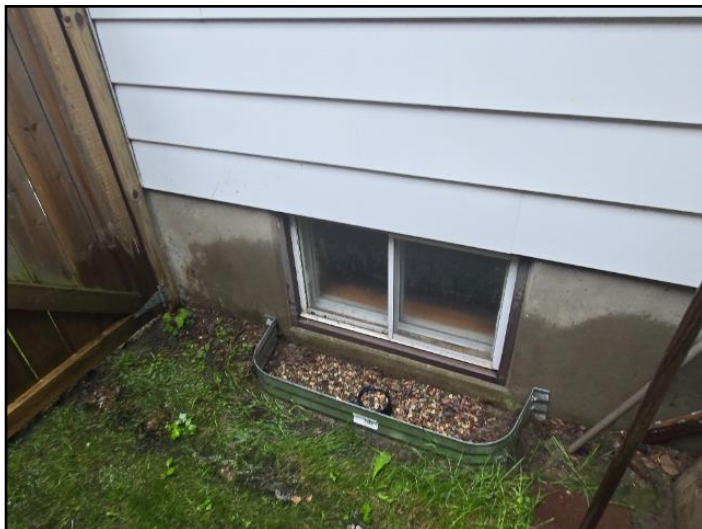
The basement windows appeared older and likely original to the property and consisted of single-glazed sliding units. Fogging was also observed between the panes of one window at the front living room addition, indicating failure of the

Old

Consider replacing the older basement windows with modern energy-efficient units. Have a qualified window contractor replace the failed insulated glazing unit at the front living room window; where the frame remains serviceable, the sealed glass unit can typically be replaced without replacing the entire window assembly.

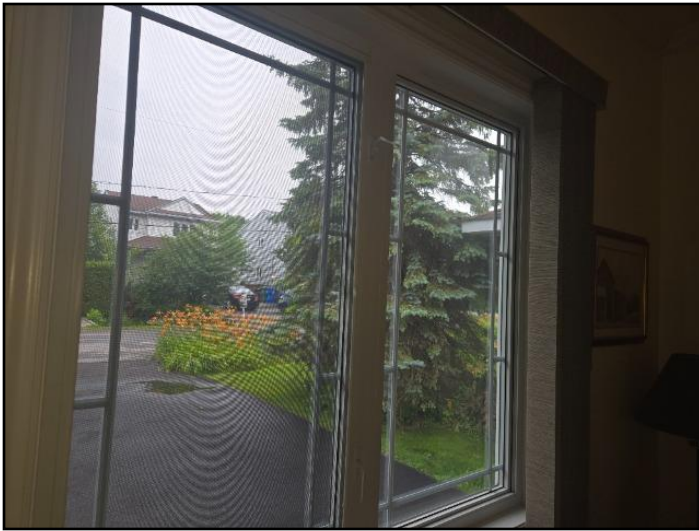
*Failed window seal*

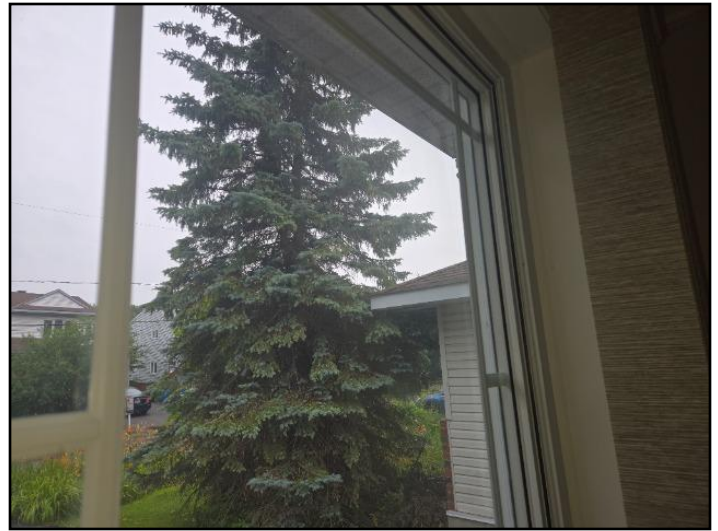
*Failed window seal*
