# INSPECTION REPORT

For the Property at:  
**SAMPLE PROPERTY**  
GATINEAU, QC XXX XXX

Prepared for: SAMPLE CLIENT  
Inspection Date: Thursday, March 19, 2026  
Prepared by: Shaun Botes

RE: Report No. 1228  
Sample Property  
Gatineau, QC  
XXX XXX

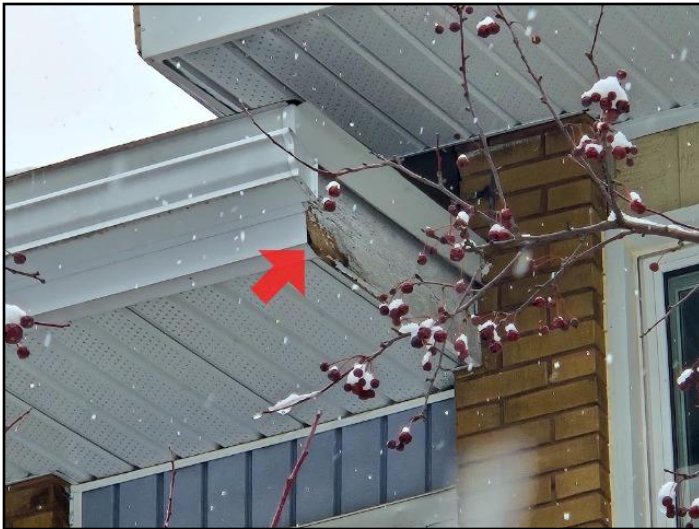
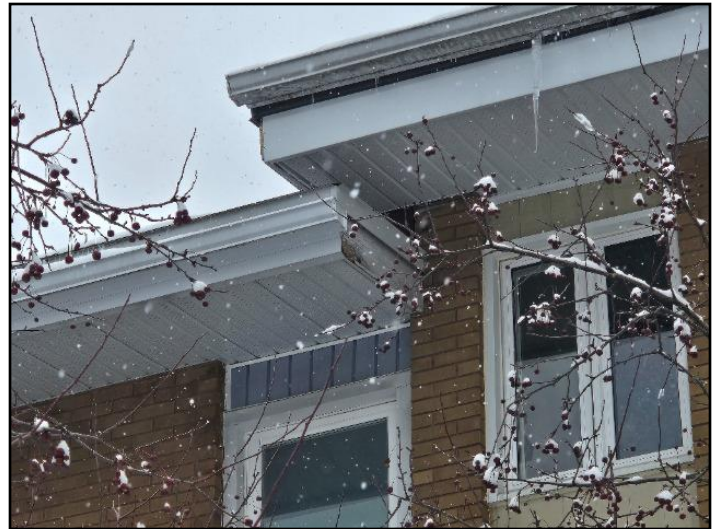
*Loose or missing pieces*

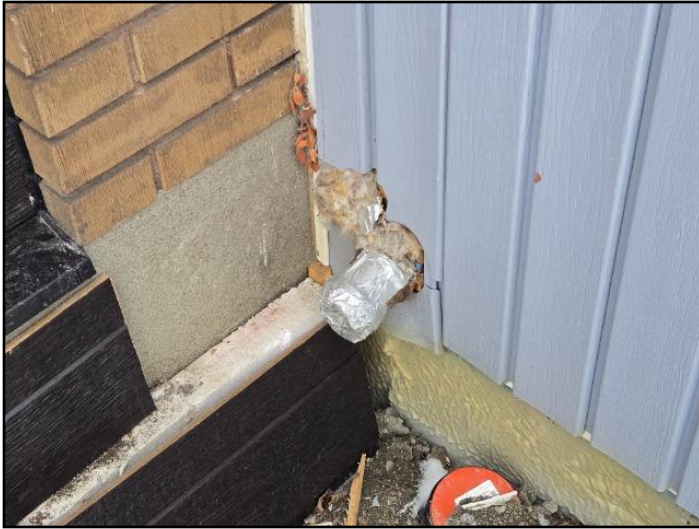
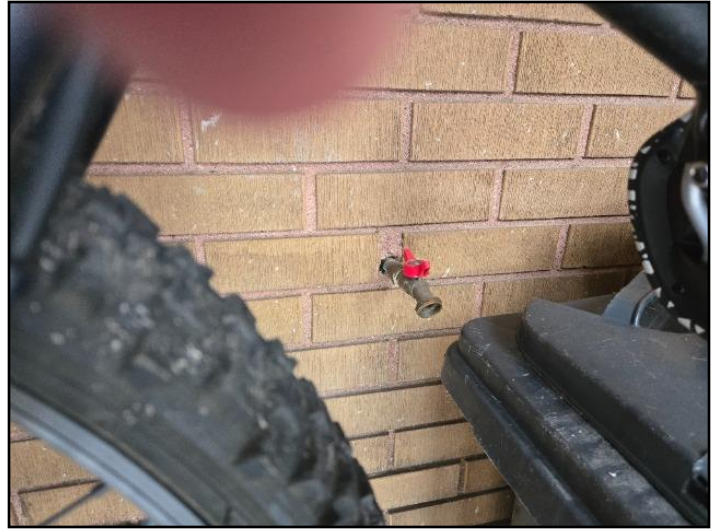
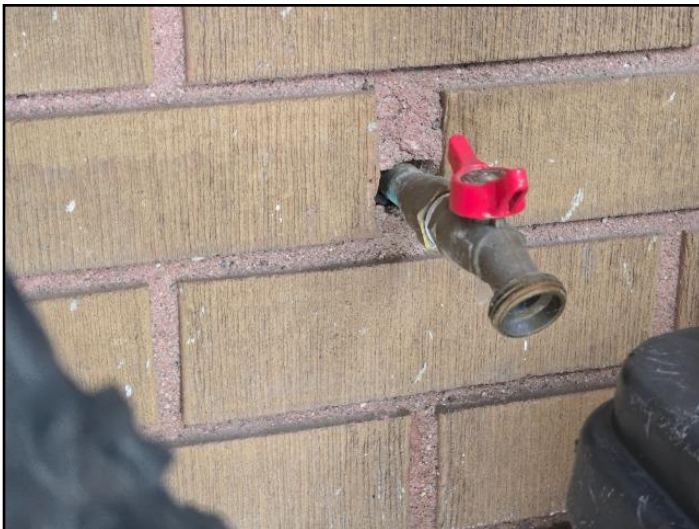
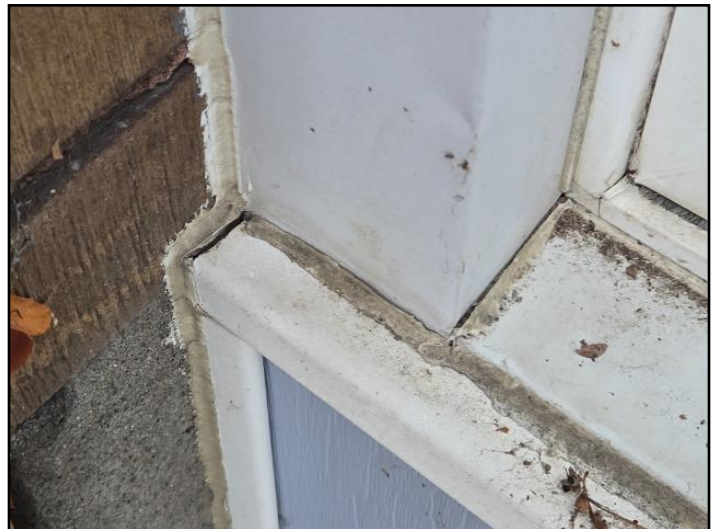
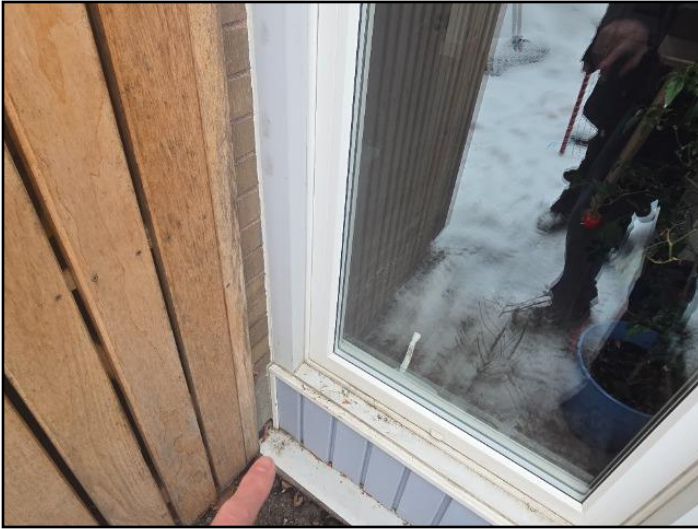
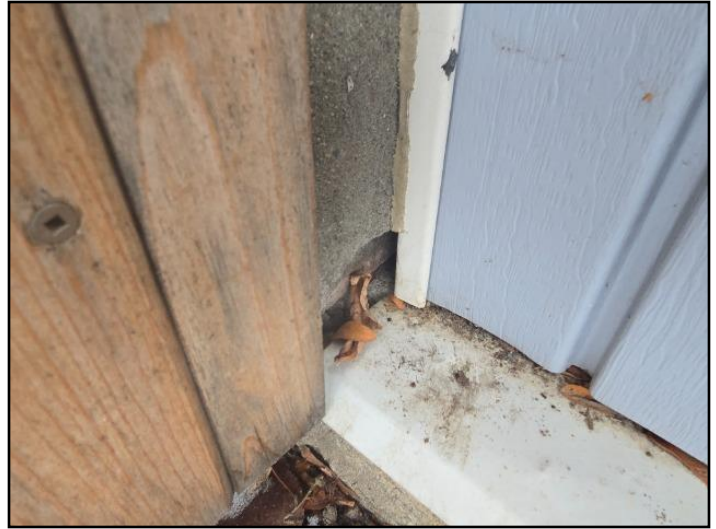
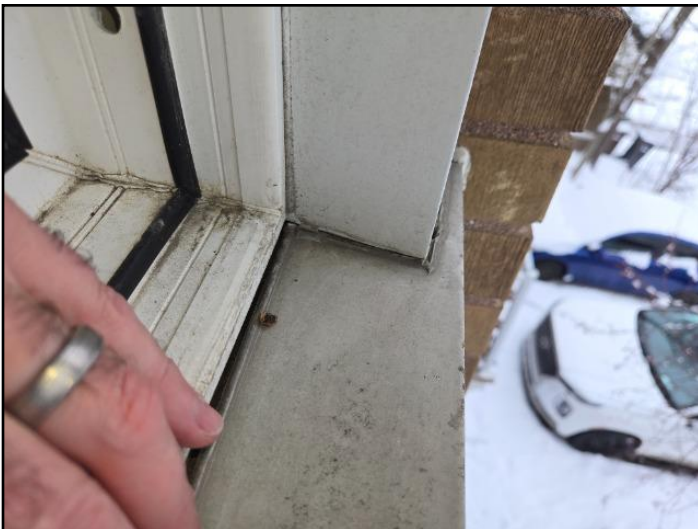
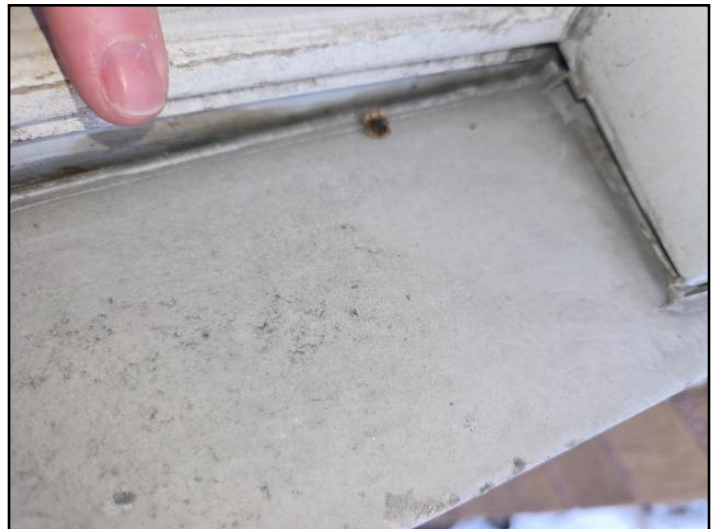
*Caulking missing or ineffective*

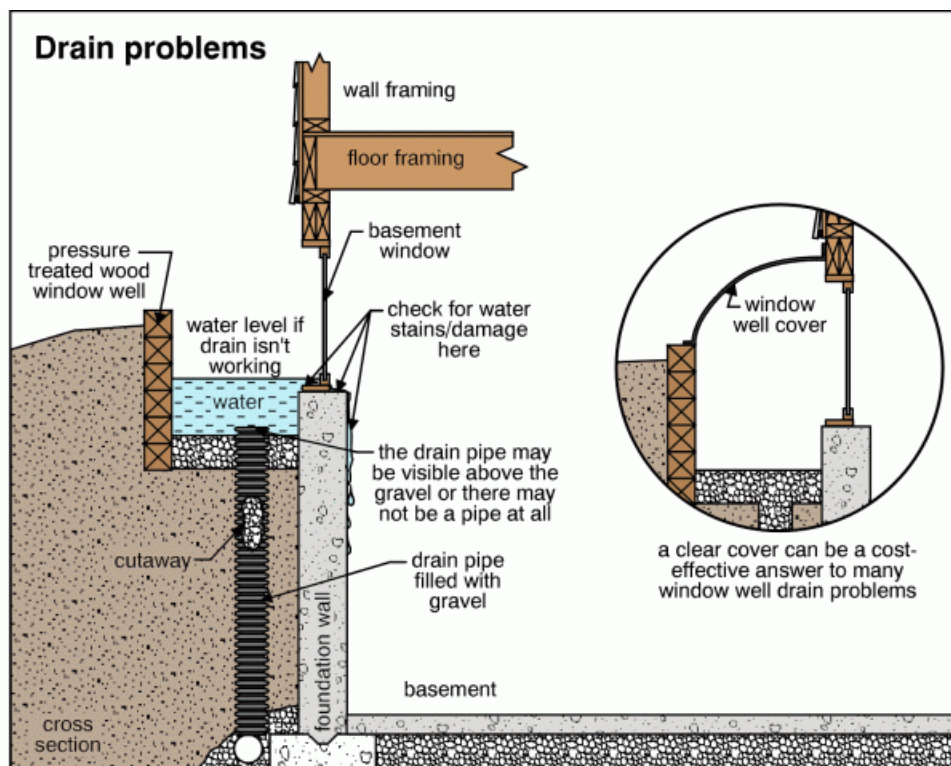
*Obstructed/clogged*

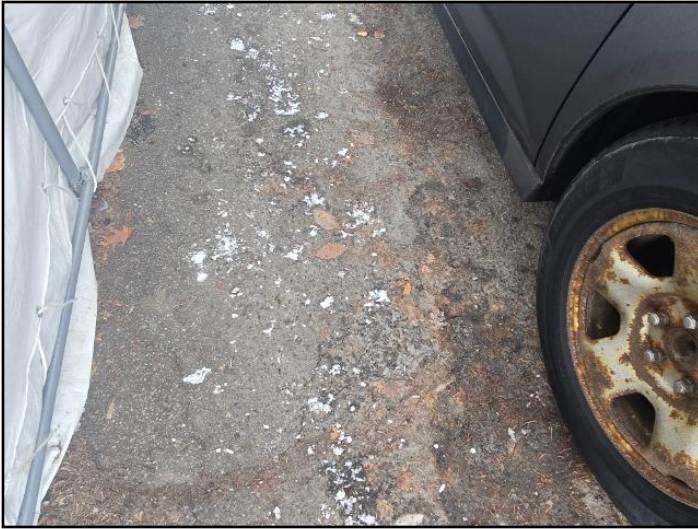
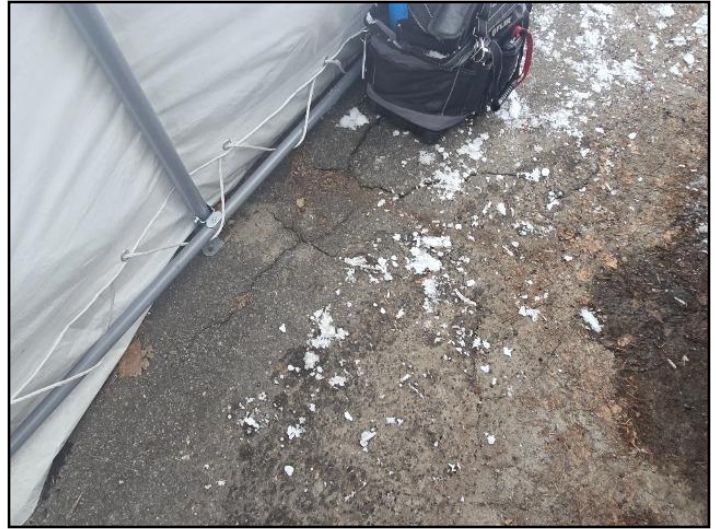
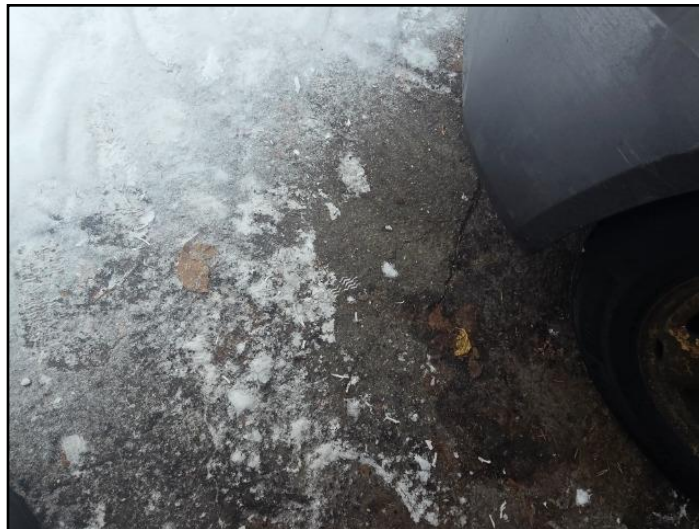
Cracked or damaged surfaces

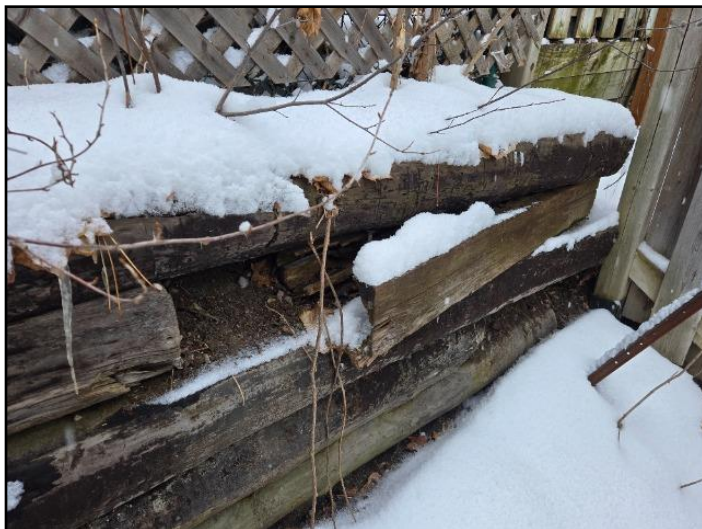
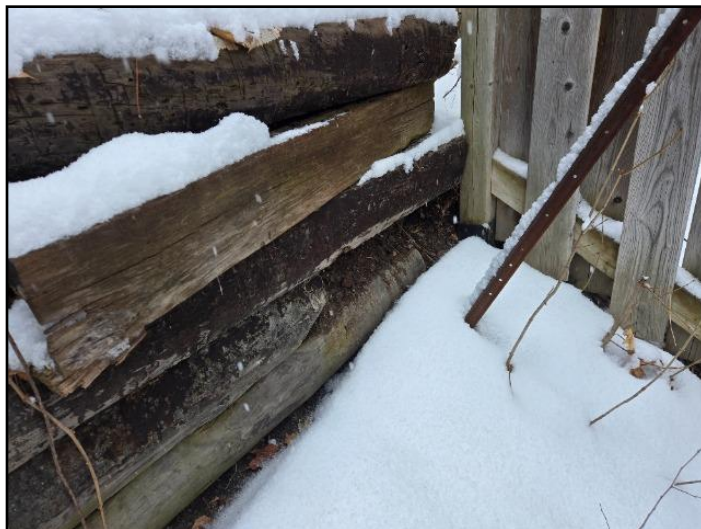
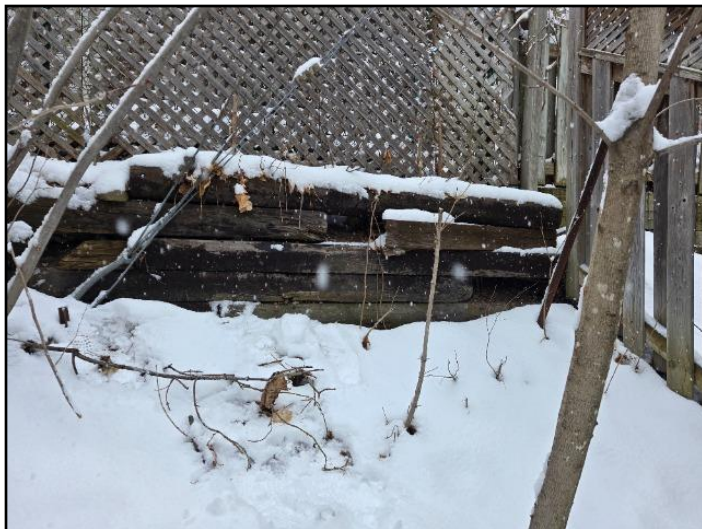
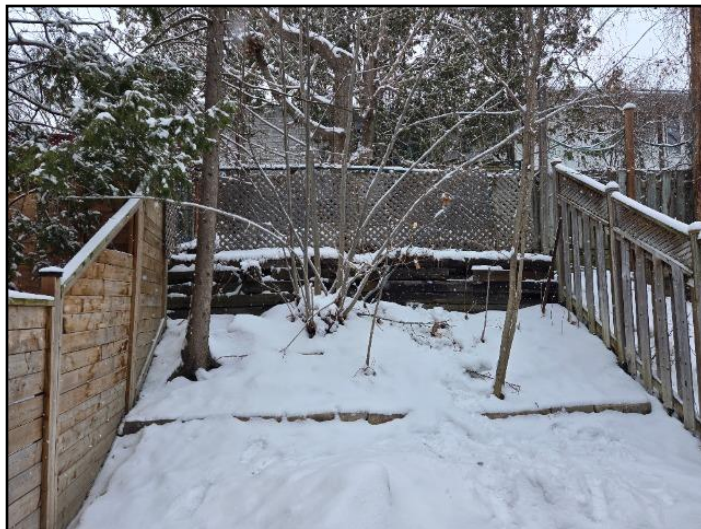
At the rear of the property, a wood retaining wall is located along the property line to support the grade of the adjacent neighbour's land, which is situated higher on the hill. Several areas of the wall exhibit signs of deterioration, including weathering, material decay, and potential structural weakness. These conditions may compromise the wall's ability to retain soil effectively over time.

If the deteriorated retaining wall is not addressed, progressive structural failure, soil erosion, and potential damage to the property may occur. In a high-slope location, compromised retaining structures can pose significant safety hazards, increase maintenance costs, and potentially lead to costly emergency repairs. Obtaining a professional assessment prior to purchase ensures the buyer understands the risks and can plan for any necessary improvements.

Wall exhibit signs of deterioration

It is strongly recommended that a qualified contractor or structural professional evaluate the retaining wall prior to closing. The evaluation should determine the extent of deterioration, identify any structural risks, and outline appropriate repair or reinforcement strategies. The contractor should also provide cost estimates for any necessary remediation to

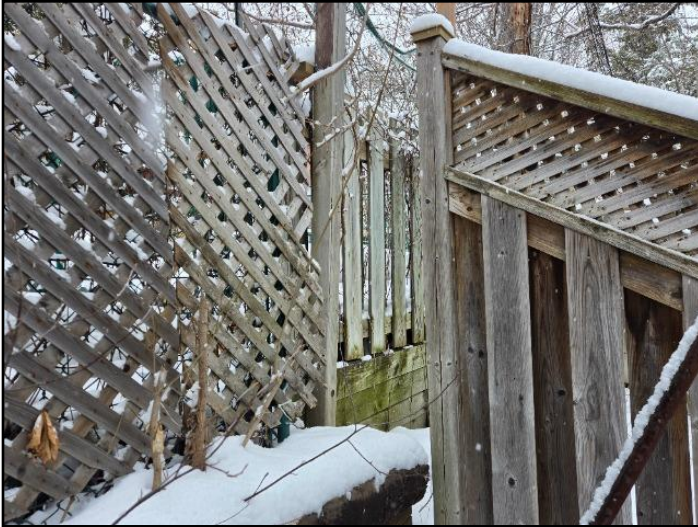
*Fence missing*

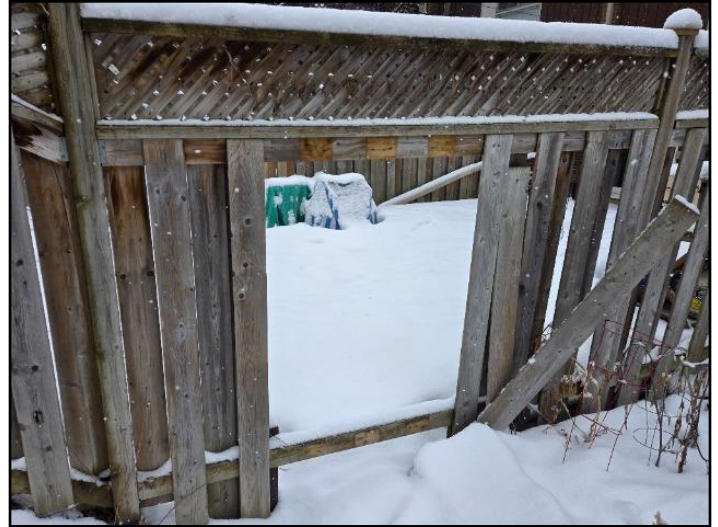
*Boards missing*

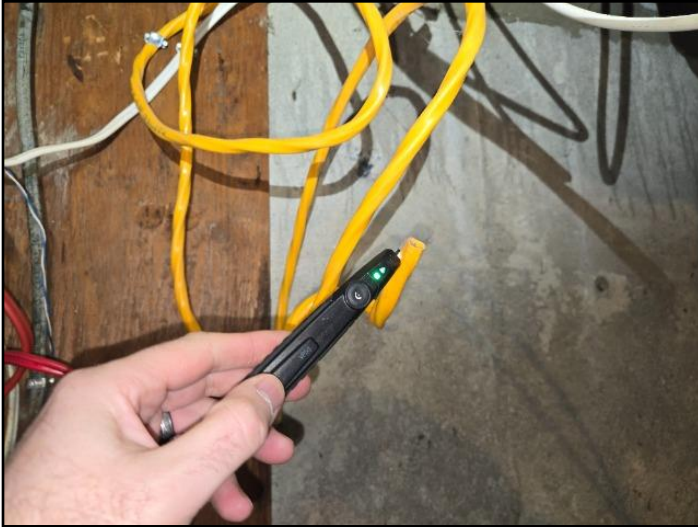
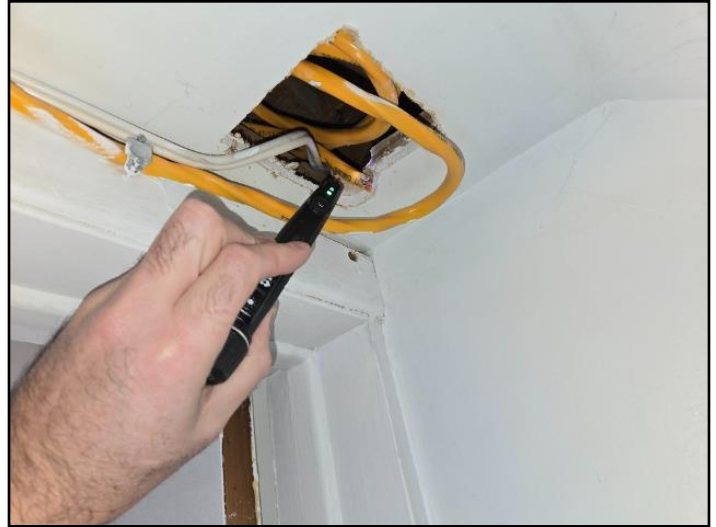
were observed. These wires were not properly secured, protected, or enclosed, presenting an immediate safety hazard for occupants. Contact with energized wires can result in electric shock, burns, or serious injury.

Failure to address exposed energized wires creates a significant risk of electrical shock or fire. Immediate remediation is critical to ensure the safety of occupants and compliance with applicable electrical codes.

*Open splices*

*Open splices***DISTRIBUTION SYSTEM \ Outlets (receptacles)****13. Condition:** • [Reversed polarity](#)

It is strongly recommended that a licensed electrician evaluate and correct the exposed wiring as soon as possible. The wires should be properly routed, secured, and enclosed in appropriate conduit or junction boxes to meet current electrical code and safety standards.

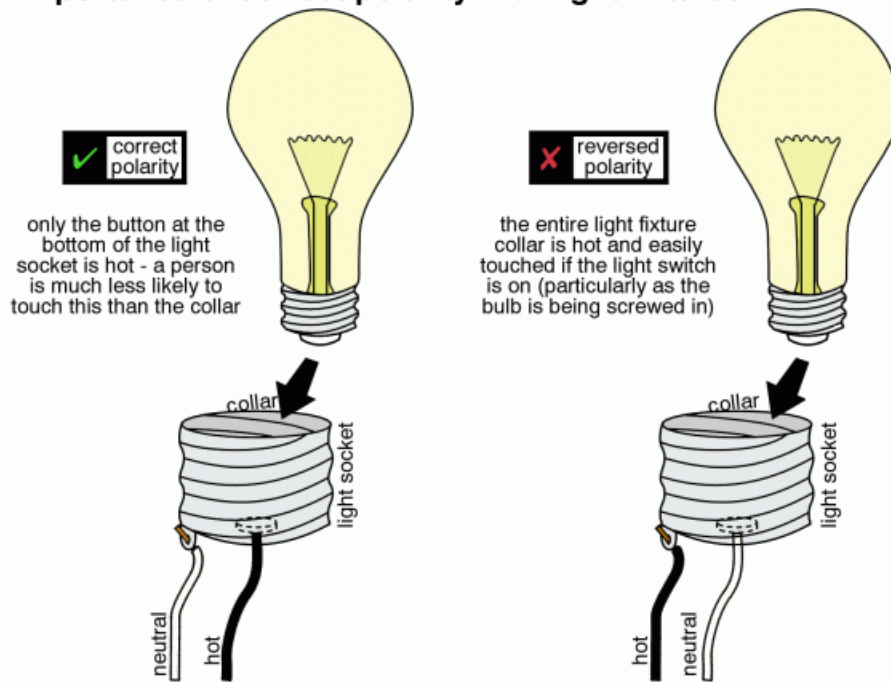
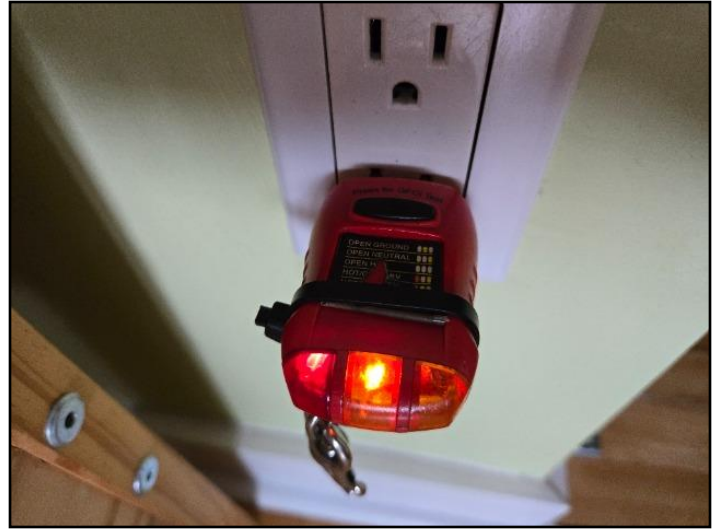
Reverse polarity was observed at an electrical outlet within the fourth-level bedroom. This condition indicates that the hot and neutral conductors are improperly connected, which can create a potential safety hazard.

*Reversed polarity*

*Reversed polarity***14. Condition:** • [Loose](#)

It is recommended that a licensed electrician evaluate and correct the wiring at the affected outlet to ensure proper polarity. Proper wiring is essential to reduce the risk of electrical shock and to ensure the safe operation of connected devices.

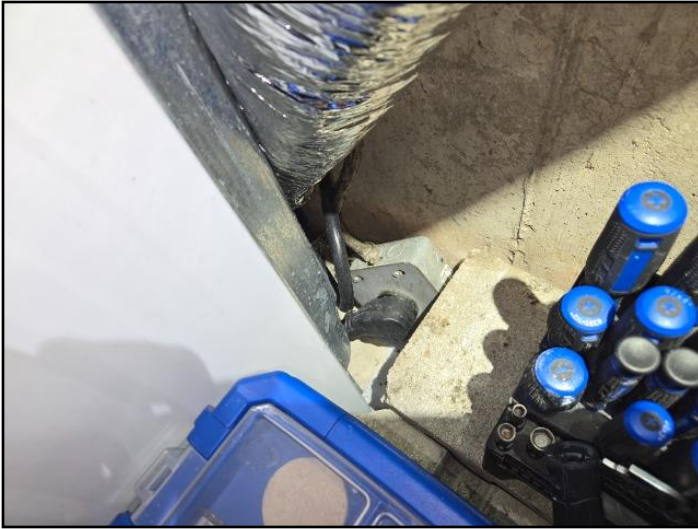
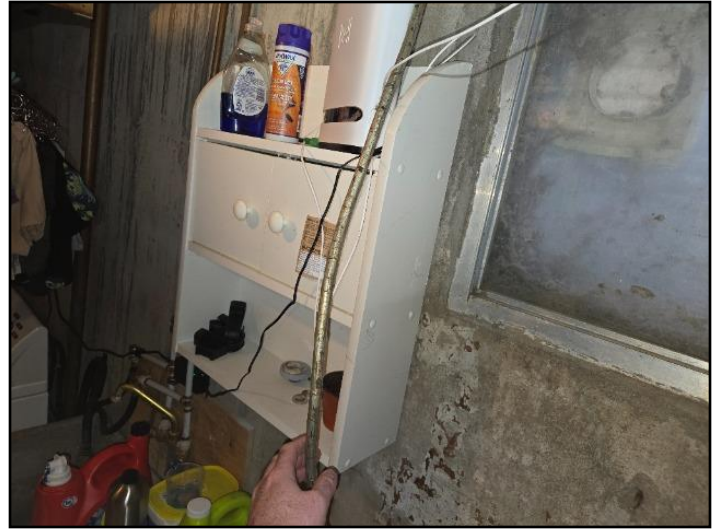
The dryer outlet receptacle in the basement was observed to be loose and hanging behind the dryer. The associated wiring is also not properly secured, leaving the installation exposed to movement or damage.

Loose

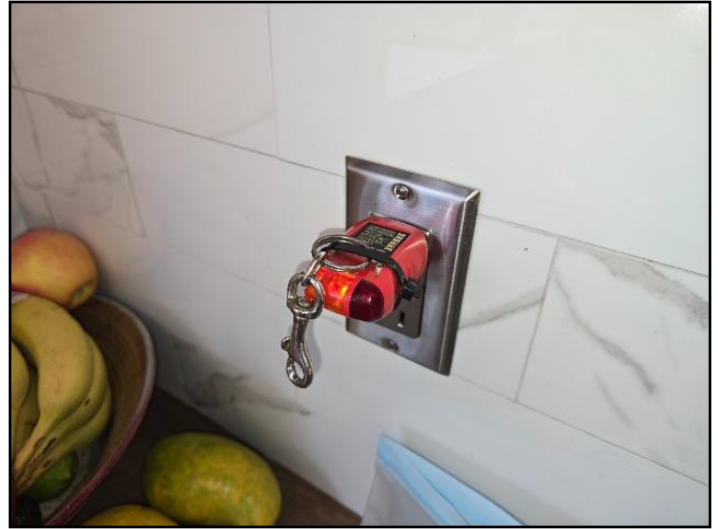
No GFCI/GFI (Ground Fault Circuit...

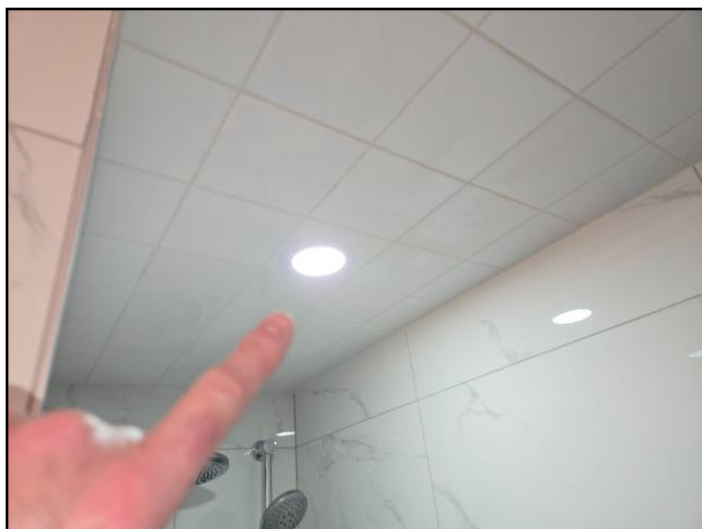
A recessed LED light fixture is installed within the shower area; however, it does not indicate a wet-location rating. Fixtures in areas subject to direct water exposure are required to be rated for wet locations. Additionally, the foam gasket on the back of the trim appears to be missing or not intact. This gasket is intended to provide an airtight seal at the ceiling plane to prevent moisture and steam from entering the ceiling or attic space.

*Conventional lights in wet areas***DISTRIBUTION SYSTEM \ Smoke alarms (detectors)****17. Condition:** • Missing

It is recommended that the fixture rating be verified, and if it is not rated for wet locations, it should be replaced with a properly rated fixture suitable for use in shower environments. Additionally, the trim should be equipped with an intact gasket to ensure a proper seal against the ceiling. Addressing these issues will help prevent moisture intrusion, reduce the risk of premature fixture failure, and protect the surrounding building components from potential condensation-related damage.

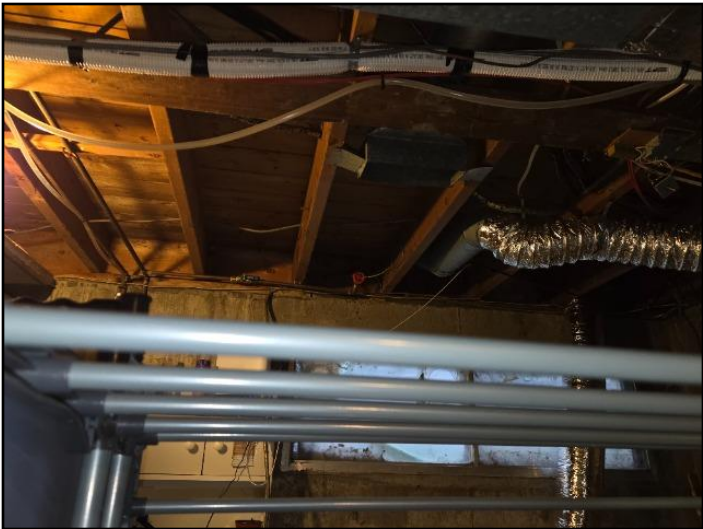
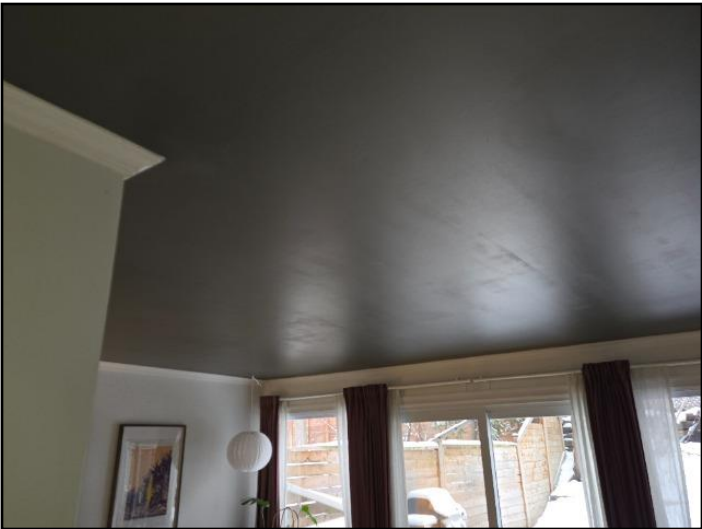
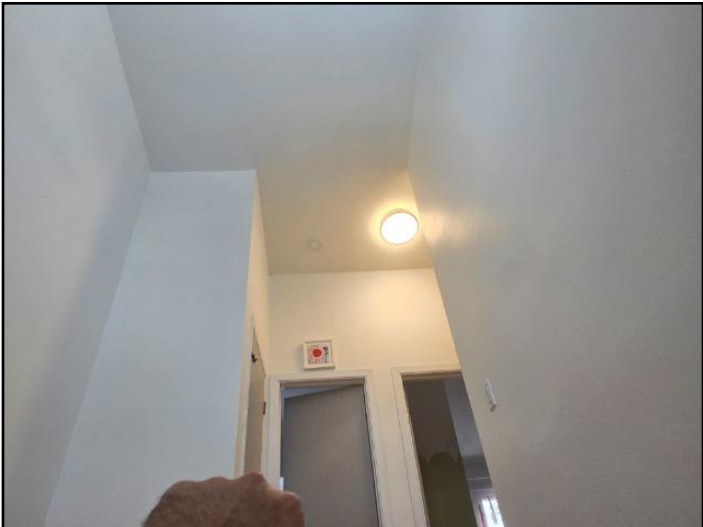
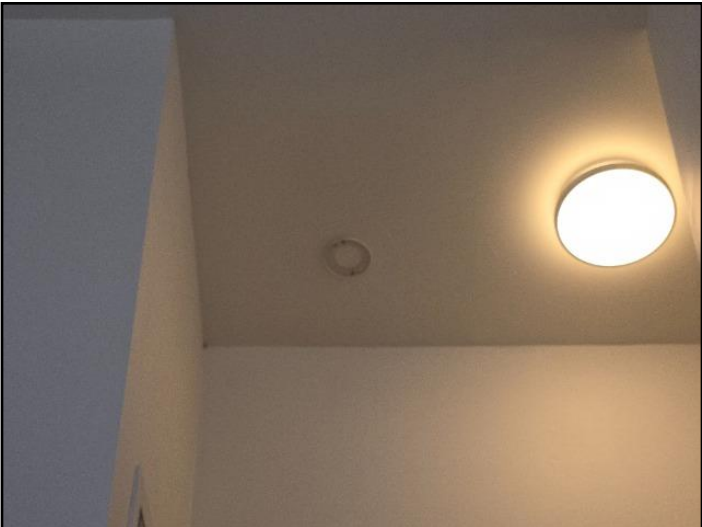
Smoke detectors were missing at multiple locations throughout the property. Smoke detection is a critical life safety system designed to provide early warning in the event of fire.

Missing

It is recommended that smoke detectors be installed in accordance with Quebec building code requirements. To ensure compliance with current Quebec building code requirements, it is recommended that a licensed contractor or electrician be engaged to assess the property, determine all necessary locations for smoke detectors, and properly install and test the units. This professional engagement ensures that all detectors are positioned correctly, fully operational, and in accordance with regulatory standards.

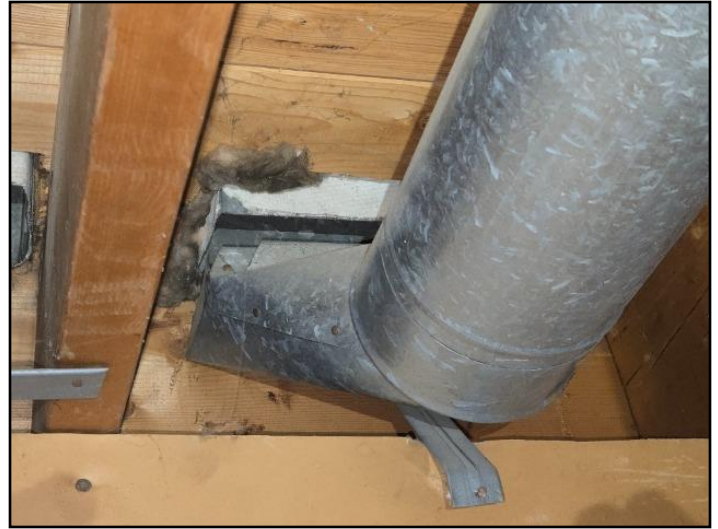
*Disconnected ducts*

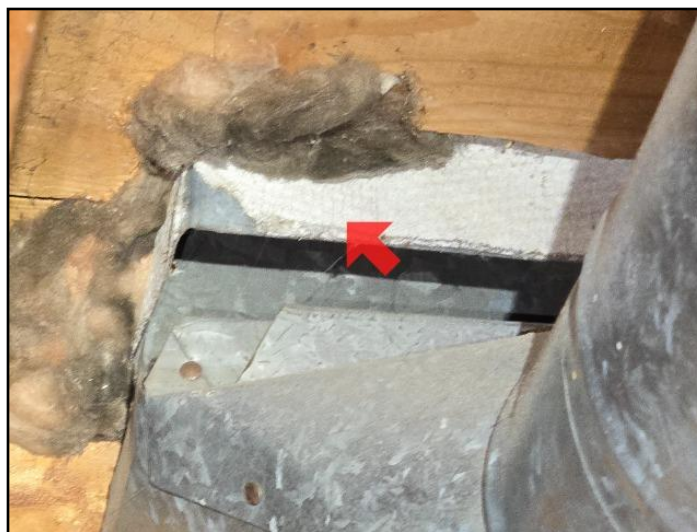
White, paper-like material was observed on the metal ducting in the basement. This material is suspected to be asbestos-containing material (ACM), likely duct tape or paper wrap commonly used on HVAC systems from the 1930s through the early 1980s. The material appears frayed or torn in some areas, which increases the potential for fibers to be released into the air if disturbed.

*Suspected asbestos-containing material (ACM)*

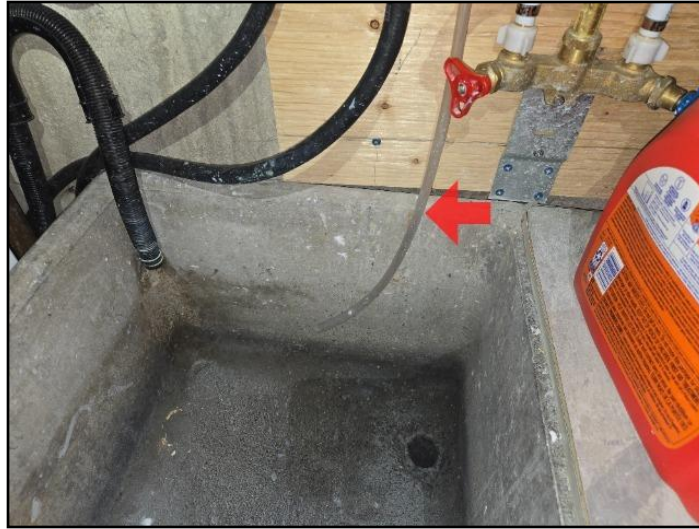
*Improper discharge point*

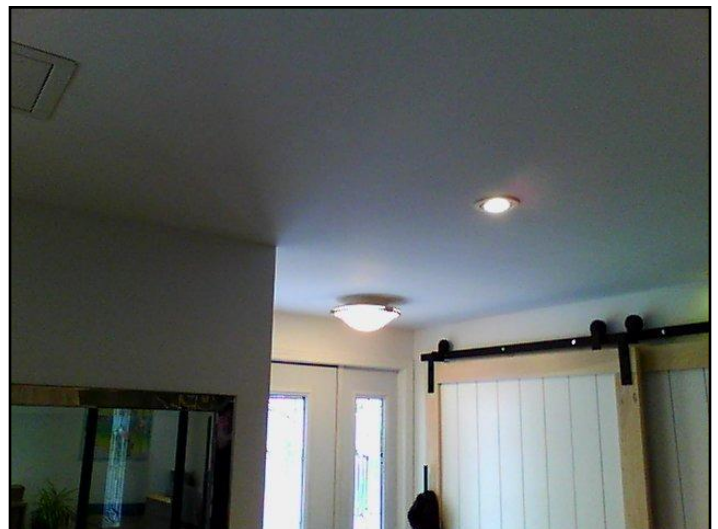
Gaps or voids

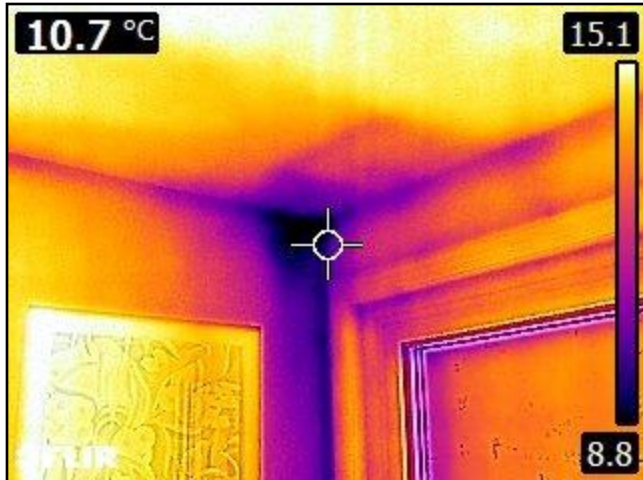
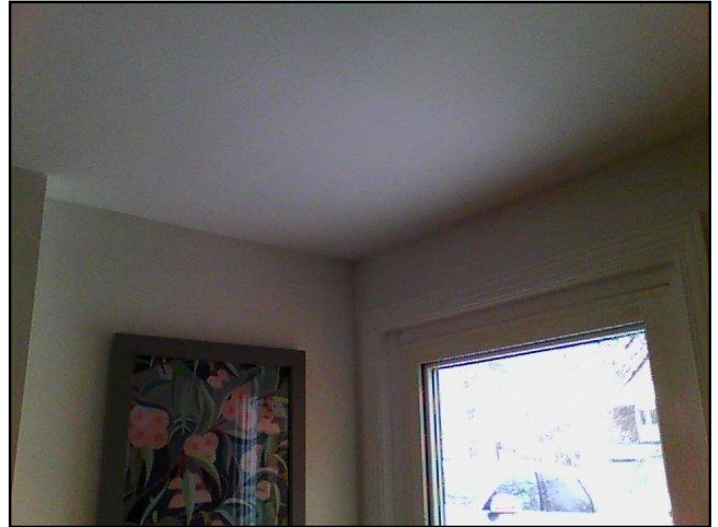
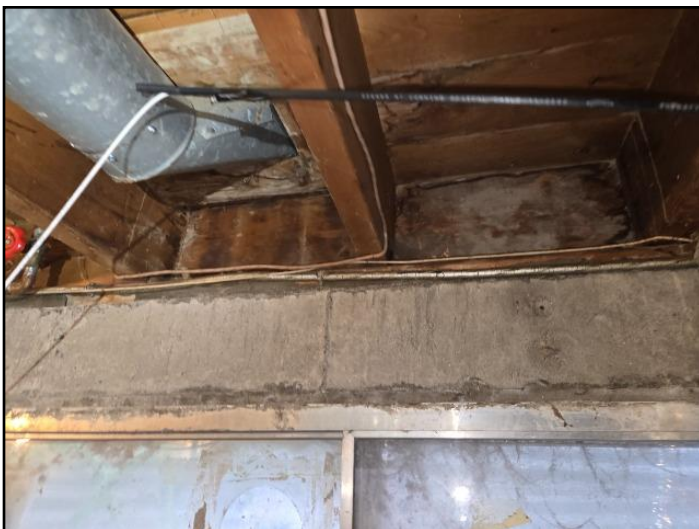
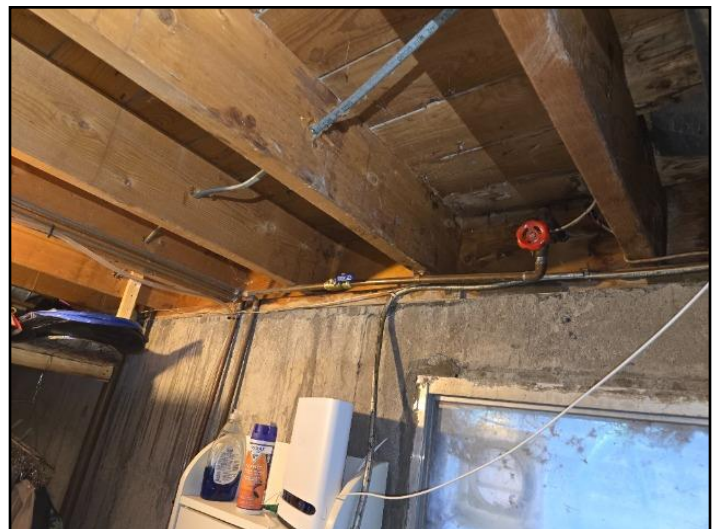
Missing at rim joist

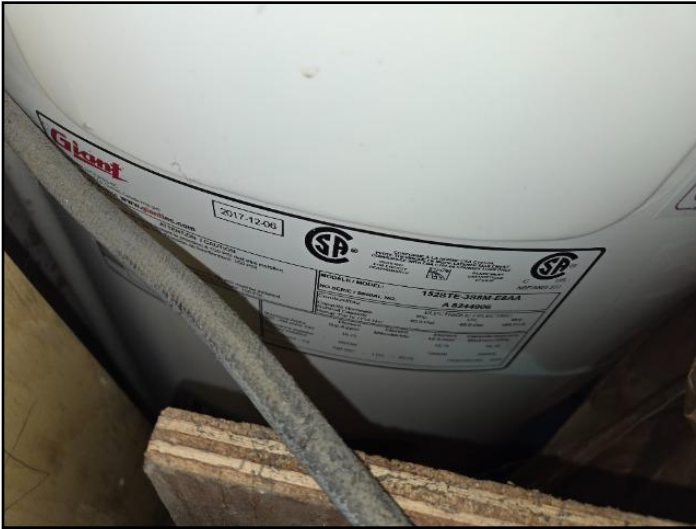
Near end of life expectancy

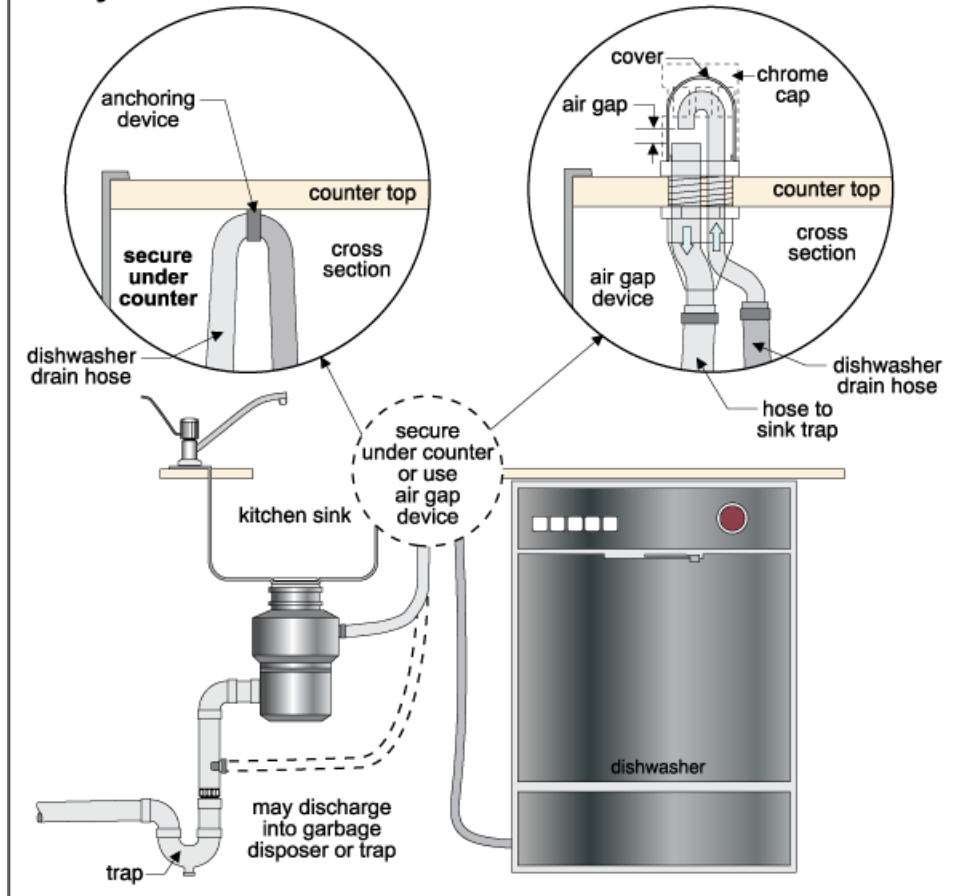
Insufficient slope

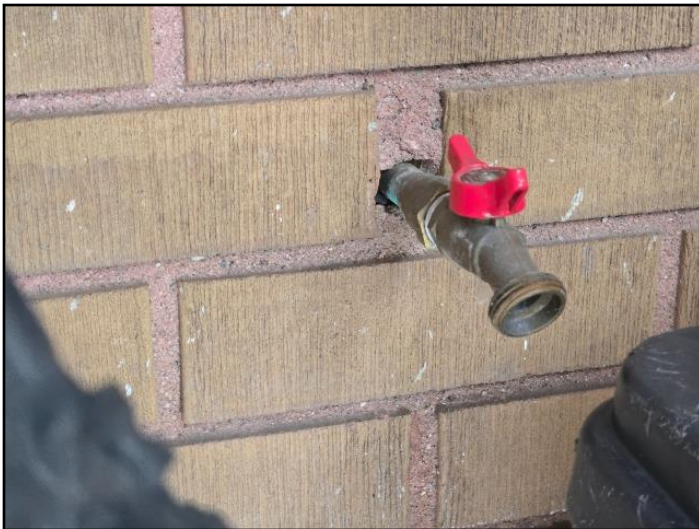
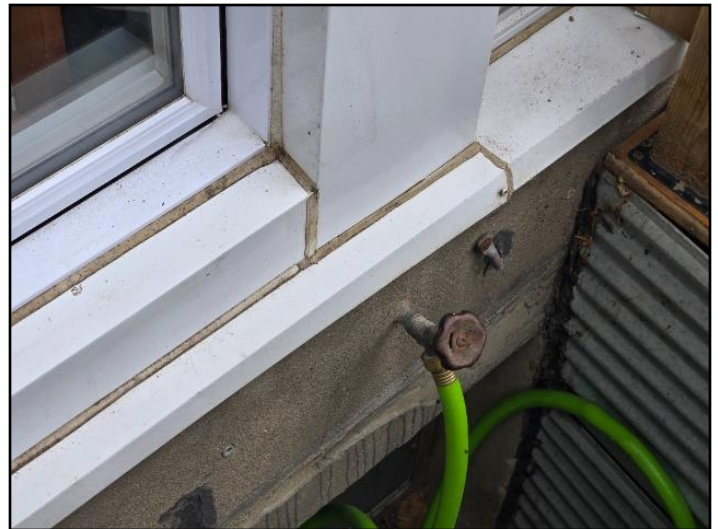
Not frost free

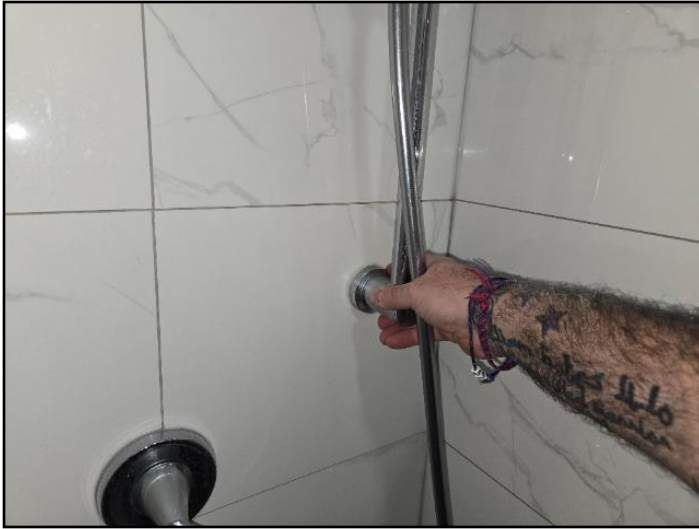
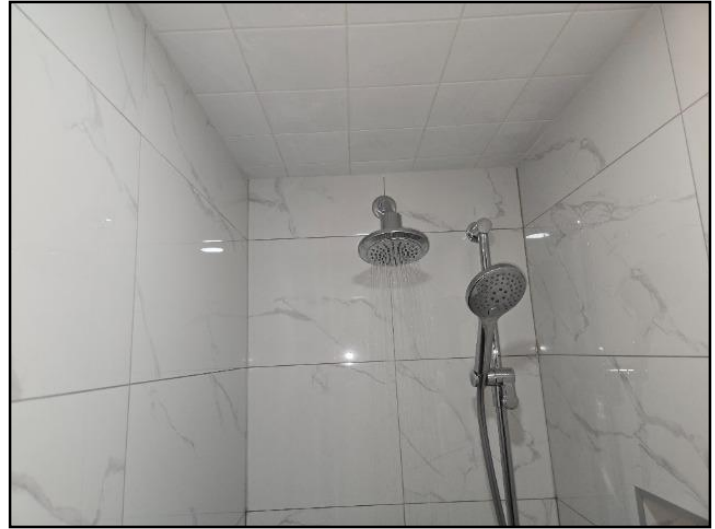
Loose

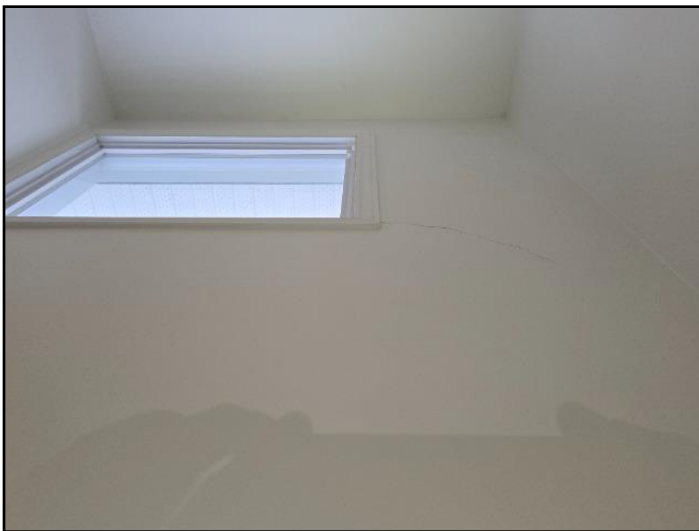
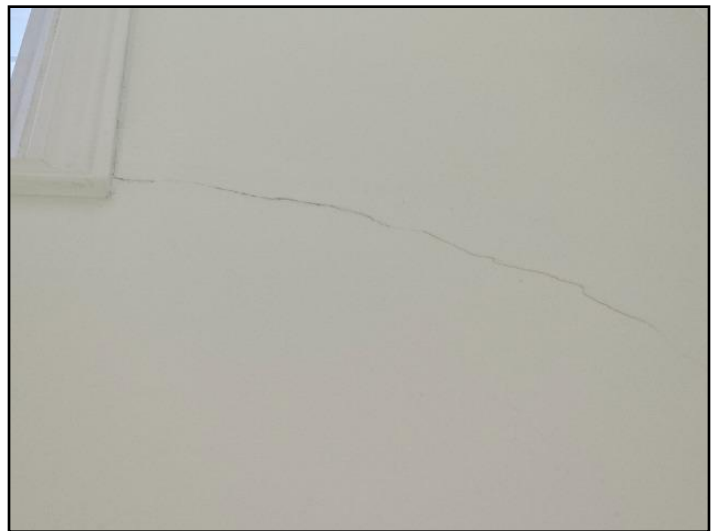
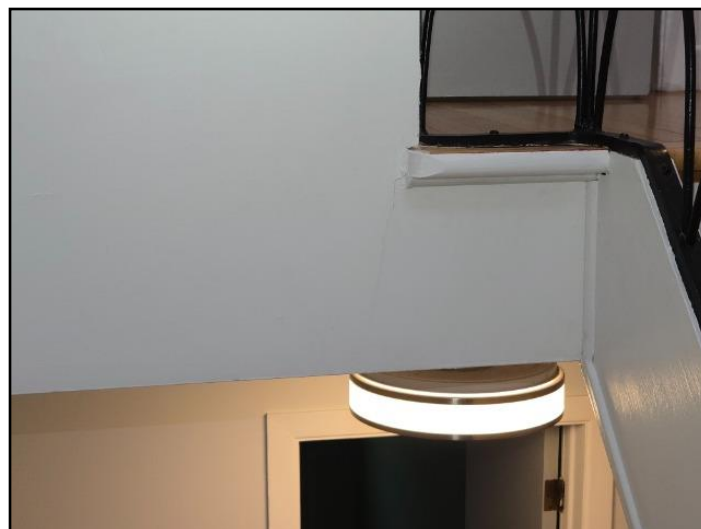
*Cracked*

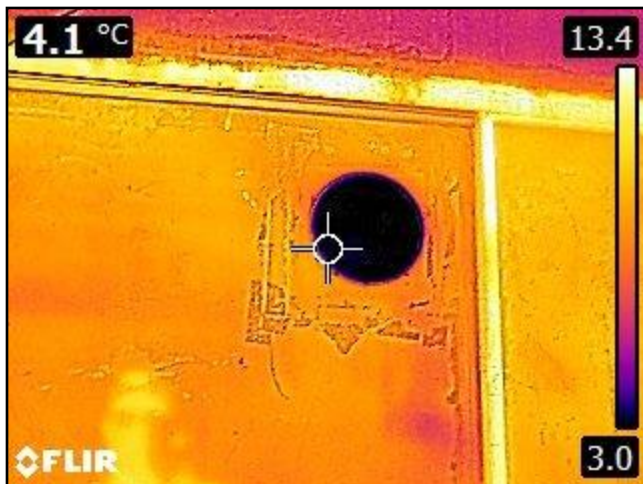
Old

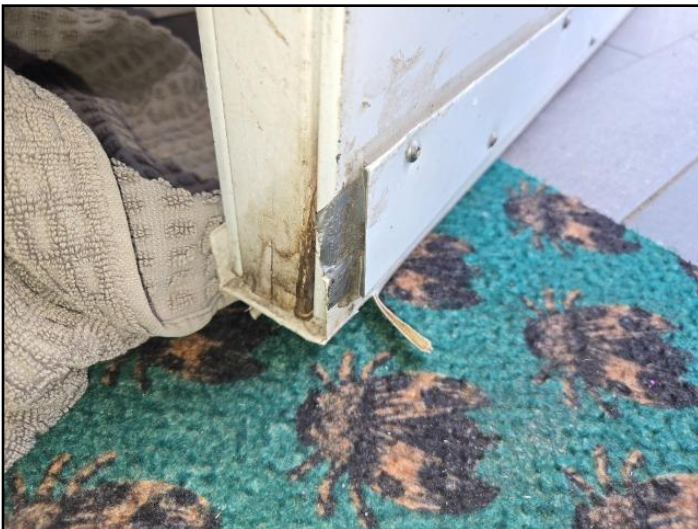
Weatherstripping ineffective

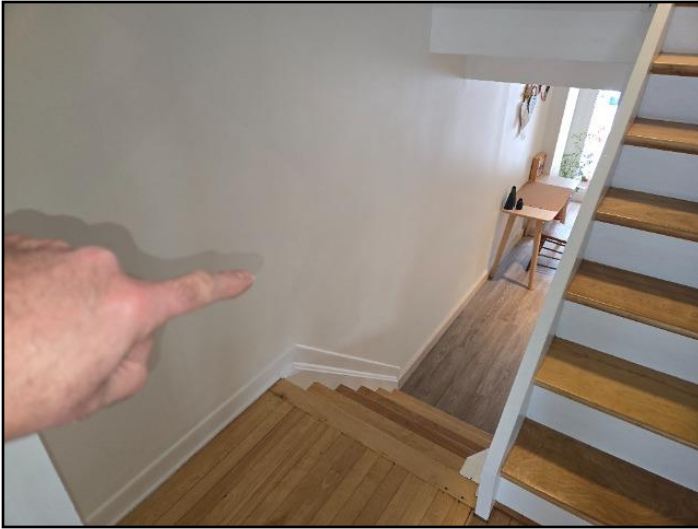
The staircase leading to the first level does not have a handrail installed. Additionally, from the first to the second level, guardrails are missing entirely. For the upper staircases from the second to the third and fourth levels, guardrails are present; however, the balusters are spaced wider than the recommended maximum opening of 100mm (4in), which does not comply with modern building safety standards. These conditions present fall hazards, particularly for children or other occupants, and compromise overall stairway safety.

Handrail Missing

It is strongly recommended that a qualified contractor install a handrail and guardrails where missing. For the upper staircases, the balusters should be modified or replaced to reduce spacing to meet the maximum code requirement of 100mm (4in). All work should comply with applicable building codes to ensure safe stairway access and prevent fall hazards.

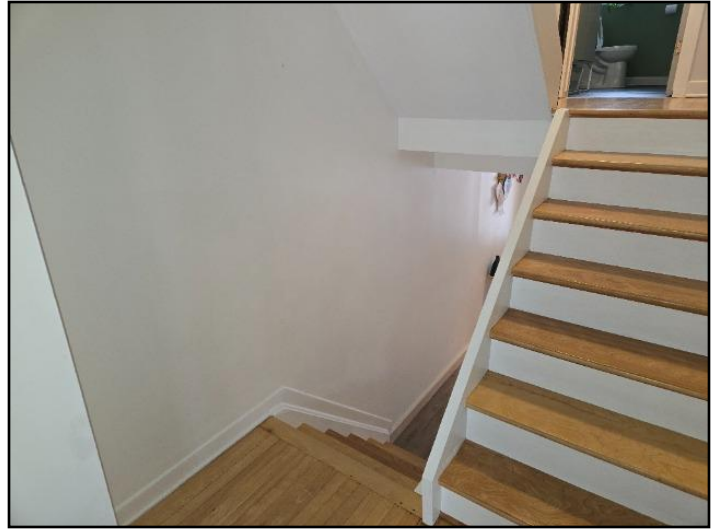
Guardrail Missing

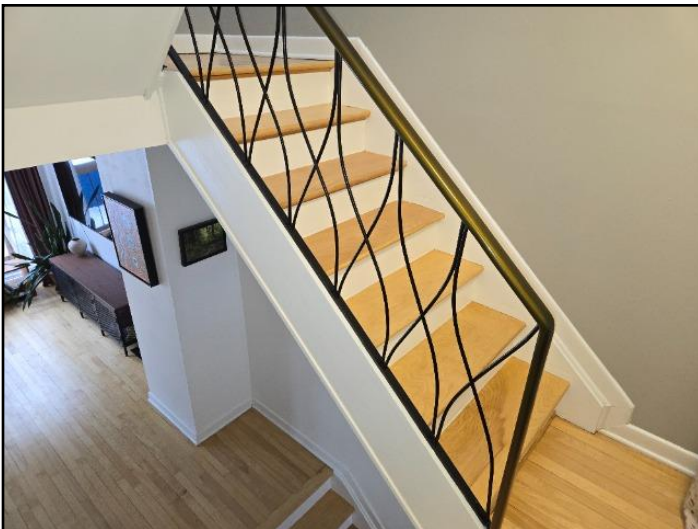
Balusters openings
