# INSPECTION REPORT

For the Property at:  
**SAMPLE PROPERTY**  
GATINEAU, QC XXX XXX

Prepared for: SAMPLE CLIENT  
Inspection Date: Thursday, March 19, 2026  
Prepared by: Shaun Botes

RE: Report No. 1228  
Sample Property  
Gatineau, QC  
XXX XXX

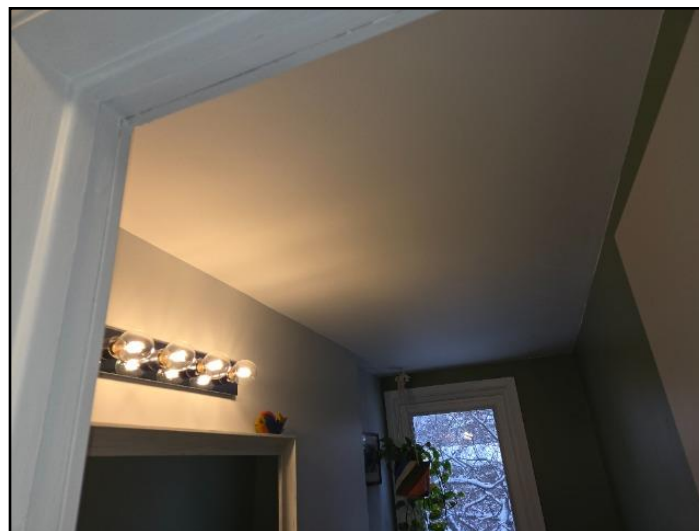
Missing

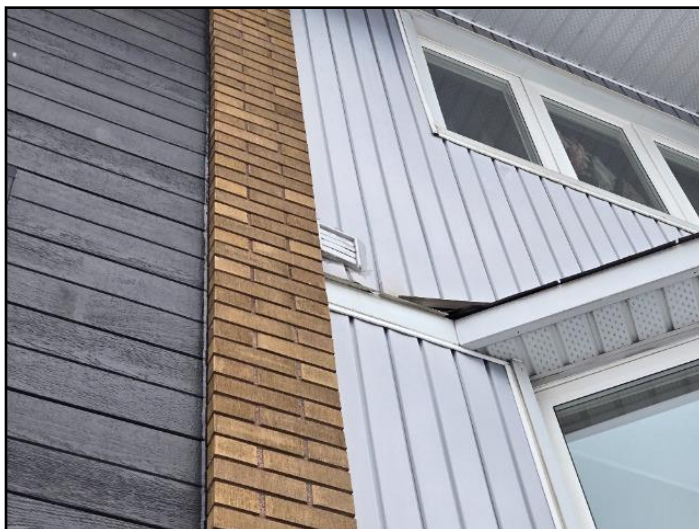
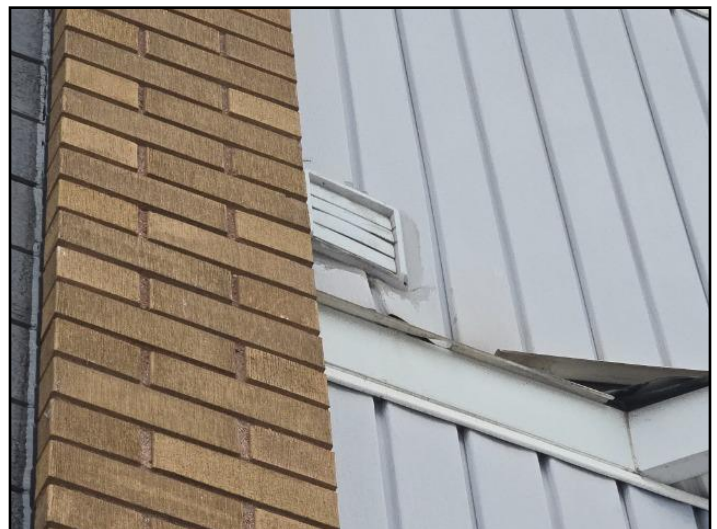
Improper Plastic Vent Termination

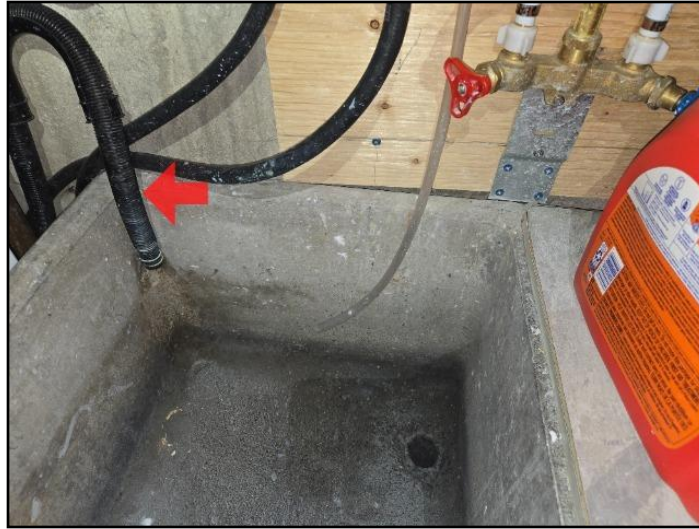
*Standpipe missing*
