# INSPECTION REPORT

For the Property at:  
**SAMPLE PROPERTY**  
GATINEAU, QC XXX XXX

RE: Report No. 1230  
Sample Property  
Gatineau, QC  
XXX XXX

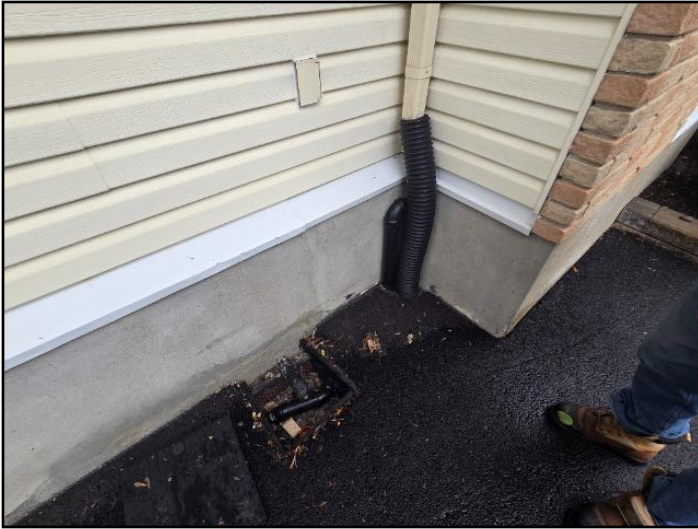
*Discharge below grade*

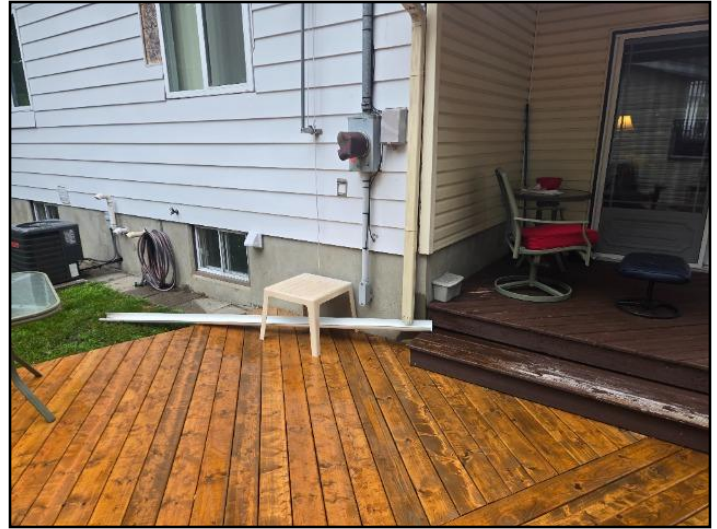
*Discharge too close to building*

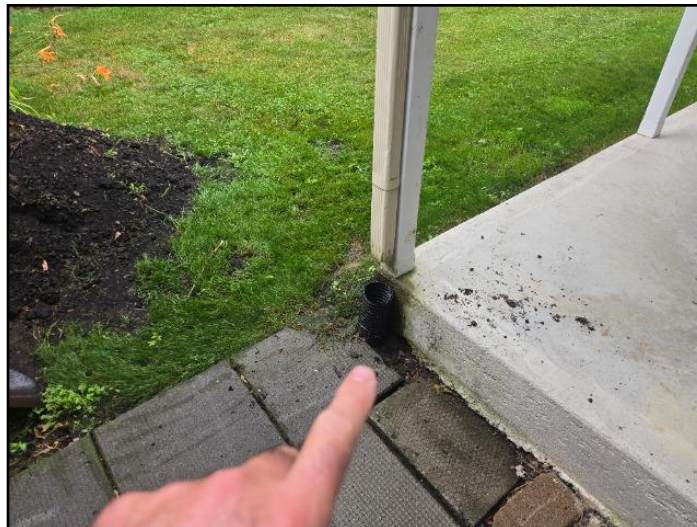
*Discharge below grade*

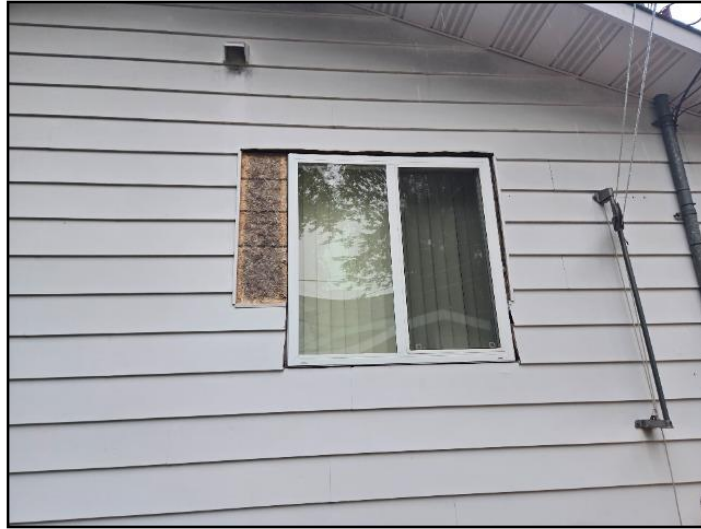
*Exterior siding incomplete*

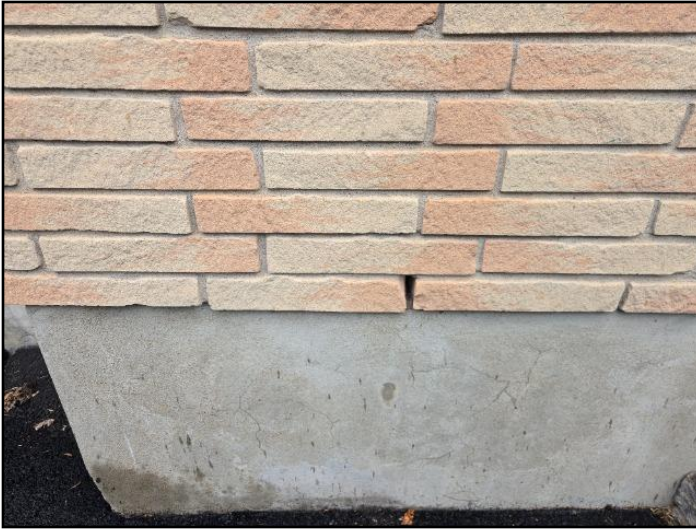
Weep holes - obstructed

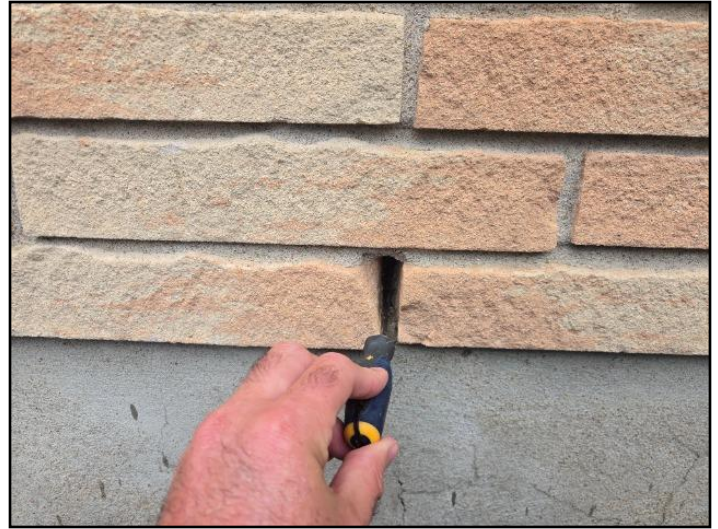
Weep holes - obstructed

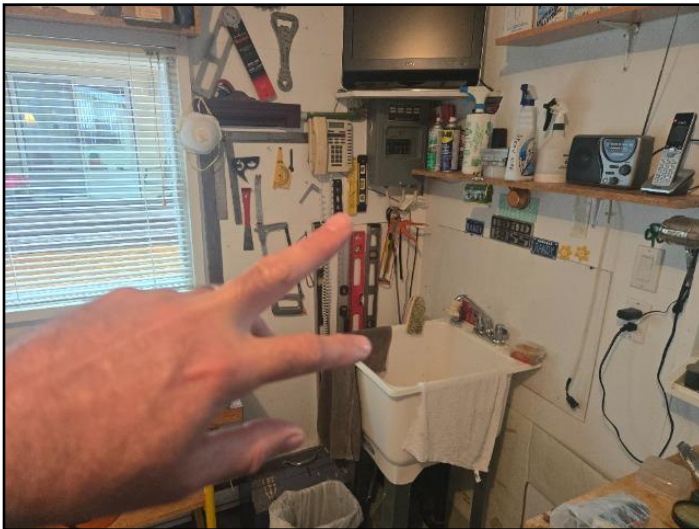
The main electrical panel was obstructed by the washer and dryer. The workshop subpanel was installed above the utility sink, not recommended near a water source and surrounded by shelving and stored materials. These conditions restrict access and do not provide a suitable working position in front of the panels.

Box location poor

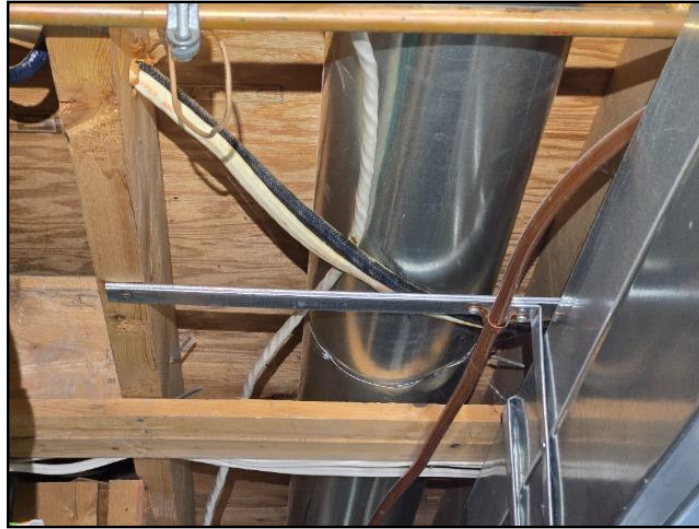
*Wiring touching heating supply ductwork*

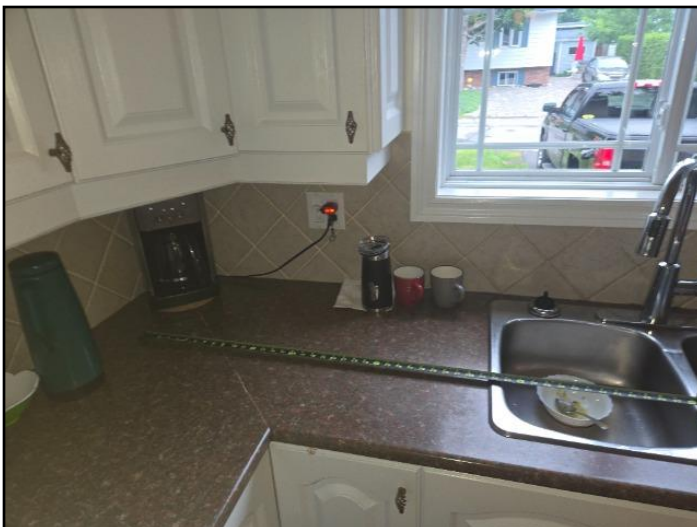
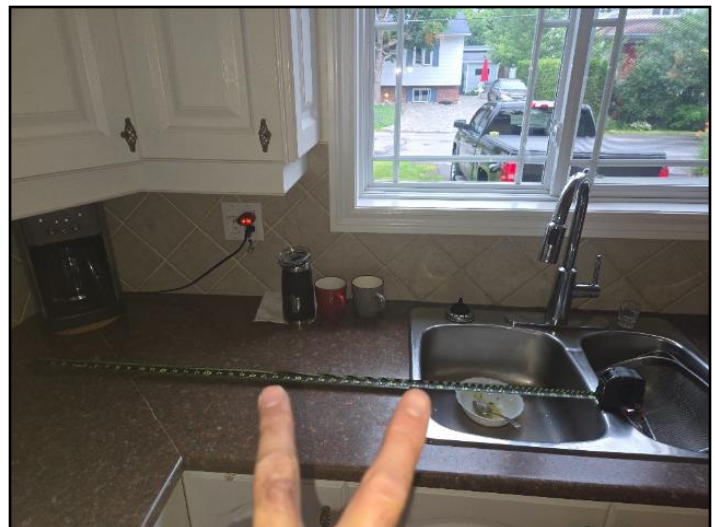
Within the kitchen, electrical receptacles were observed in close proximity to the sink/water source. These receptacles did not appear to be GFCI-protected at the time of inspection.

No GFCI/GFI (Ground Fault Circuit...

Recommend upgrading the affected kitchen receptacles to GFCI-protected outlets or providing GFCI protection at the circuit level by a qualified electrician. The electrician should verify the full kitchen circuit arrangement, confirm proper grounding and polarity, and ensure that all receptacles requiring protection are properly protected and functioning as intended.

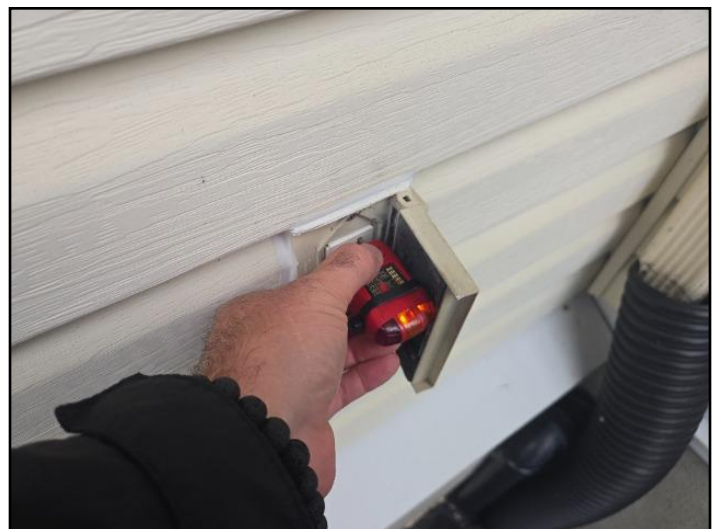
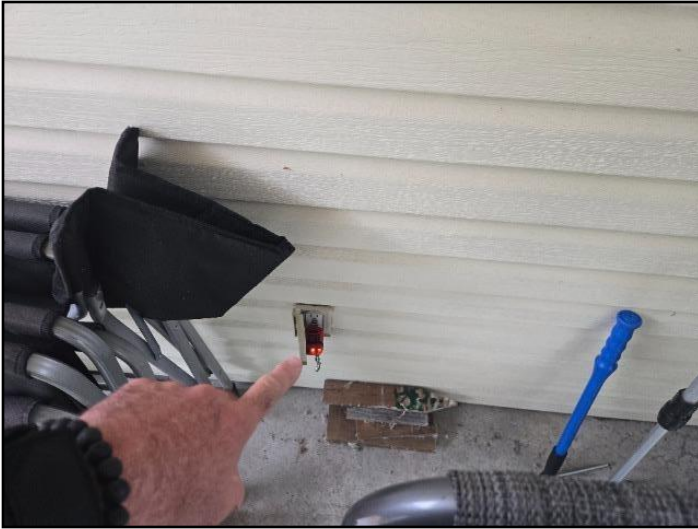
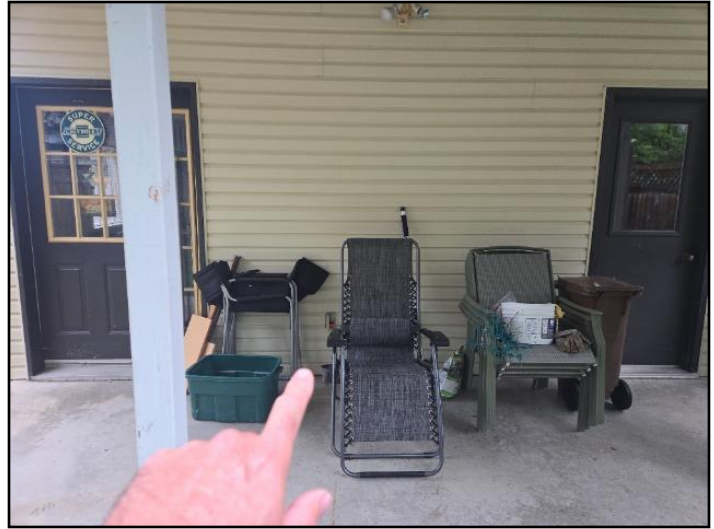
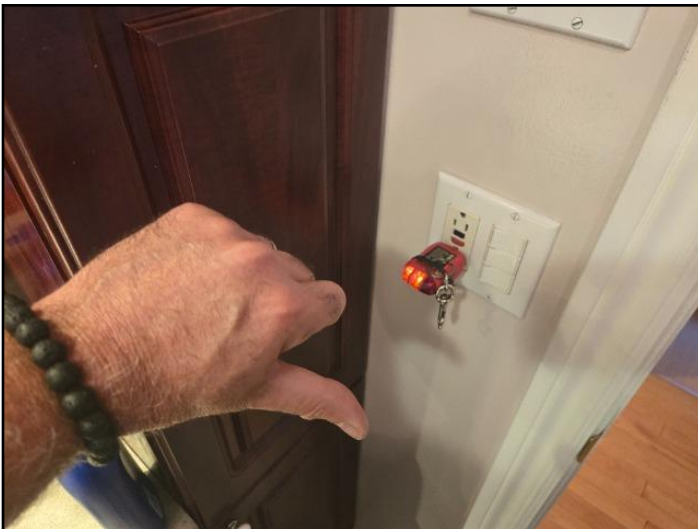
Test faulty on GFCI

Have a licensed electrician evaluate and repair or replace the affected devices and confirm that appropriate ground-fault protection is provided at all required locations.

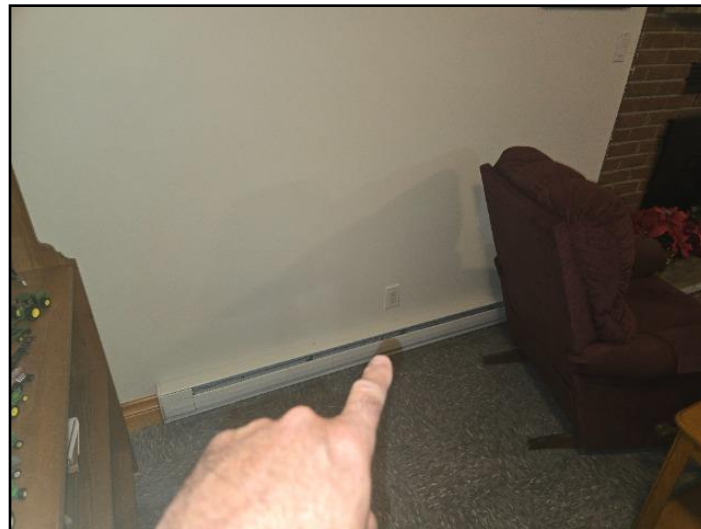
An electrical receptacle was observed directly above the electric baseboard heater. Although this configuration may be present in some older installations, it is not considered a recommended installation, as electrical cords plugged into the receptacle may drape over the heater and be exposed to excessive heat, creating a potential fire hazard.

*Electrical receptacle above heater*

It is recommended that a qualified electrician evaluate the receptacle location and relocate it, if necessary, to a position away from the baseboard heater. Electrical cords should never hang over or come into contact with an operating electric baseboard heater.

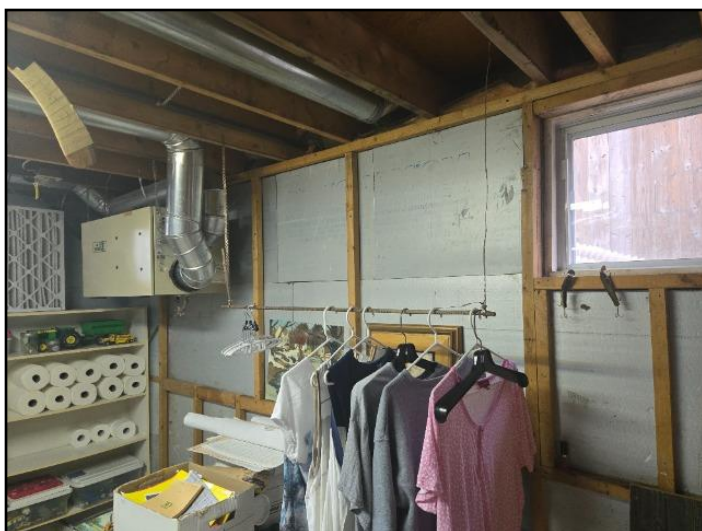
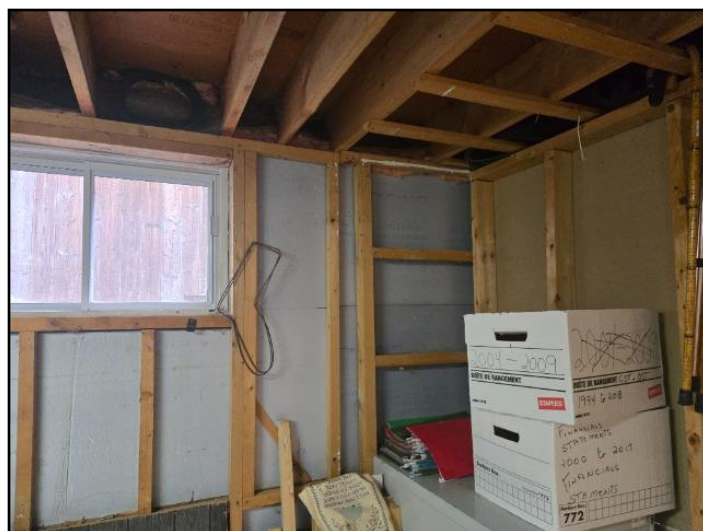
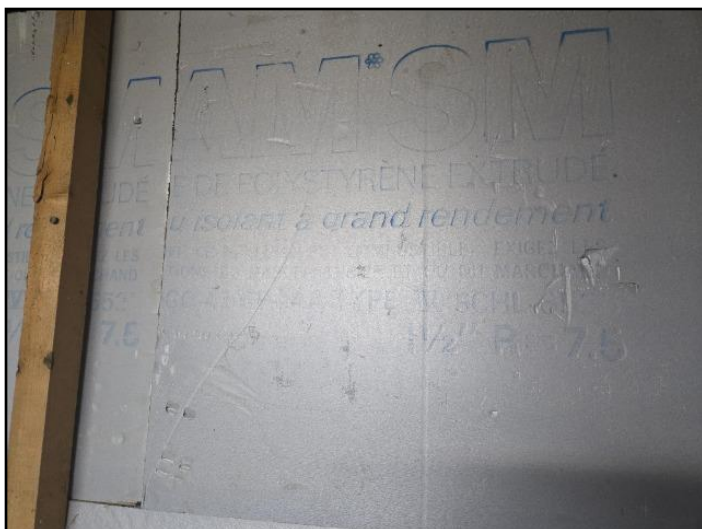
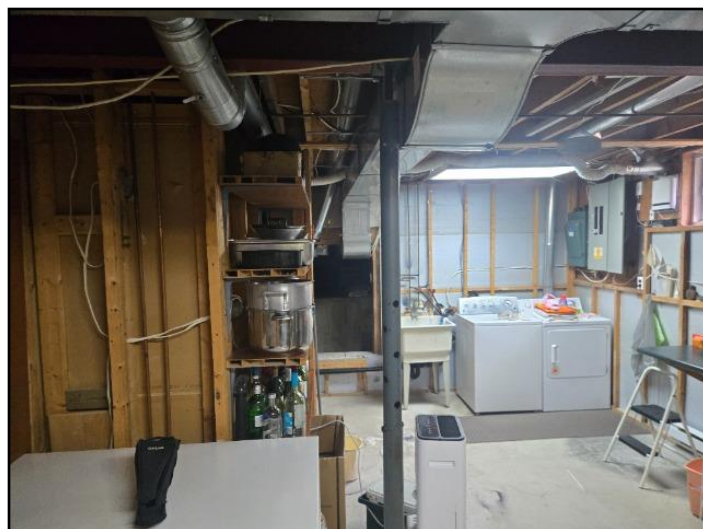
*Exposed combustible insulation*

Exposed combustible insulation

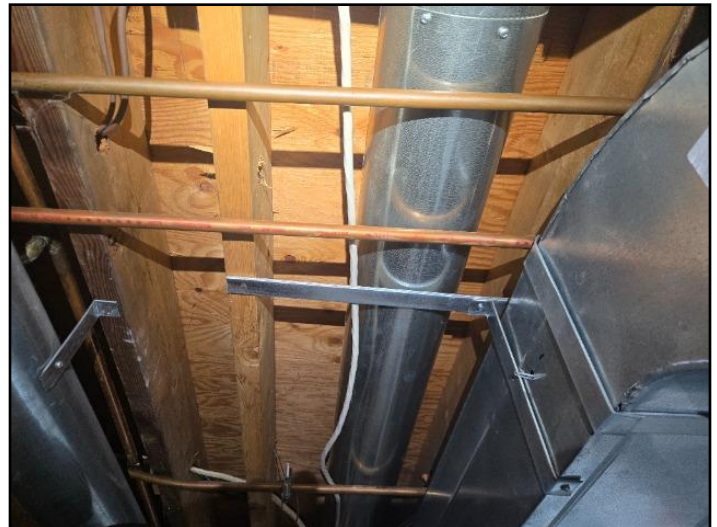
*Isolated from the metal ductwork*

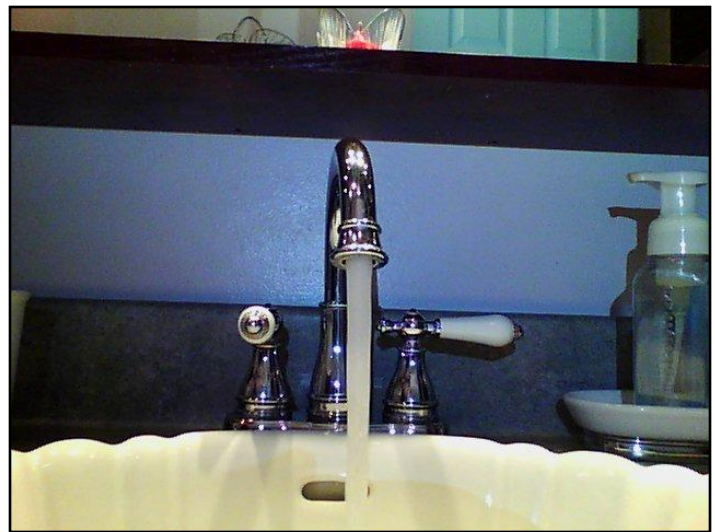
Water too hot

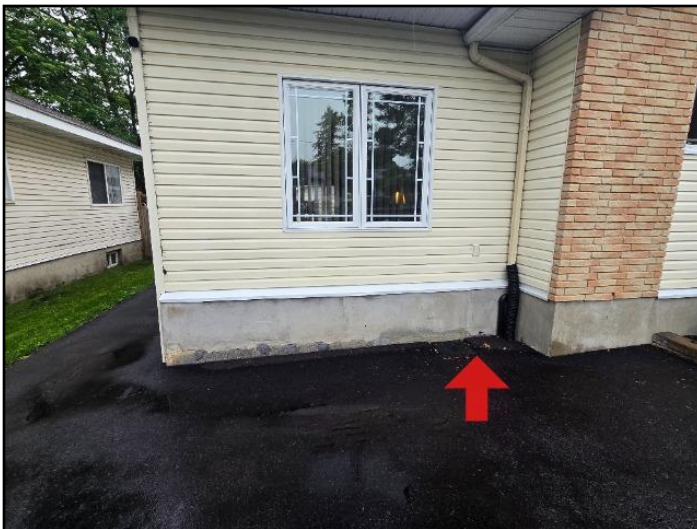
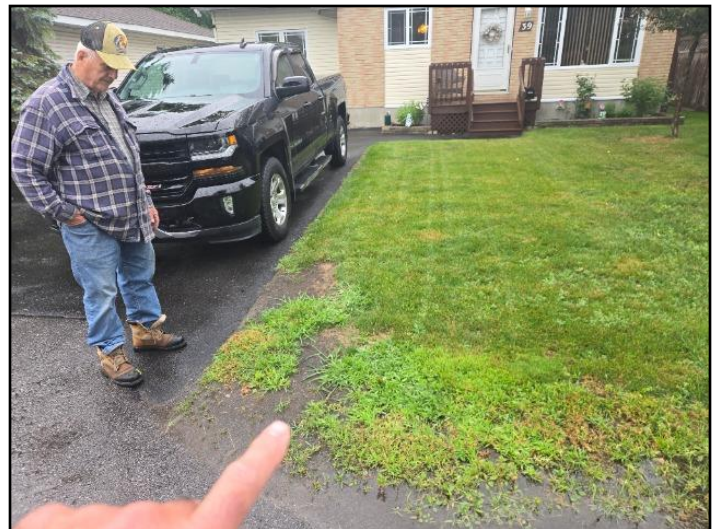
*Discharge pipe problems*

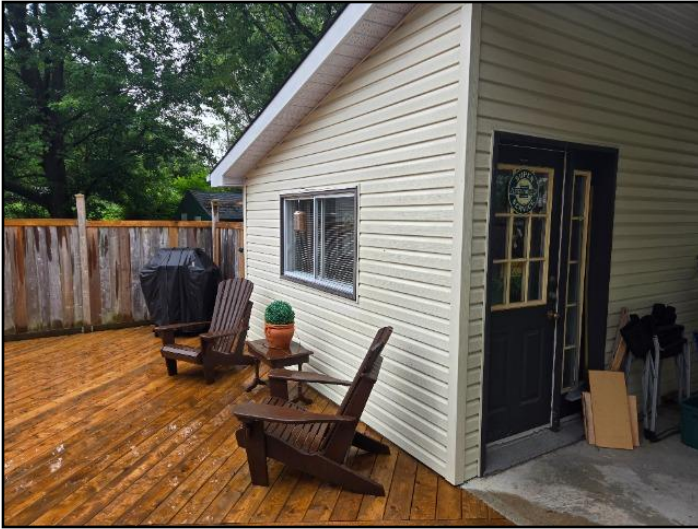
Deteriorated and damaged weatherstripping was observed at various exterior doors, including the front entry door and the exterior shed door. The door sweep beneath the shed entry door also showed signs of deterioration and no longer appeared to provide an effective seal.

*Shed Weatherstripping ineffective*

Replace the deteriorated weatherstripping and door sweep with new exterior-grade materials to restore an effective weather seal and improve energy efficiency while reducing air and moisture infiltration.

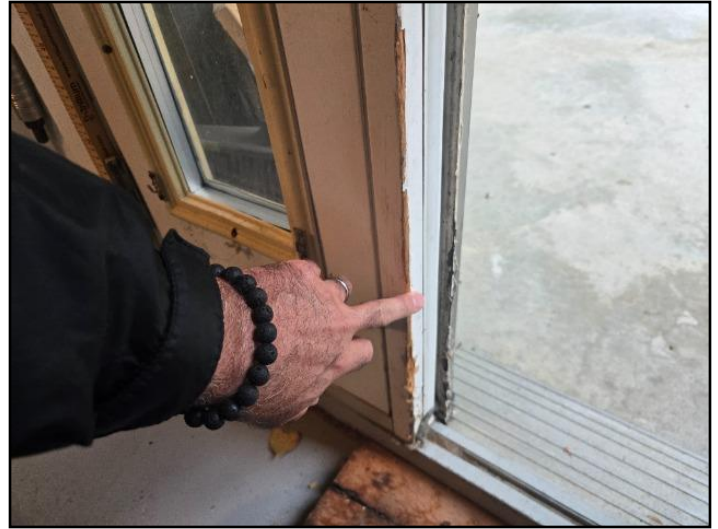
*Shed Weatherstripping ineffective*

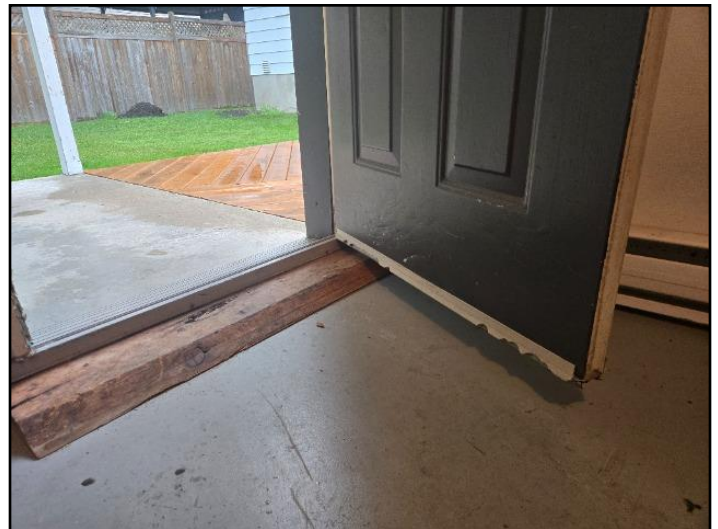
*Shed Weatherstripping ineffective*
