# INSPECTION REPORT

For the Property at:  
**SAMPLE PROPERTY**  
GATINEAU, QC XXX XXX

Prepared for: SAMPLE CLIENT  
Inspection Date: Thursday, March 19, 2026  
Prepared by: Shaun Botes

RE: Report No. 1228  
Sample Property  
Gatineau, QC  
XXX XXX

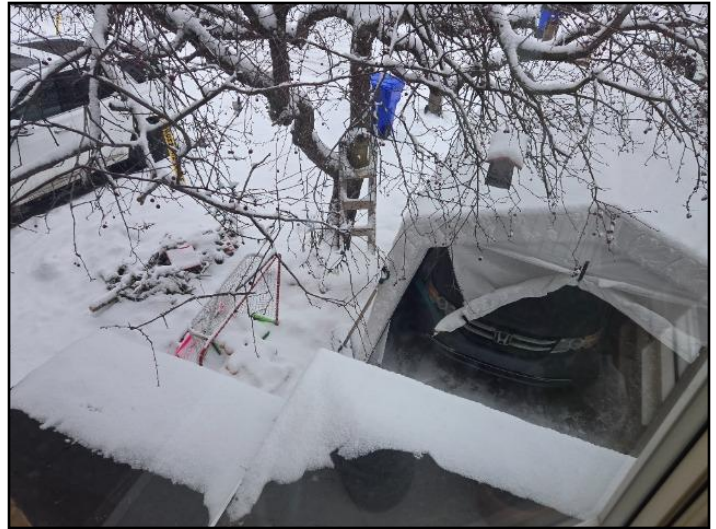
*Tree Branches In Close Proximity*

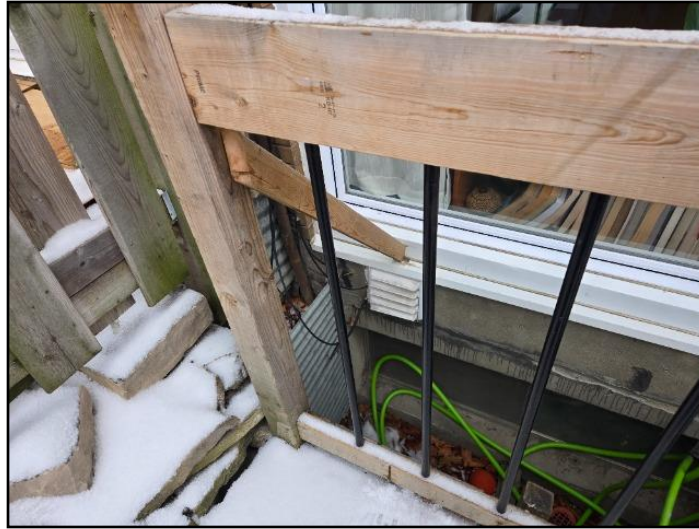
At the exterior surrounding the window well, a guardrail is present; however, the spacing between the spindles (balusters) exceeds current safety recommendations. Wide gaps may allow small children or pets to pass through, creating a fall hazard.

**Implication(s):** Fall hazard

*Openings between spindles (balusters) too...*

It is recommended that the guardrail be modified or replaced to comply with applicable building codes in Quebec. Current standards generally require that openings in guardrails or balusters do not allow a 100 mm (approximately 4 inches) diameter sphere to pass through. A qualified contractor should evaluate the existing guardrail and adjust the spacing of the balusters or install additional infill to meet safety requirements. Prompt correction will reduce the risk of falls and ensure compliance with local safety standards.

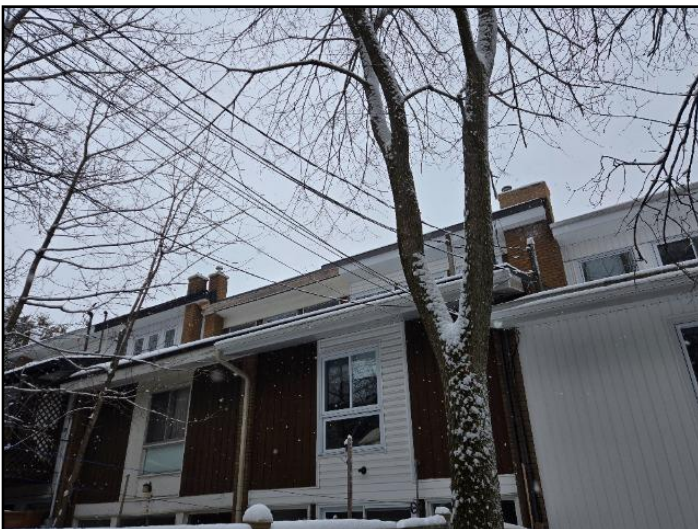
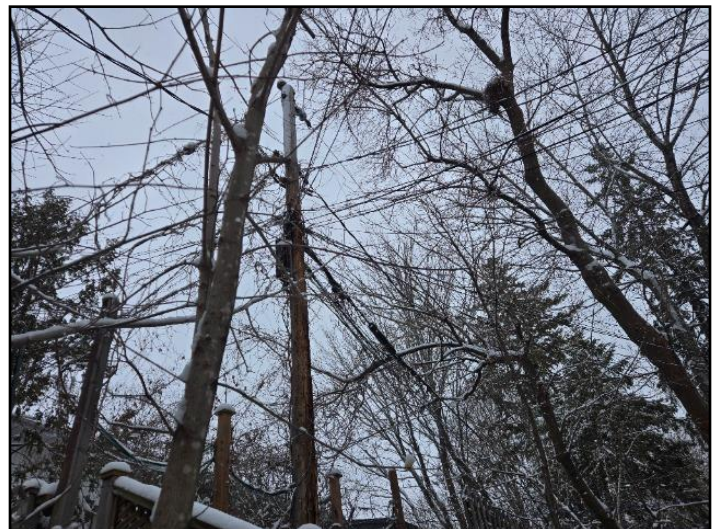
*Branches / vines interfering with wires*

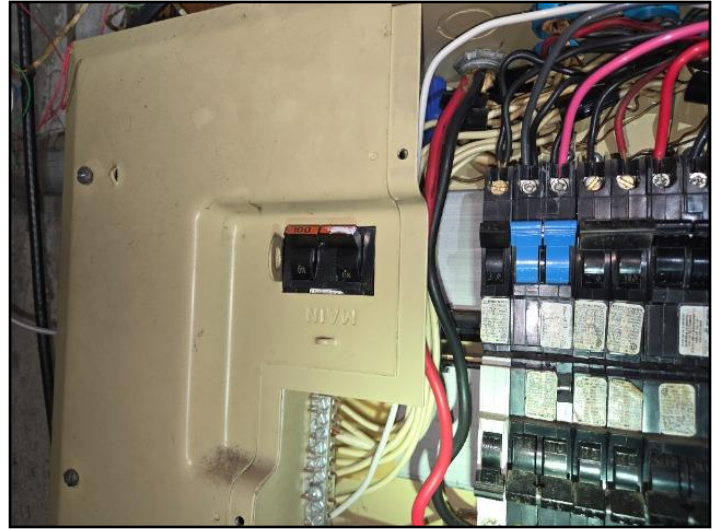
*Wires crossing bus bar*

It is strongly recommended that a licensed electrician evaluate the panel as soon as possible. All exposed openings should be properly covered, double-tapped circuits should be corrected, and wires should be appropriately terminated and organized within the panel. Given the Stab-Lok design, the electrician should assess the overall condition of the breakers and panel to determine if replacement or upgrades are advisable to meet modern electrical safety standards.

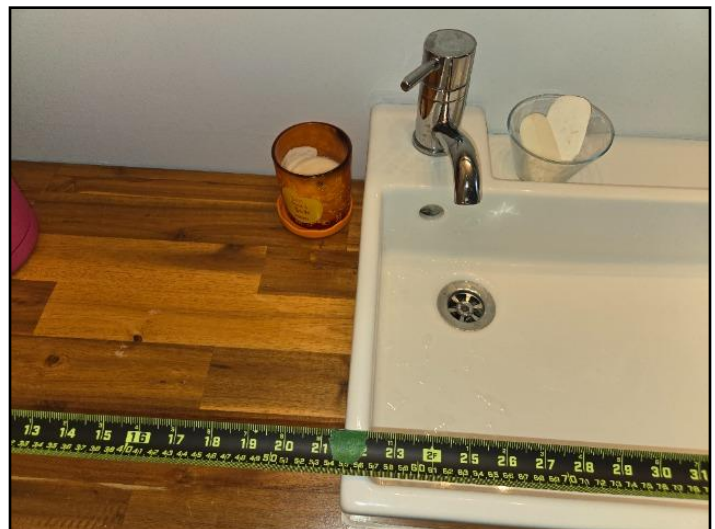
No GFCI/GFI (Ground Fault Circuit...)

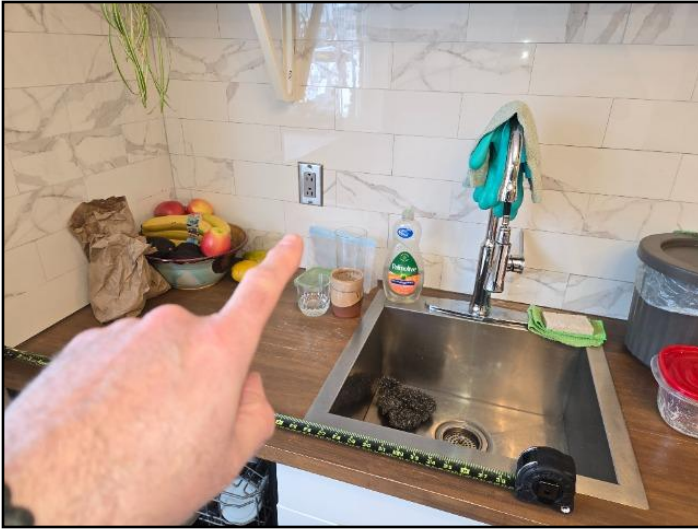
No GFCI/GFI (Ground Fault Circuit...

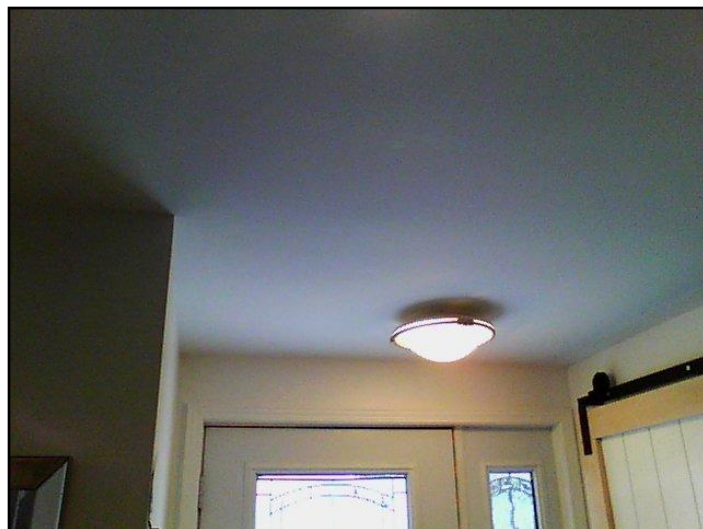
Gaps or voids

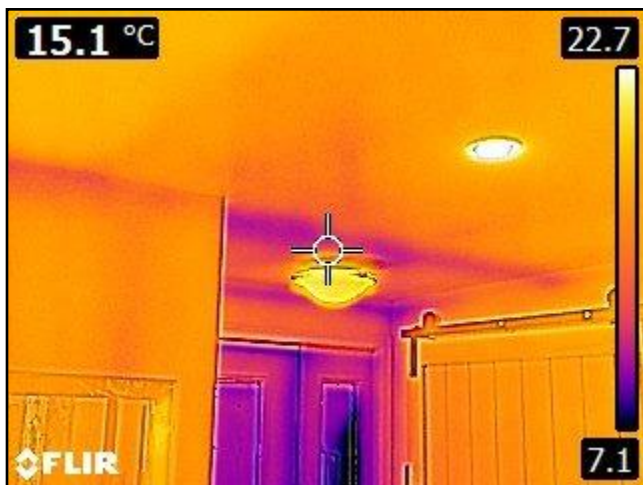
Gaps or voids

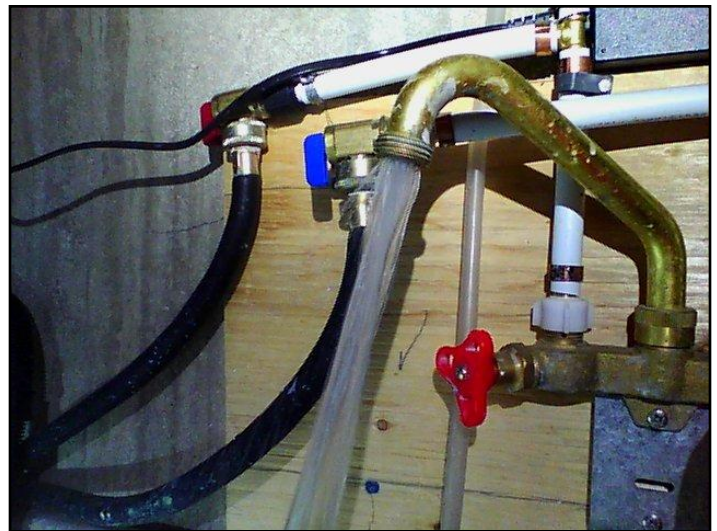
Water too hot
