# INSPECTION REPORT

For the Property at:  
**SAMPLE PROPERTY**  
GATINEAU, QC XXX XXX

RE: Report No. 1230  
Sample Property  
Gatineau, QC  
XXX XXX

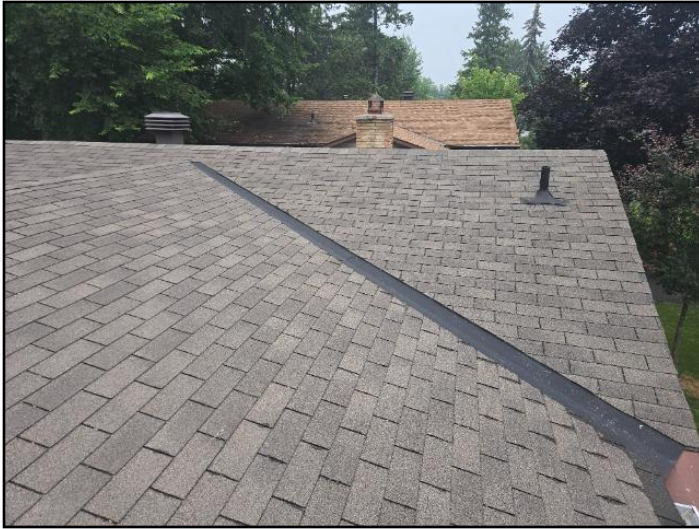
The asphalt shingle roofing system was observed to be at or nearing the end of its expected service life. Widespread signs of age-related deterioration were noted, including granular loss, tab separation, and exposed fibreglass matting at various locations. In addition, localized soft spots were identified adjacent to the main plumbing vent stacks at the front, suggesting deterioration of the underlying roof sheathing in this area.

Granule loss

It is recommended that a qualified roofing contractor perform a comprehensive evaluation of the roof. Localized repairs to the deteriorated sheathing around the plumbing vent stacks are required; however, due to the overall age and condition of the roofing material, budgeting for a complete roof replacement in the near future is strongly recommended.

Replacement should include inspection and repair of any damaged roof decking, installation of new underlayment, flashing, and plumbing vent flashings, as required.

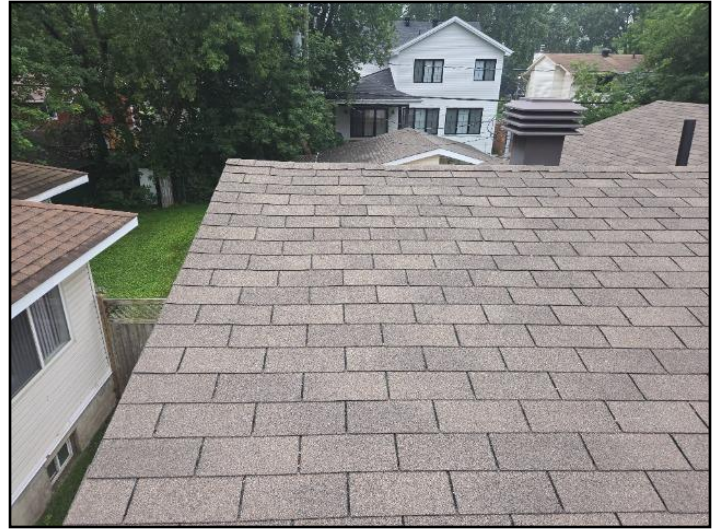
Granule loss

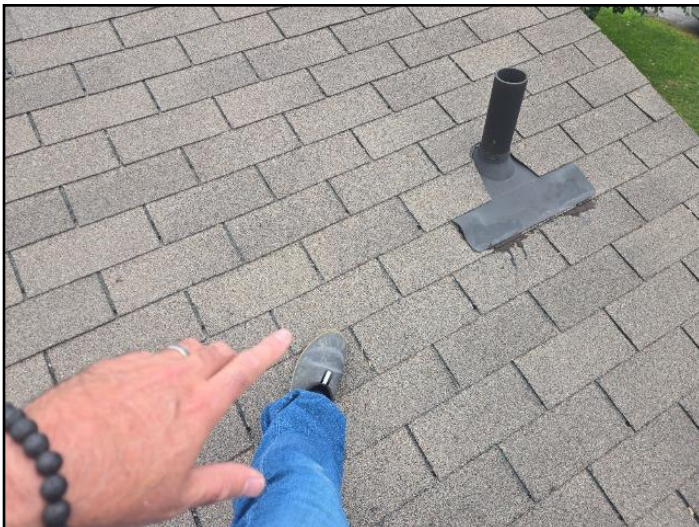
Soft spot

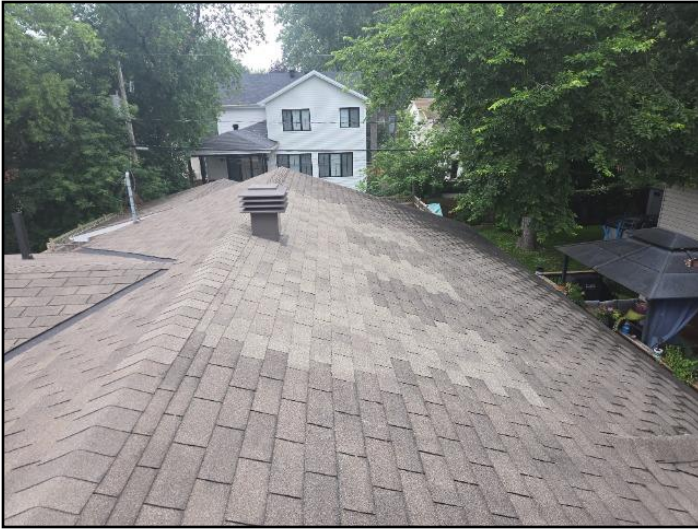
Granule loss

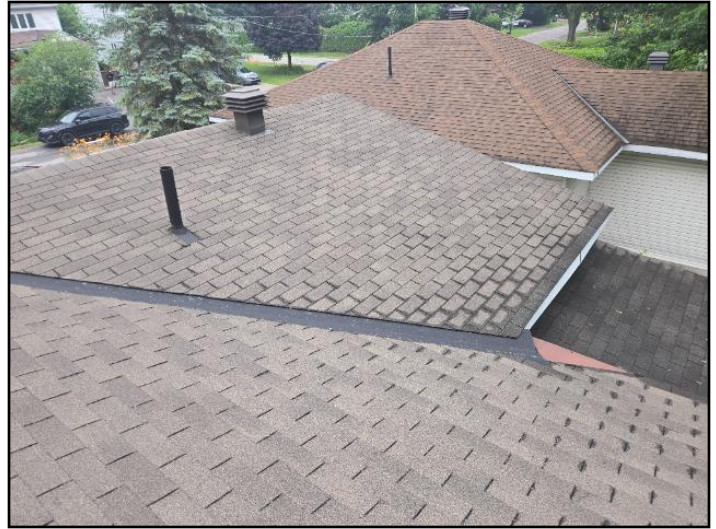
Granule loss

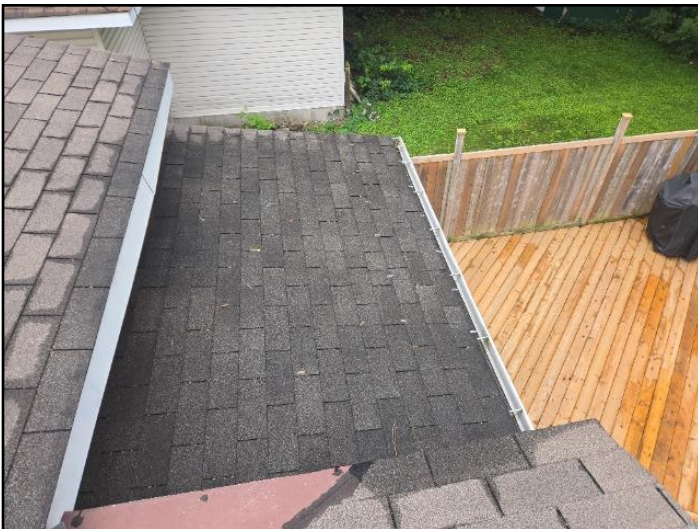
Granule loss

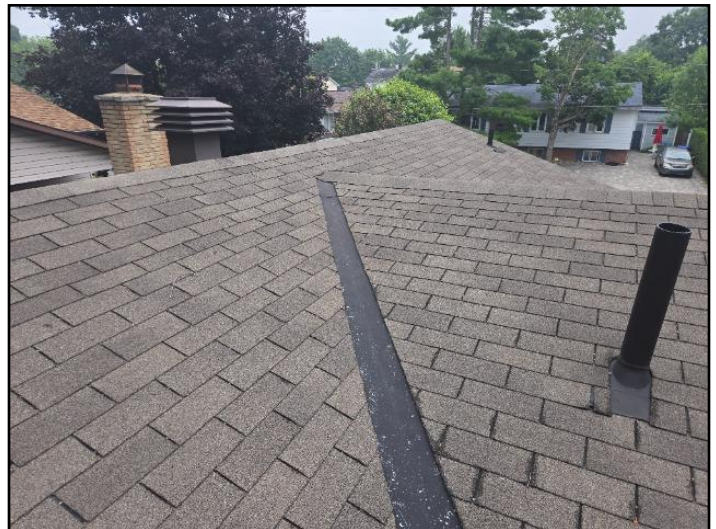
Granule loss

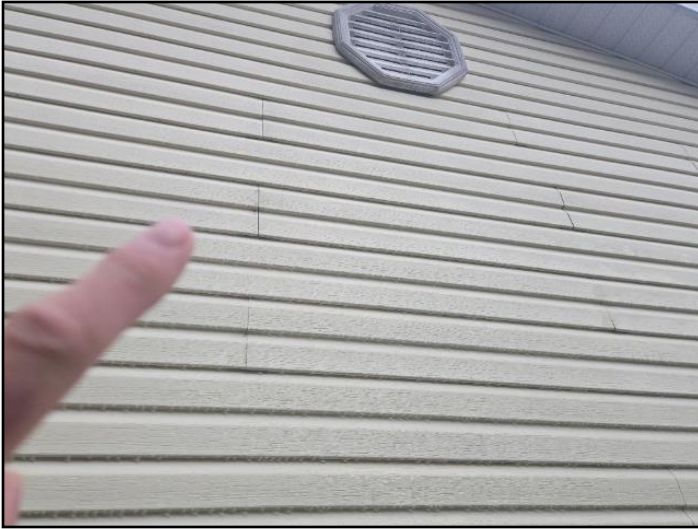
*Joint separation*

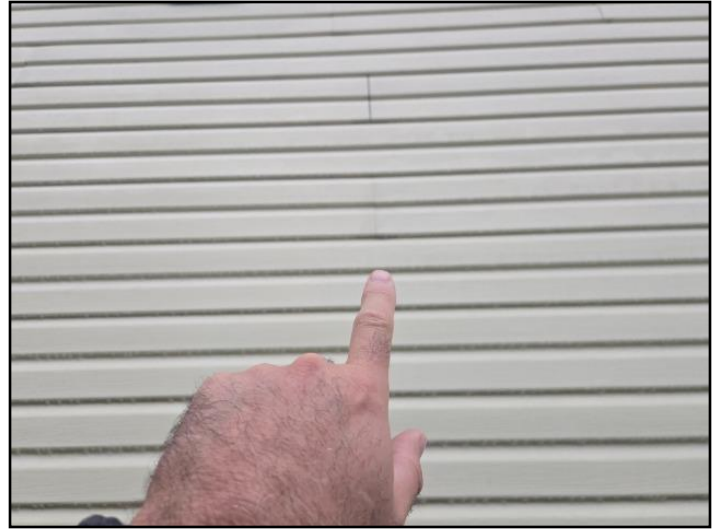
*Joint separation*

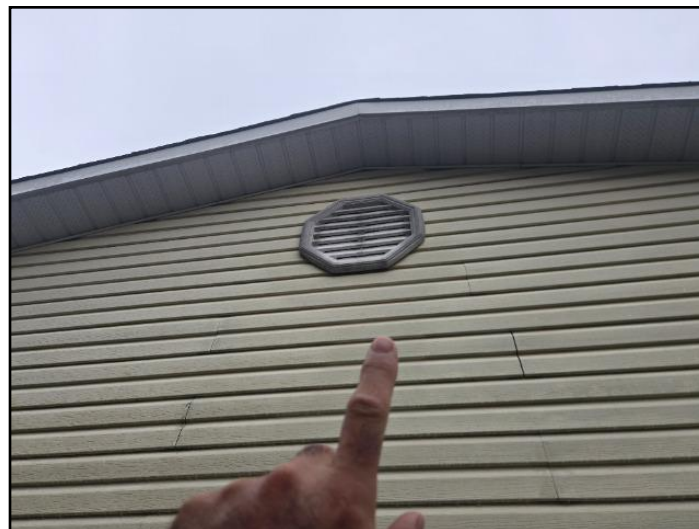
*Joint separation*

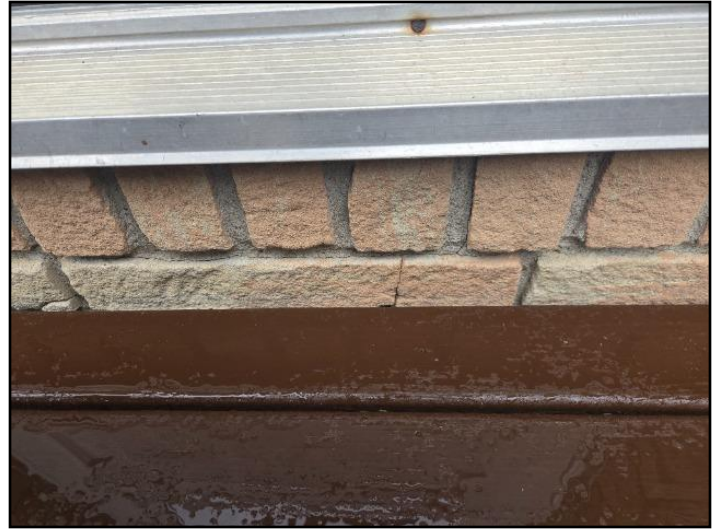
Cracked

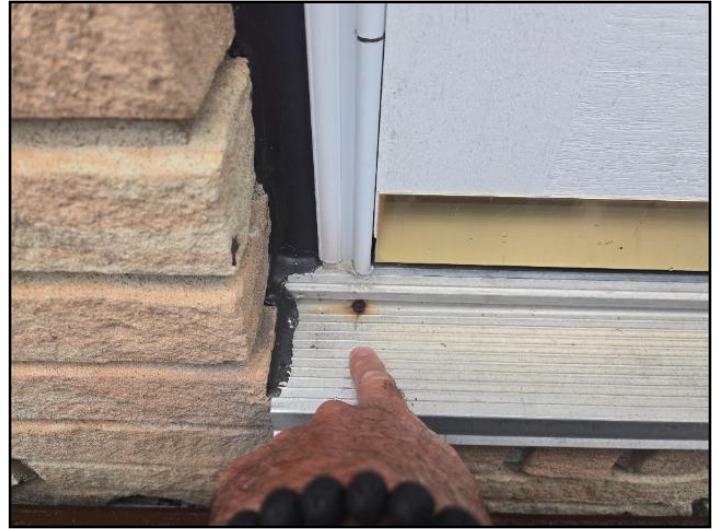
Rust

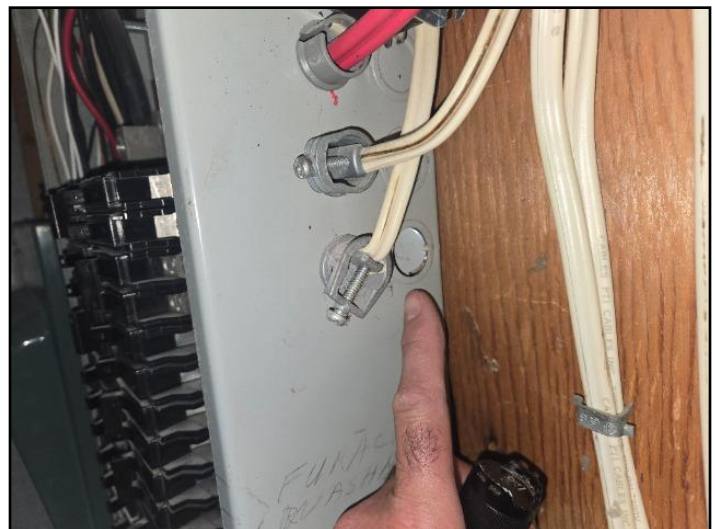
Unprotected openings

It is recommended that a licensed electrician install approved knockout seals in all unused panel openings and verify that all cable entries are properly secured and protected to maintain the safety and integrity of the electrical enclosure.

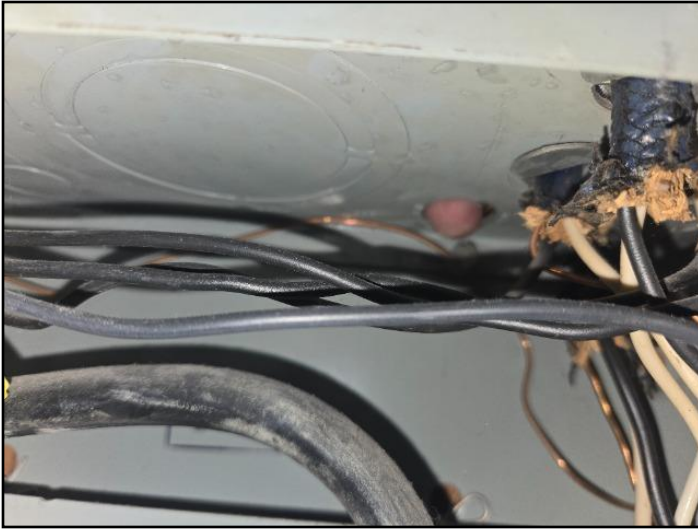
Unprotected openings

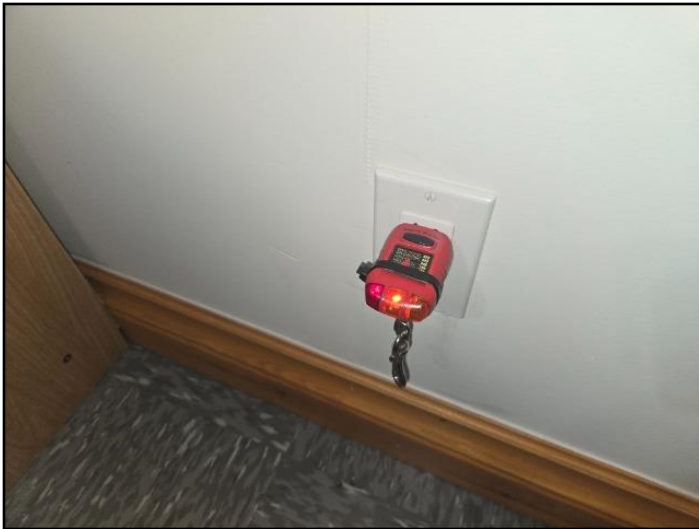
*Reversed polarity Basement*

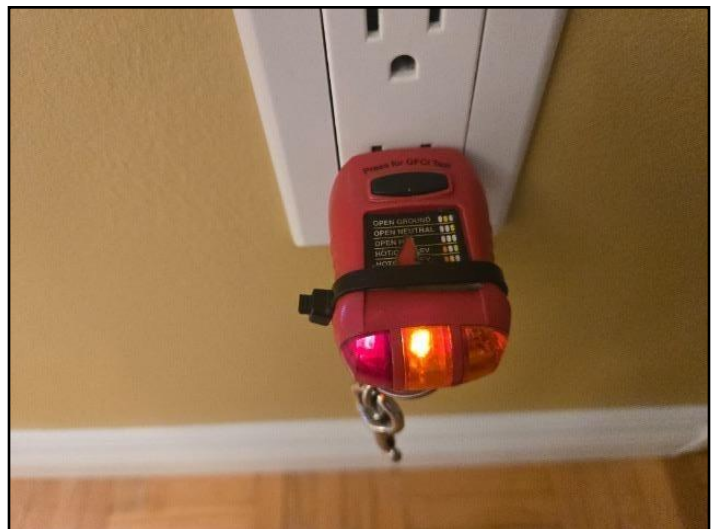
*Reversed polarity Front door*

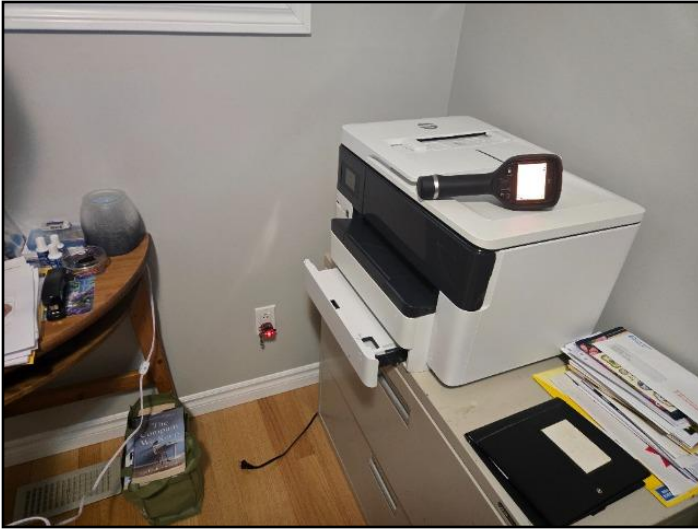
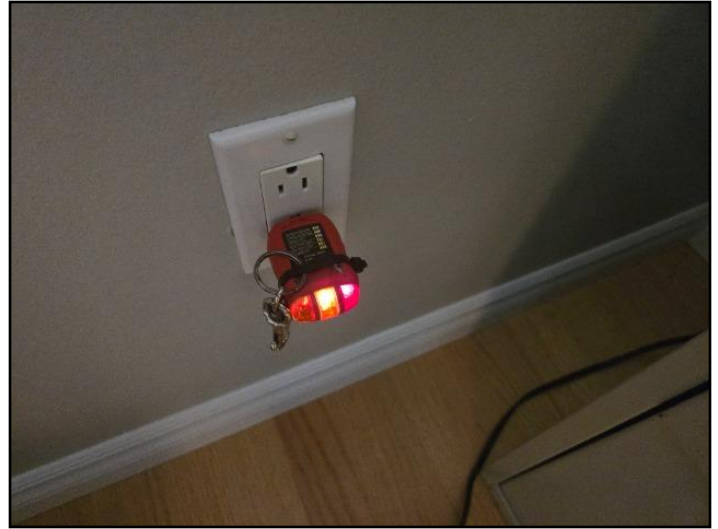
*Reversed polarity Study*

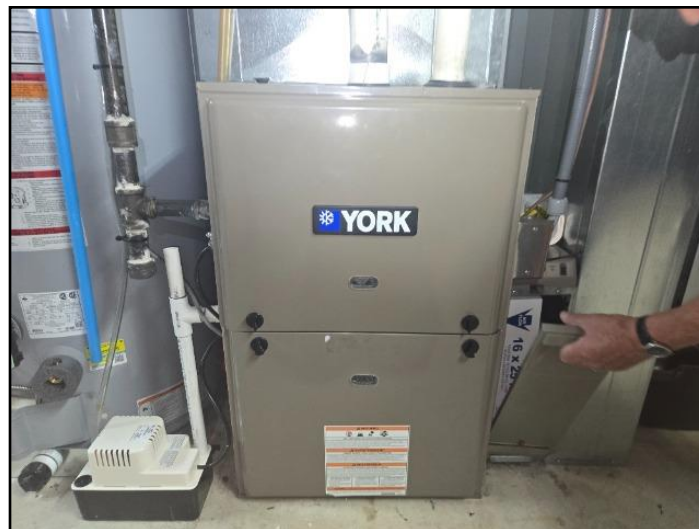
**26. Condition:** • The homeowner reported that the furnace has experienced intermittent short cycling since the central air conditioning system was installed. The furnace completed normal operation during the limited inspection; however, the reported condition could not be confirmed or fully evaluated during the inspection.

*Further evaluate*

Because the reported issue began following the air conditioning installation, it is recommended that a qualified HVAC contractor evaluate the complete heating and cooling system installation, including the thermostat, control wiring, airflow, evaporator coil, blower settings, and safety controls, to determine the cause of the short cycling and perform any necessary repairs or adjustments.

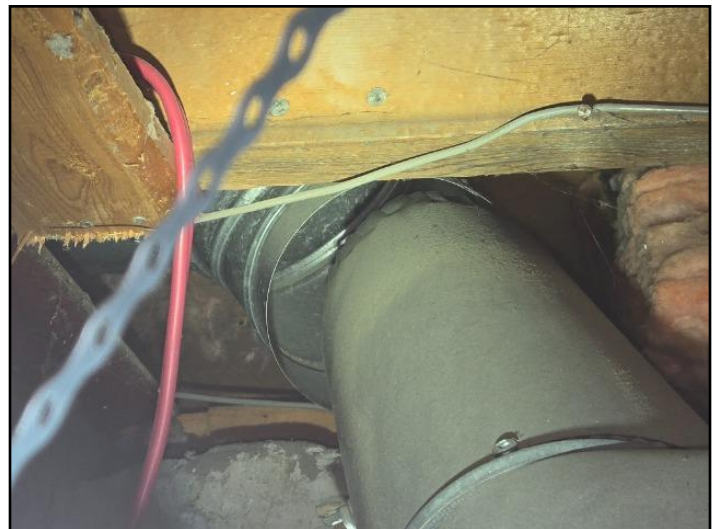
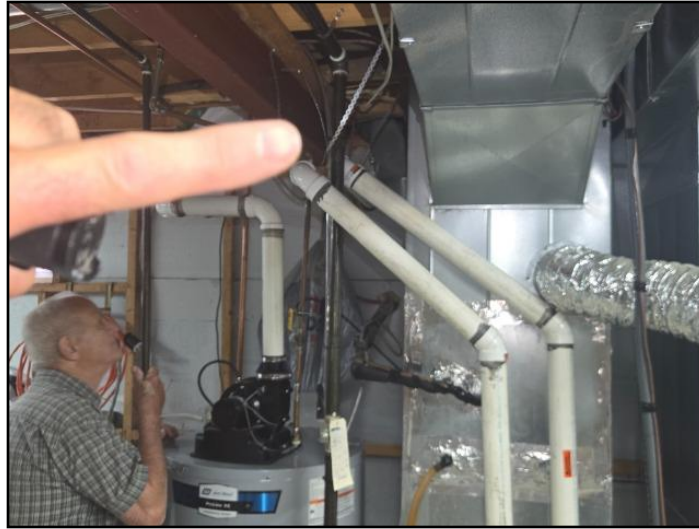
The supply duct located behind the furnace within the basement utility room was observed to be disconnected. A disconnected supply duct can reduce heating and cooling efficiency, decrease airflow to conditioned areas, and allow conditioned air to be discharged into the utility room instead of the intended living spaces.

Disconnected ducts

*Disconnected ducts*

It is recommended that a qualified HVAC contractor reconnect and properly seal the disconnected supply duct using approved materials. The entire duct system should also be inspected to verify that all duct connections are secure, properly supported, and free of air leakage

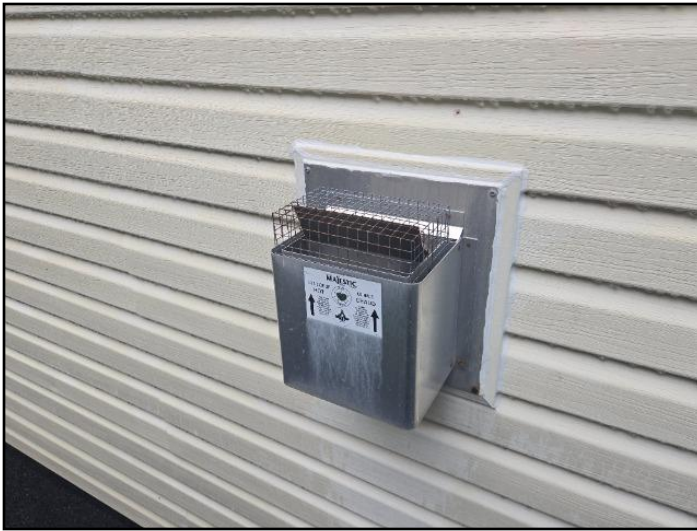
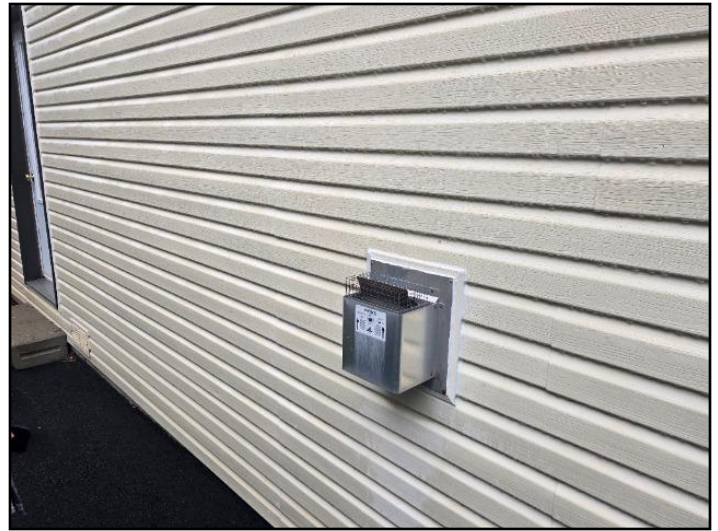
Direct vent clearance

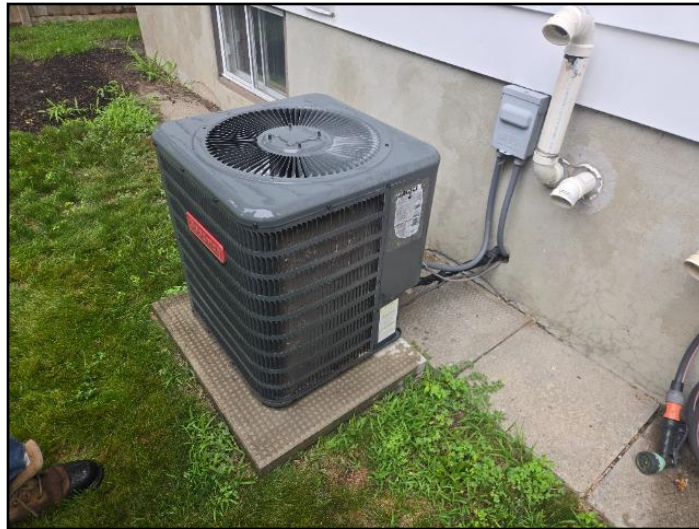
Dirty

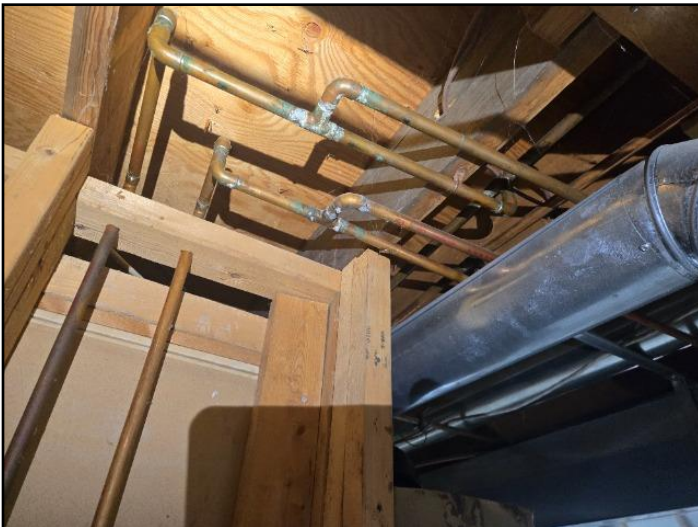
*Green oxidation*

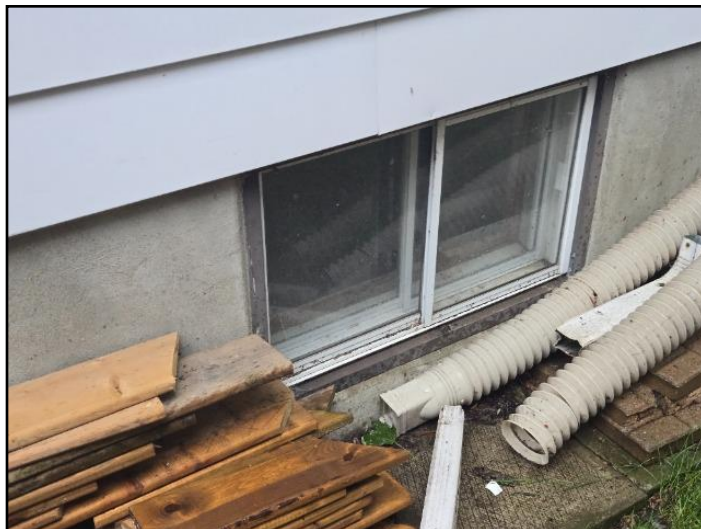
The basement windows appeared older and likely original to the property and consisted of single-glazed sliding units. Fogging was also observed between the panes of one window at the front living room addition, indicating failure of the insulated glazing unit seal.

Old

Consider replacing the older basement windows with modern energy-efficient units. Have a qualified window contractor replace the failed insulated glazing unit at the front living room window; where the frame remains serviceable, the sealed glass unit can typically be replaced without replacing the entire window assembly.

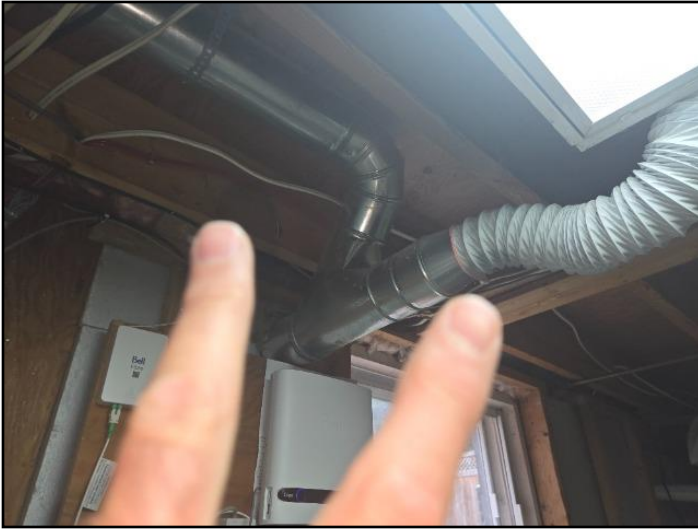
**Implication(s):** Chance of condensation damage to finishes and/or structure

Poor connection

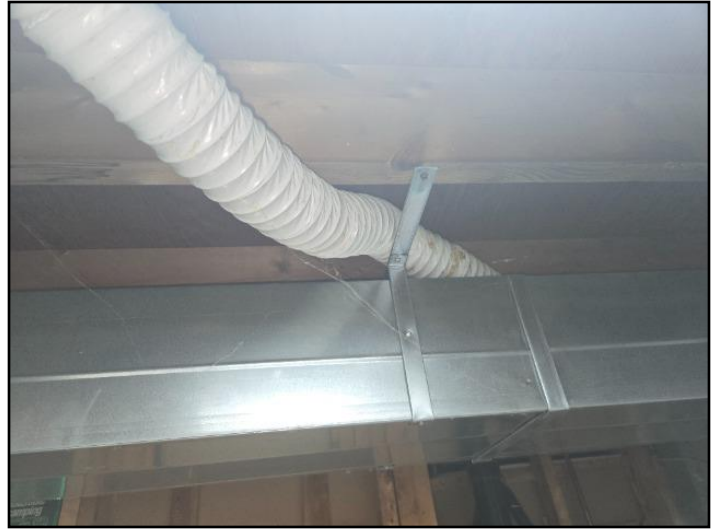
Poor connection
