# INSPECTION REPORT

For the Property at:  
**SAMPLE PROPERTY**  
GATINEAU, QC XXX XXX

Prepared for: SAMPLE CLIENT  
Inspection Date: Thursday, March 19, 2026  
Prepared by: Shaun Botes

RE: Report No. 1228  
Sample Property  
Gatineau, QC  
XXX XXX

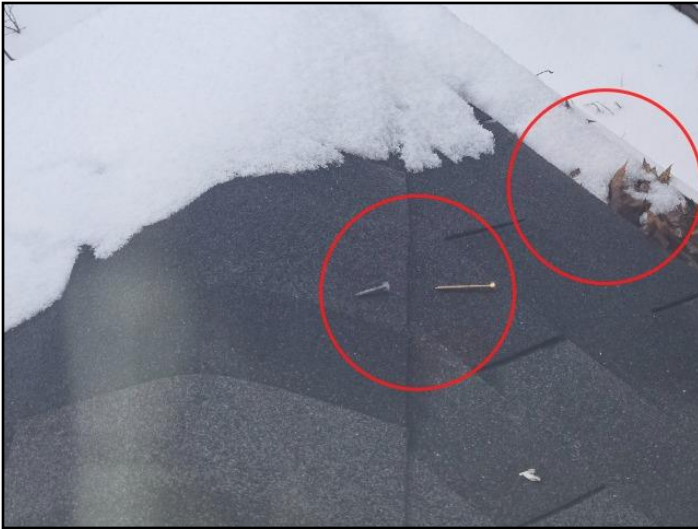
*Mechanical Fasteners/Organic Material*

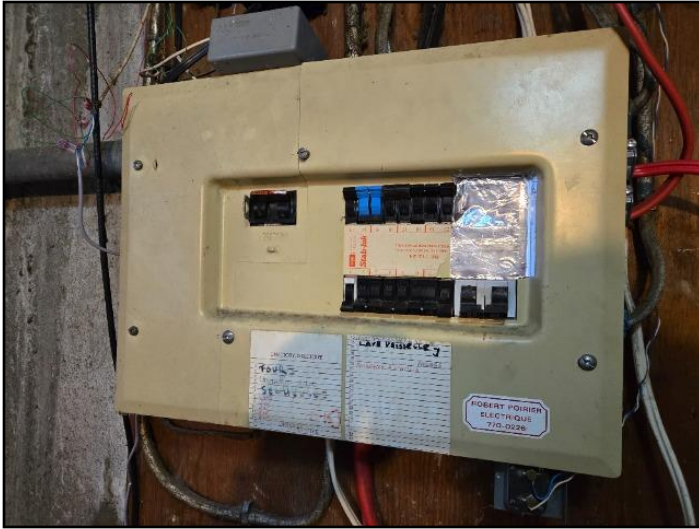
The main electrical panel is a Federal Pioneer Stab-Lok type. During the inspection, several safety and code-related concerns were observed:

- Panel aging
- Exposed openings were noted within the panel, with improper or missing mechanisms to safely cover these openings.
- Multiple circuits were double-tapped (two wires connected under a single breaker terminal), which can create overheating risks.
- Several electrical wires were routed across the bus bar.

These conditions present potential safety hazards, including increased risk of electrical arcing, short circuits, and fire. The Stab-Lok design has known reliability concerns and has been identified in some jurisdictions as requiring careful evaluation by a licensed electrician.

*Aging Federal Pioneer/Stab-Lock*

It is strongly recommended that a licensed electrician evaluate the panel as soon as possible. All exposed openings should be properly covered, double-tapped circuits should be corrected, and wires should be appropriately terminated and organized within the panel. Given the Stab-Lok design, the electrician should assess the overall condition of the breakers and panel to determine if replacement or upgrades are advisable to meet modern electrical safety standards.

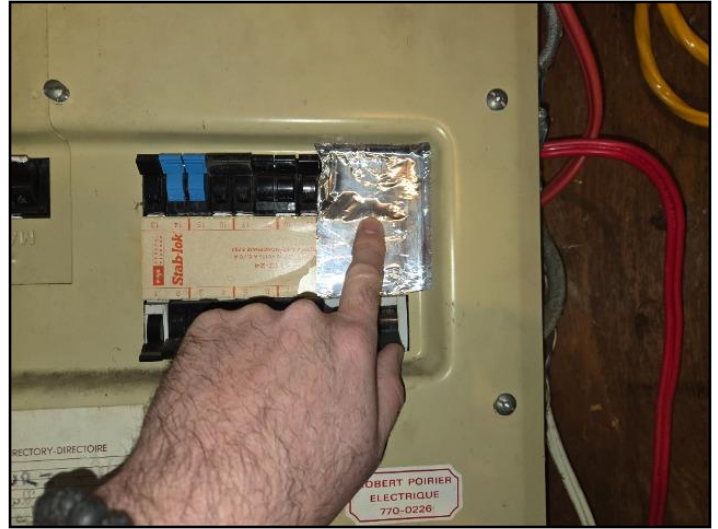
*Exposed openings*

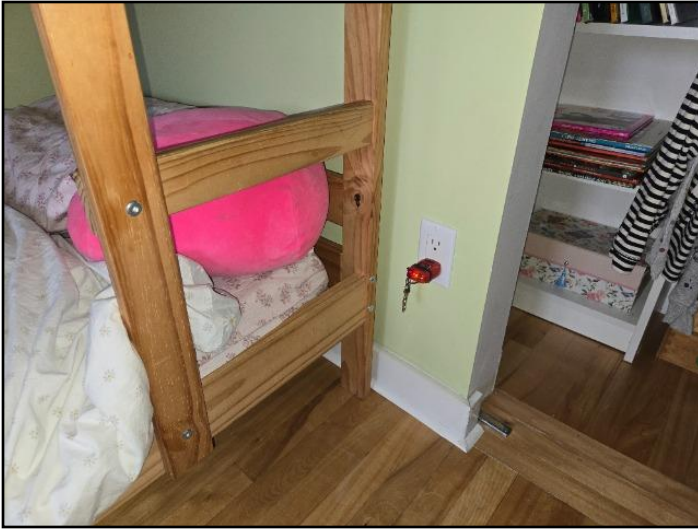
*Reversed polarity*

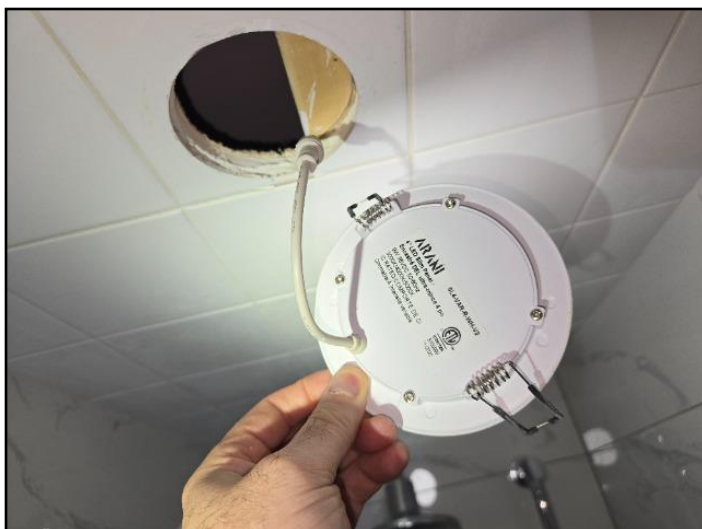
*Conventional lights in wet areas*

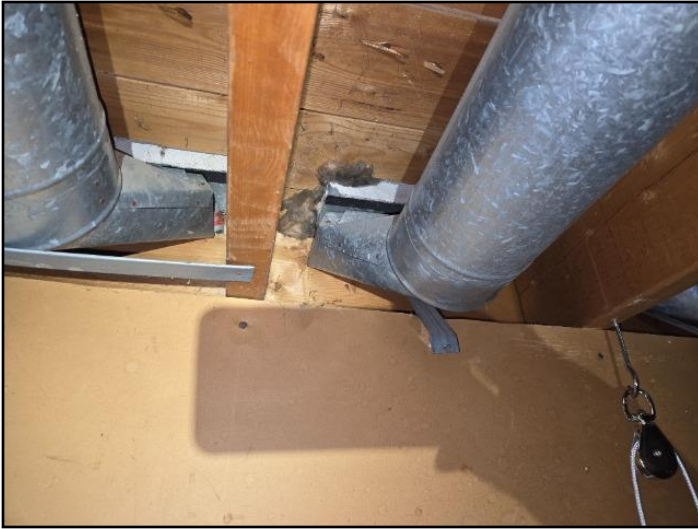
*Disconnected ducts*

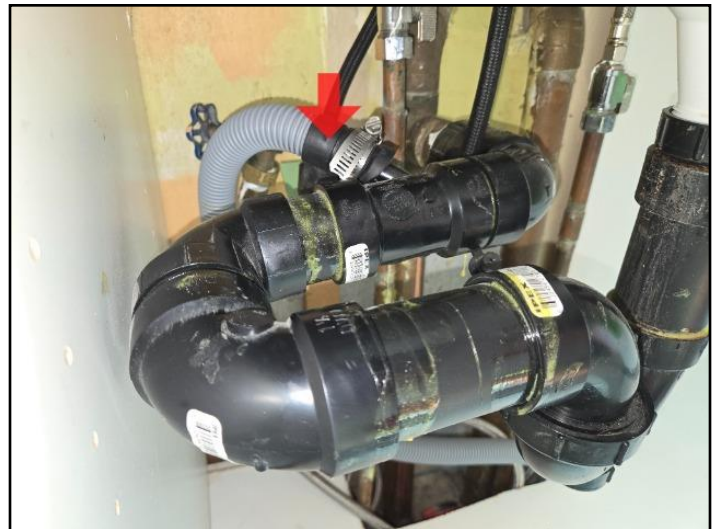
Dishwasher drain connections

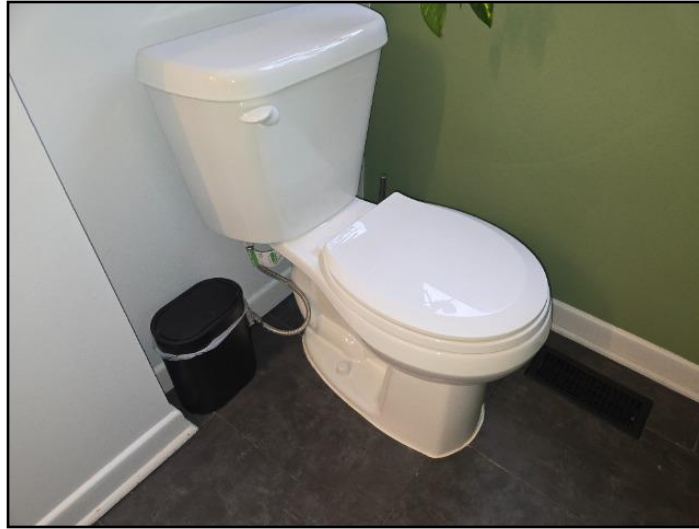
The toilet in the powder room is sealed to the tile floor with a bead of sealant. This creates a watertight joint at the base of the toilet, preventing surface water and debris from entering the gap between the fixture and the finished floor. While this is a common practice for sanitation and moisture protection, it can conceal early signs of a failed wax seal if a leak occurs.

Sealant

It is recommended to maintain the sealant in good condition and inspect it periodically for cracks or deterioration. For early leak detection, some professionals recommend leaving a small gap at the rear of the toilet unsealed. A qualified plumber should ensure the toilet and wax ring are properly installed before sealing and verify that the bead of sealant is applied correctly to protect the floor while allowing for visual monitoring of potential leaks.

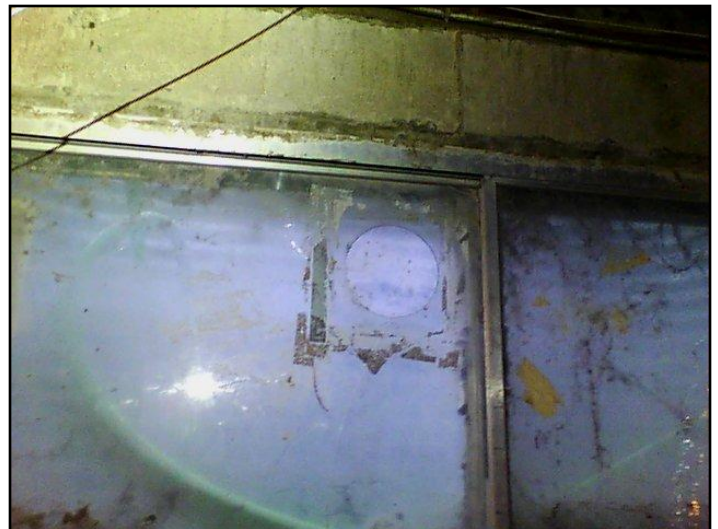
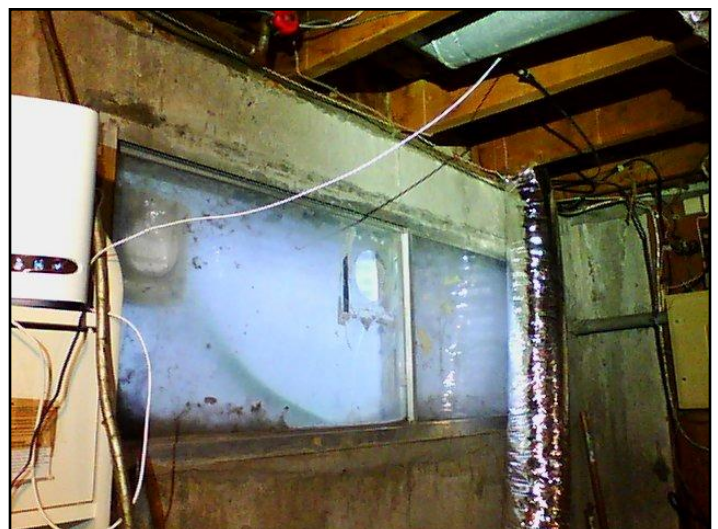
The window at the rear of the basement is a single-pane sliding glass unit, consisting of one panel on the interior and one on the exterior. Deterioration and penetrations were observed within the glazing, allowing cold air infiltration at this location. The window appears to be aged and is not performing effectively as part of the building envelope.

Old

It is recommended that the window be replaced with a modern, energy-efficient unit (e.g., double-glazed) to improve thermal performance and prevent air infiltration. Replacement will enhance comfort, reduce energy loss, and improve the overall integrity of the building envelope.

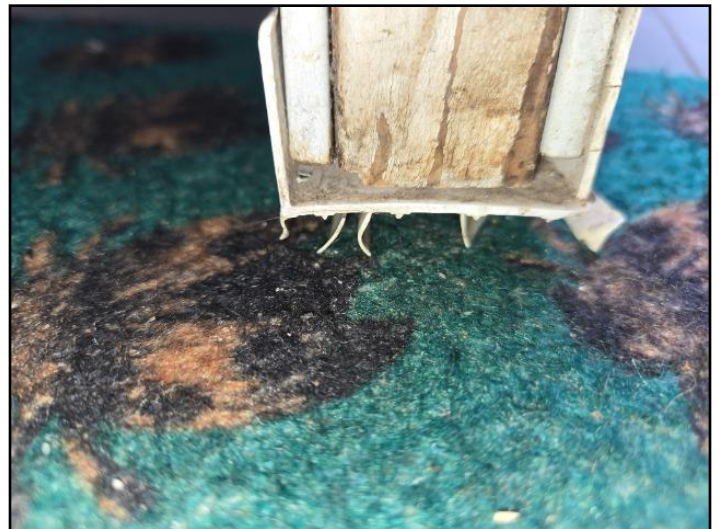
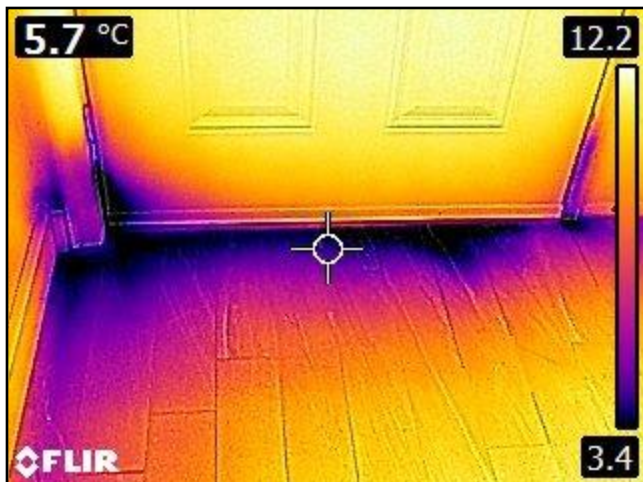
Weatherstripping ineffective

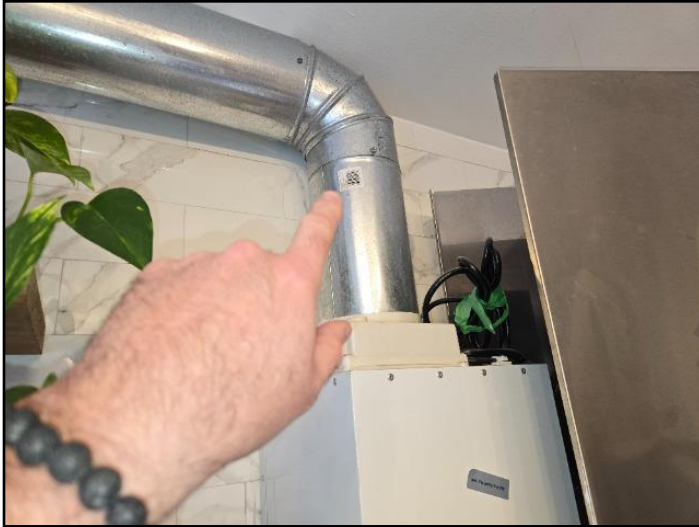
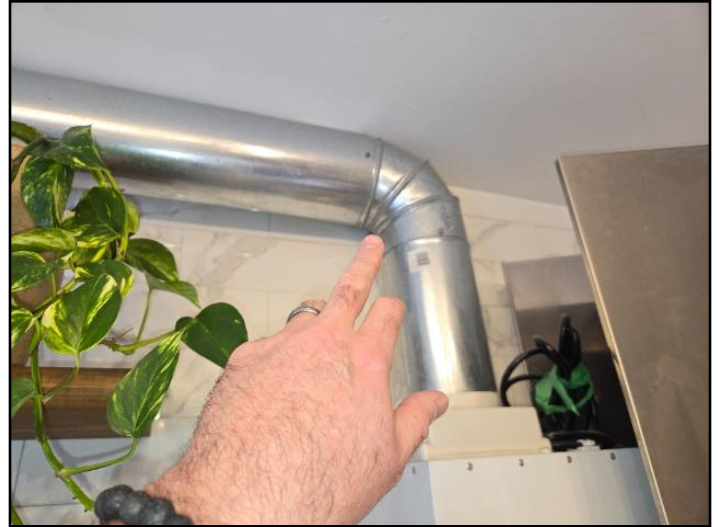
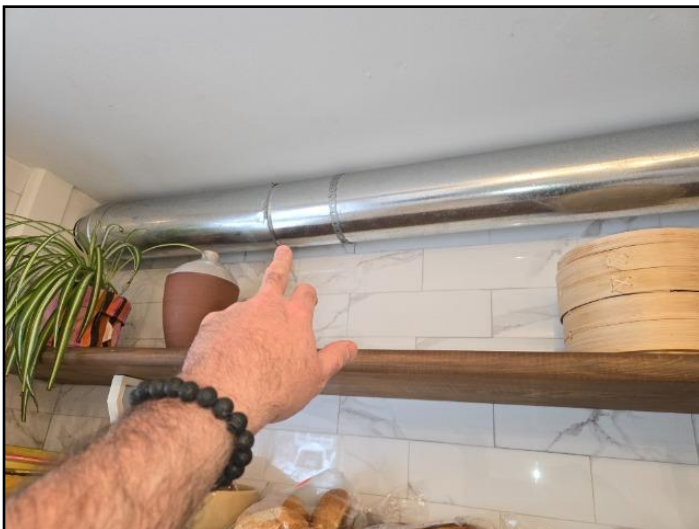
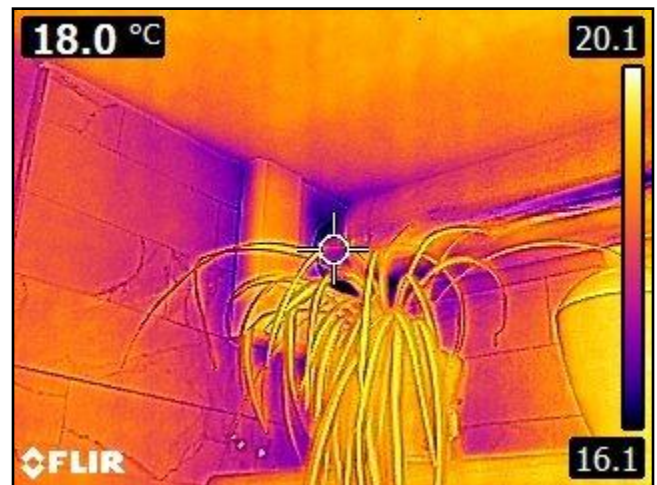
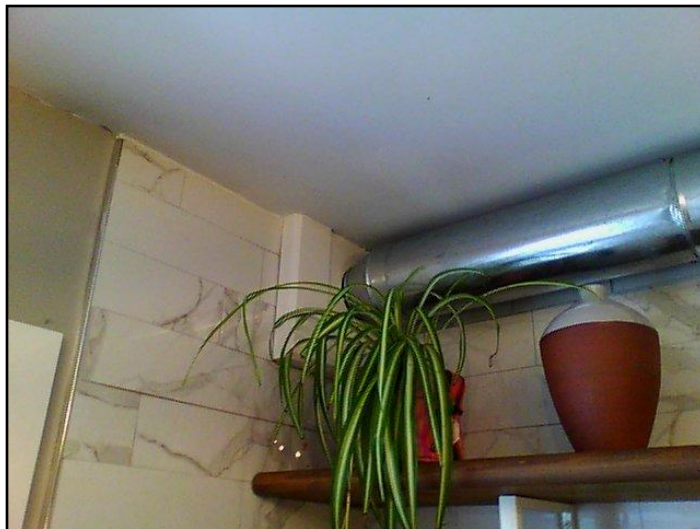
Poor connection

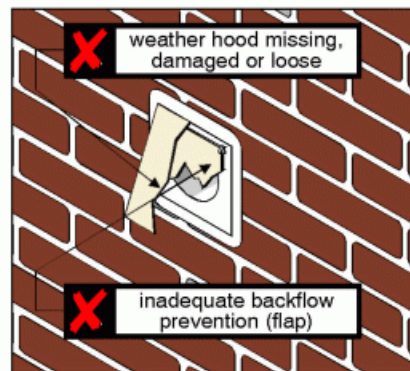
Improper Plastic Vent Termination
